PROJECT PROFILE

Robert D. Moreton Building

Assessment of Distress to Precast Facade Panels | Austin, TX

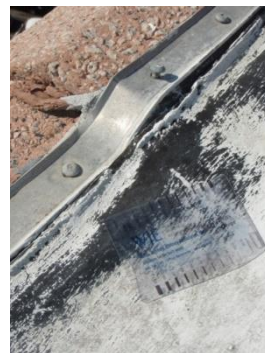
At the time of WJE's facade assessment, the distressed panels at the Moreton Building were comprised of an architectural concrete mix, with exposed crushed granite aggregate and pink pigment. The wall panel distress included bowing of the precast wall panels, separations in wall finishes adjacent to the exterior walls, and spalling of the panels near joints. WJE was requested to perform an assessment of the panel bowing.

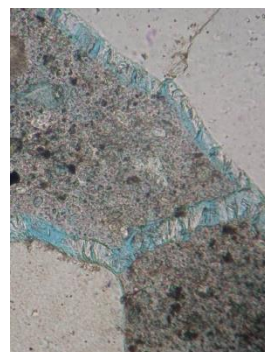
WJE's initial investigation included a visual condition survey and laboratory analysis of core samples taken from the building. Through this assessment, WJE was able to determine that the distress was due to delayed ettringite formation, a type of internal sulfate attack. WJE performed additional laboratory analysis and determined it was highly likely that the distress would continue, to the point that the structural integrity of the panels could be compromised. WJE developed temporary repairs to slow the rate of distress but recommended that the State plan to eventually replace the panels. The State implemented the temporary repairs and then began allocating funds for removal of the panels and replacement of the building envelope. WJE subsequently served as the exterior envelope consultant on the design team for the recladding project.
