**PROJECT PROFILE**

# Frankford Elevated Rapid Rail Line

Bearing Failure Evaluation and Repair Design | Philadelphia, PA

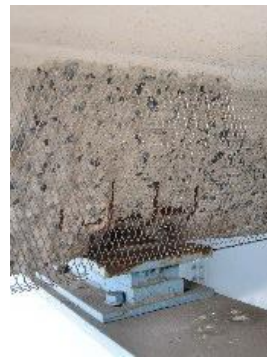
The Frankford elevated rapid rail line was reconstructed due to deterioration coupled with constant inspection and maintenance. The new design was intended to have a life span of 100 years. Shortly after reconstruction was complete, haunch bearings began cracking and spalling. Others recommended repairs but did not identify the cause of distress. WJE was retained by SEPTA to perform a peer review of previous analysis and reports, review existing haunch bearing conditions, determine the cause of concrete haunch distress, and provide repair details.

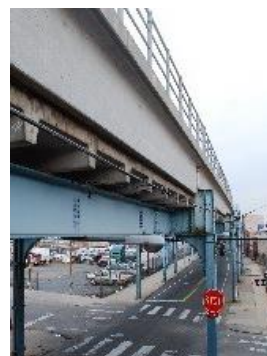
WJE visually inspected and documented the condition of 18,000 haunches using a web-based user interface developed in-house and database software. WJE engineers installed instrumentation to perform field testing under controlled conditions and during normal train operation to measure the cyclic loads, stresses, and displacements experienced by the haunches and supporting steel stringers. Surplus decks were tested in WJE's structural laboratory to evaluate the different loading mechanisms causing the haunch distress.

A repair was designed and then tested in the structural laboratory based on the field test measurements to determine the ability to resist cyclic loading. The repair design was able to resist over forty-five years of simulated loading without any deterioration or loss of bearing support. The repair has been implemented on the rail line.
