## RESTORING THE MONUMENT

# Monumental

By **Daniel J. Lemieux, AIA, R.A., M.ASCE,**  
and **Terrence F. Paret, M.ASCE**

# Challenge

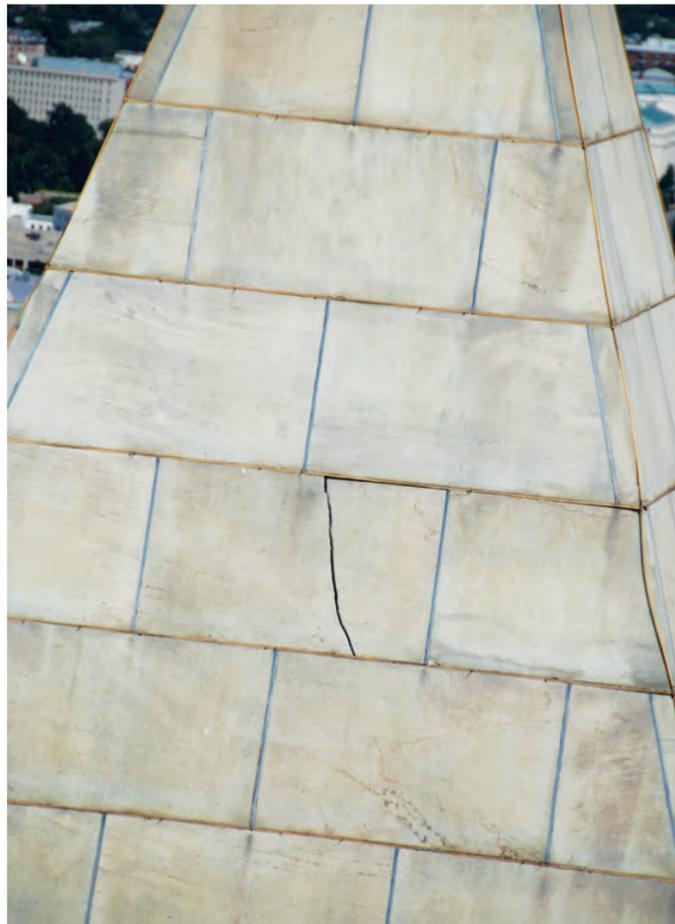
**Cracking is visible on a marble panel unit at course G on the west elevation of the pyramidion (stone W. 529.2).**

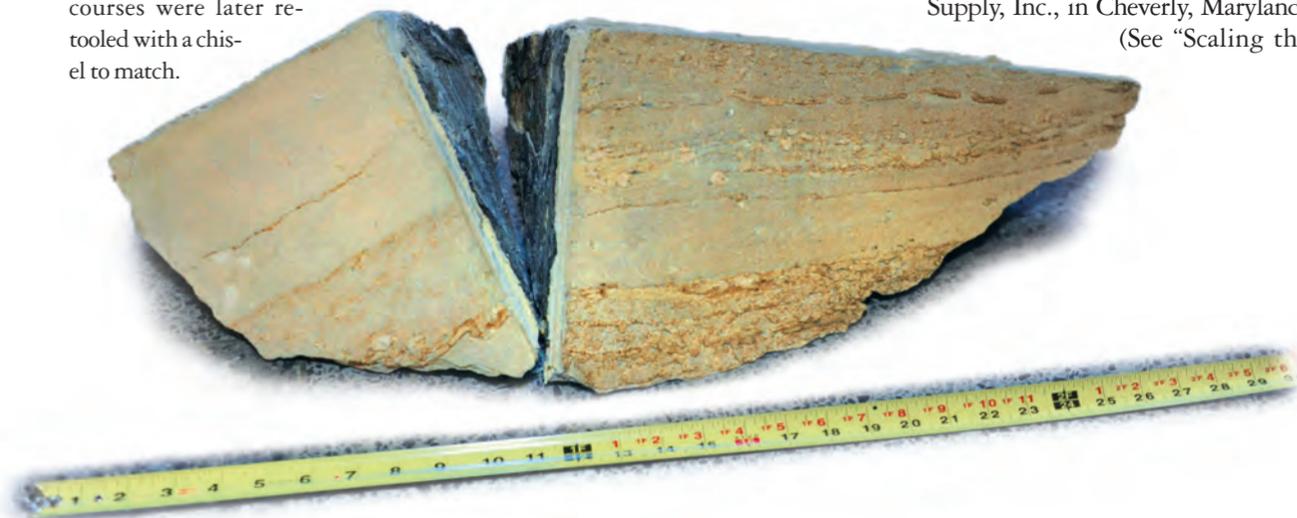
The two largest pieces of stone to be safely removed from the monument were located adjacent to one another at the 490 ft level. They were at the southeast corner on the east elevation.

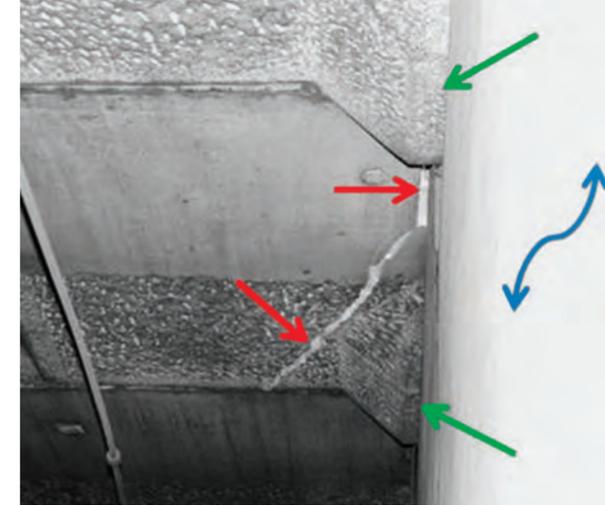
Red arrows indicate a crack at course G on the west elevation of the pyramidion (stone W. 529.2); green arrows indicate the knuckles; the blue arrow indicates the rib. The illustration below indicates the interior construction of the pyramidion as viewed from the west face.

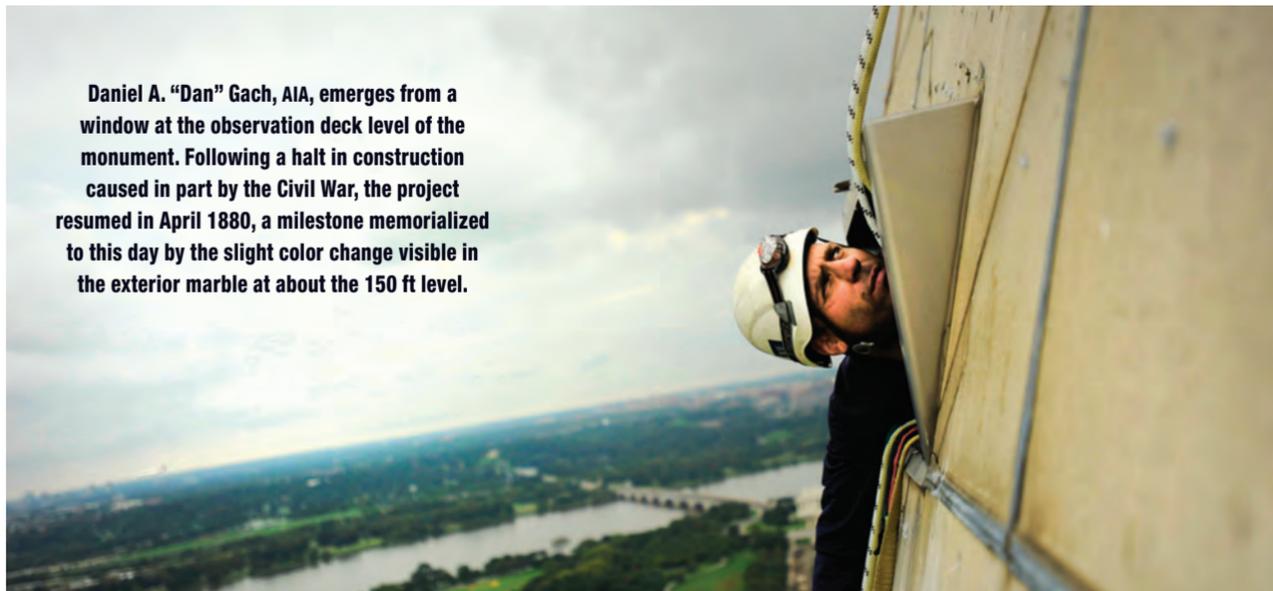
**Daniel A. "Dan" Gach, AIA, emerges from a window at the observation deck level of the monument. Following a halt in construction caused in part by the Civil War, the project resumed in April 1880, a milestone memorialized to this day by the slight color change visible in the exterior marble at about the 150 ft level.**
