180 Grand Avenue
Pre-Purchase Survey and Cladding Investigation
Oakland, California

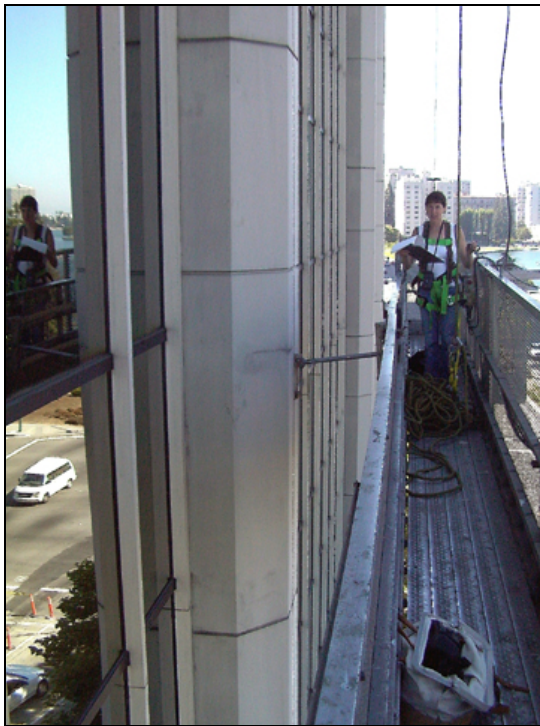
- Performed swingstage "drops" on the exterior of the building (lower photo), identified locations of cracking, and surveyed typical crack patterns
- Observed panel interior surfaces and panel structural supports to ascertain the cause of the cracking and to assess the current condition of the panel supports

- Concluded the GFRC panels were cracking due to a lack of flexibility in the structural supports, which were constructed in a manner that precludes the panels from relieving thermal stresses during daily heating and cooling (expansion and contraction) cycles
- Observed that the existing structural supports were relatively free of corrosion and appeared adequate to continue supporting the panels
- Recommended initiation of a regular maintenance program to help limit water intrusion and to monitor the cracking in the panels
- Provided recommendations for routing and sealing the cracks in the GFRC panels
