1901 Van Ness Avenue

Evaluation of Blast and Fire Damage
San Francisco, California

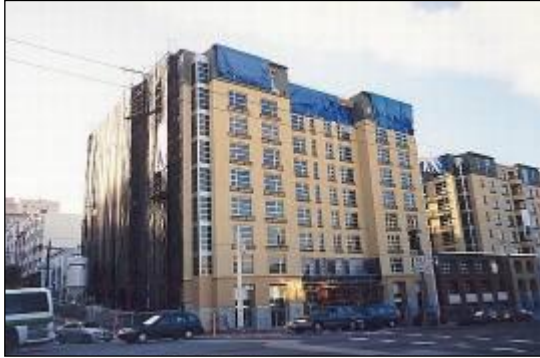
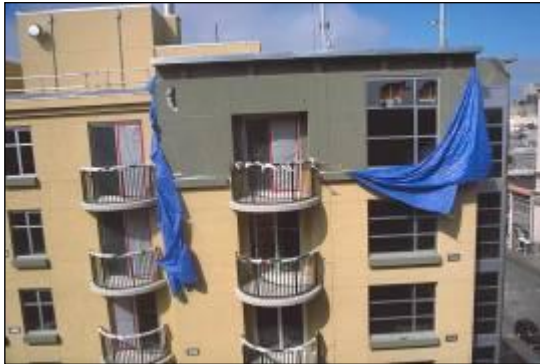
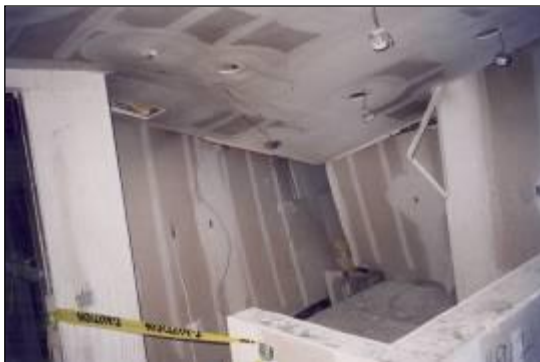
During construction of two residential towers, an explosion occurred in the top floor of the south tower. The blast and subsequent fire caused extensive damage to the stucco cladding, nonstructural partitions, ceilings, and windows. While much of the damage was easily identified, the insurance company was concerned about the presence of less obvious damage to both structural and nonstructural elements.

Through simple visual examination and limited nondestructive sounding, we quickly determined that damage to the buildings' structural systems was limited to minor spalls that had no impact on structural integrity. WJE's findings were later confirmed through additional testing by an independent laboratory. We also identified the limits of blast and fire damage to the exterior cladding and helped develop evaluation criteria for interior partitions and windows.
