PROJECT PROFILE

# Cable-Stayed Roof Structure

Structural Cable Inspection | Midwest

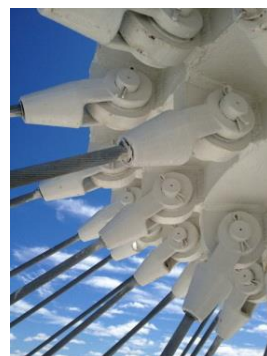
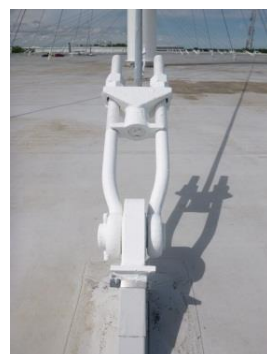
Each suspender cable is composed of many small diameter steel wires that are wound in a helical pattern. During WJE's inspection, some cables were noted to have localized discoloration or light surface corrosion beginning between the individual cable strands. Also, near the upper ends of several cables, water dripping from the top row of clevises onto cables anchored at the two rows below caused areas of the lower cables to experience prolonged exposure to moisture. Accelerated wear of the galvanized coating in localized areas and the onset of corrosion began as a result. Spreading of the individual wires of the cables in these areas was observed at one such location. Abrasion of the galvanized coating along the length of the cables was also observed to have caused moderate surface corrosion in localized areas.

The level of corrosion did not pose a structural concern. However, since these cables serve as the primary structural support for the roof, WJE recommended a more frequent inspection cycle to establish the rate of progression of the corrosion on the cables. To avoid the expense of constructing scaffolding around the cables to facilitate access for inspections, WJE was retained to utilize industrial rope access techniques to access the tops of the masts and to inspect the lengths of the cables and their anchorages. Climbing, rappelling, and ascending were utilized to provide arms-length inspection of the cable anchorages at the tops of the masts as well as at an assortment of cables during each inspection.
