PROJECT PROFILE

# Duke University Chapel

Visual Inspection of the Vaulting System | Durham, NC

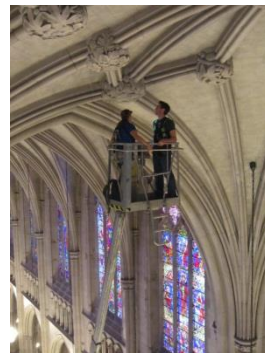
In the summer of 2012, a stone fragment from one of the stone ribs was discovered on the floor of the nave. The University erected scaffolding in the bay where the stone fragment was discovered and contacted WJE to perform an initial inspection of the vaulted ceiling system. Following the initial inspection, a close-up visual inspection was performed from lifts.

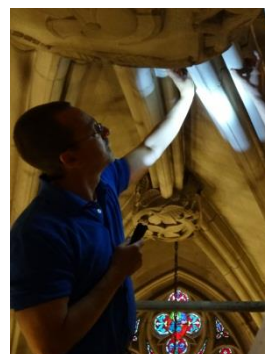
The close-up inspection revealed cracks in several keystones, stone ribs, Akoustolith ceiling tiles, and mortar joints. Separations were noted between the stone ribs and the Akoustolith ceiling, and vertical translation of individual stones in the vaulted ribs was observed in several locations. Cracking and movement of the stone ribs likely occurred over a long period of time, as evidenced by observations of sealer applied in 1973 both inside of and stretched across the existing cracks. At one of the displaced pieces, spalled white mortar indicated recent movement, and the cracking pattern suggested upward movement of the crown and lateral movement of the lower portions of the ribs. The cause(s) of these movements were not readily apparent from the results of the close-up inspection; however, the widespread nature of the distress reflected a systemic problem rather than a localized condition. Loose pieces of stone and mortar were removed during the close-up inspection, yet continued movement will likely result in additional loose pieces.

To temporarily stabilize the area until permanent repairs could be made, WJE recommended hanger rods be attached to anchors set into the stone pieces and to steel angles anchored to the concrete roof deck above. Long-term repairs will be determined from additional materials testing and structural analysis.
