PROJECT PROFILE

Duke University Chapel

Visual Inspection of the Vaulting System | Durham, NC

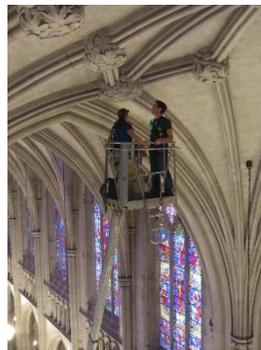
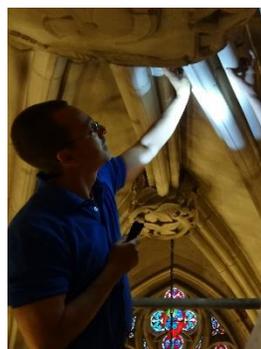
The close-up inspection revealed cracks in several keystones, stone ribs, Akoustolith ceiling tiles, and mortar joints. Separations were noted between the stone ribs and the Akoustolith ceiling, and vertical translation of individual stones in the vaulted ribs was observed in several locations. Cracking and movement of the stone ribs likely occurred over a long period of time, as evidenced by observations of sealer applied in 1973 both inside of and stretched across the existing cracks. At one of the displaced pieces, spalled white mortar indicated recent movement, and the cracking pattern suggested upward movement of the crown and lateral movement of the lower portions of the ribs. The cause(s) of these movements were not readily apparent from the results of the close-up inspection; however, the widespread nature of the distress reflected a systemic problem rather than a localized condition. Loose pieces of stone and mortar were removed during the close-up inspection, yet continued movement will likely result in additional loose pieces.

To temporarily stabilize the area until permanent repairs could be made, WJE recommended hanger rods be attached to anchors set into the stone pieces and to steel angles anchored to the concrete roof deck above. Long-term repairs will be determined from additional materials testing and structural analysis.
