Fresenius Building

Slab-on-ground Assessment

Oregon, Ohio

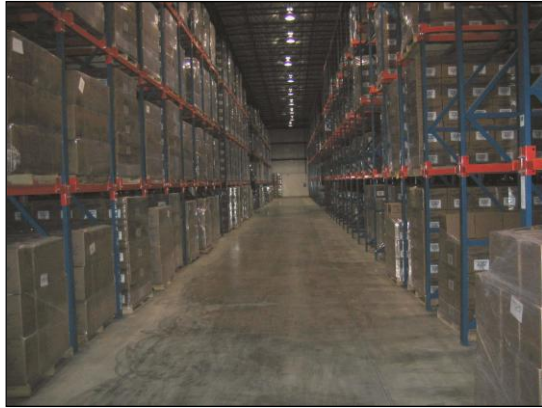
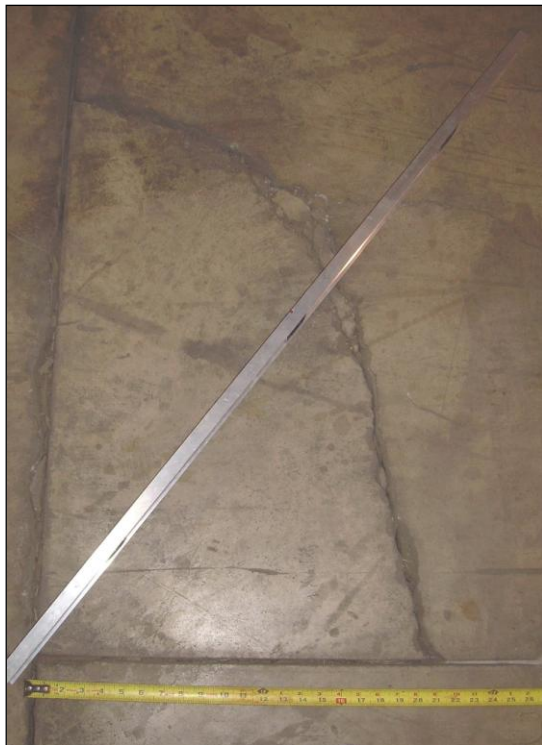
The Fresenius Building is an industrial warehouse building with a 6-inch-thick concrete slab-on-ground. After less than three years, the slab exhibited widespread cracking, wide joint openings, and excessive surface undulations.

A review of the slab system indicated that it was generally well suited for the loadings that existed at the time of our evaluation. We also concluded that the observed distress was due primarily to curling with some evidence of localized soil problems; future distress related to these problems should not be extensive. Since, in general, the distressed areas of the slab system remained serviceable, we developed a series of recommendations to improve their stability and reduce the potential for future deterioration.
