Georgia Transmission Towers

Evaluation of Foundational Cracking | Various Locations, GA

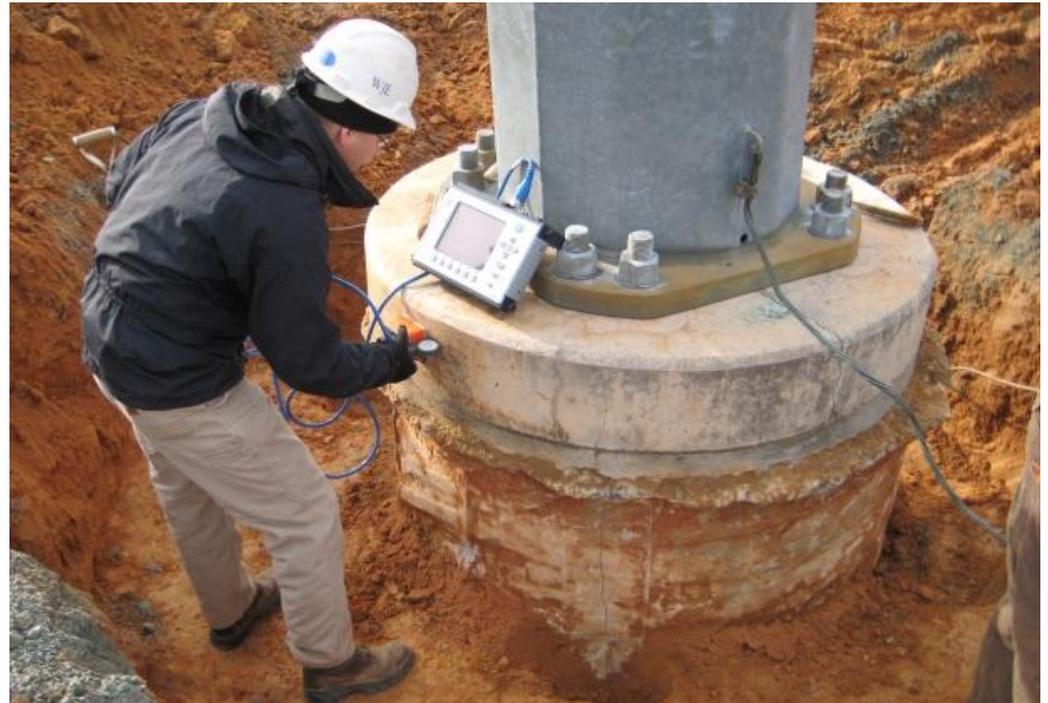
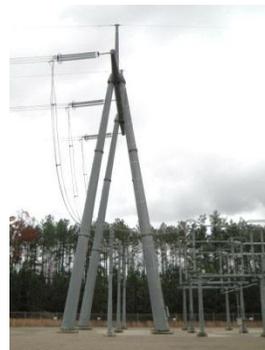
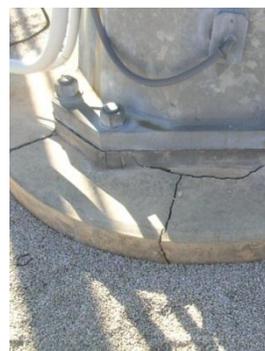
The cracks, oriented both radially and longitudinally, were commonly 0.100 inches or wider, while some were as wide as 0.625 inches. The cracks initiated primarily at the surface and top corners of the piers and typically passed through or were in close proximity to the anchor bolt locations.

Using microscopic techniques, WJE petrographers identified the likely causes of the cracking: volume change of the concrete as a result of drying shrinkage, autogenous shrinkage, temperature change, and internal chemical reactions such as Alkali-Silica Reaction and Delayed Ettringite Formation. Based on these findings, various temporary and long-term repair options were presented to the client to address both immediate safety concerns and to extend the service life of the existing tower foundations.
