PROJECT PROFILE

Kenosha Medical Center Campus

Masonry Distress Investigation and Repair Design | Kenosha, WI

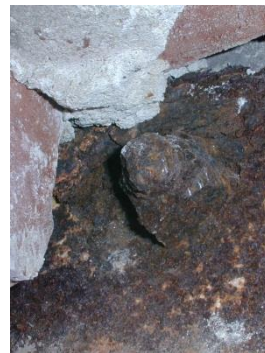
A masonry-clad hospital building experienced problems of moisture penetration, staining of exposed surfaces, outward displacement of masonry, and spalling of limestone trim pieces. The property owner sought to determine the cause of the distress and to implement repairs to restore the exterior walls.

- The mortar contained extremely high levels of chloride ions at concentrations well above the threshold necessary to promote corrosion of embedded steel. The probable source of chlorides in the mortar was the use of calcium chloride as an accelerator during construction in cold weather.
- Advanced corrosion had developed on embedded steel elements in the masonry, including wall ties and shelf angles. Spalling occurred in the masonry as a result of forces generated by this corrosion.
- Poor flashing details allowed water to remain within the walls, compounding the vulnerability of steel to corrosion.

Remedial measures were developed to salvage most of the building's facade components. These included replacement of the embedded steel shelf angles and through-wall masonry flashings, remedial anchoring of the masonry veneer, selective replacement of limestone trim around windows and at other locations where spalling occurred, and tuckpointing of mortar joints to help minimize water penetration.
