Robert D. Moreton Building

Assessment of Distress to Precast Facade Panels | Austin, TX

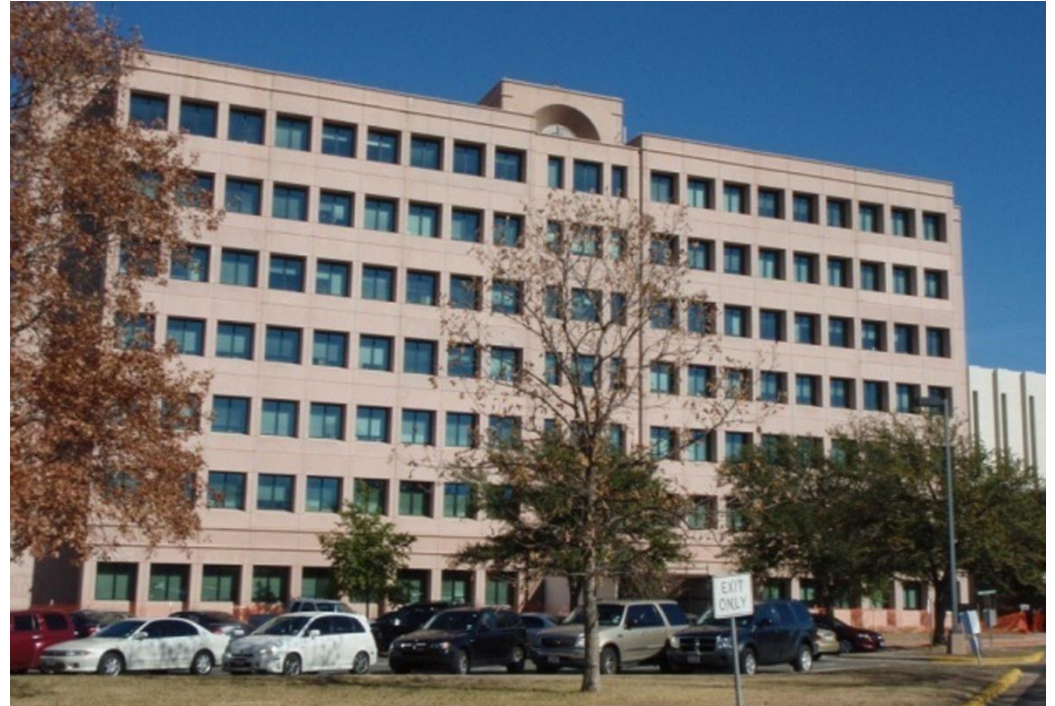
The distressed panels at the Moreton Building are comprised of an architectural concrete mix, with exposed crushed granite aggregate and pink pigment. The wall panel distress included bowing of the precast wall panels, separations in wall finishes adjacent to the exterior walls, and spalling of the panels near joints. WJE was requested to perform an assessment of the panel bowing.

WJE's initial investigation included a visual condition survey and laboratory analysis of core samples taken from the building. Through this assessment, WJE was able to determine that the distress was due to delayed ettringite formation, a type of internal sulfate attack. WJE performed additional laboratory analysis and determined it was highly likely that the distress would continue, to the point that the structural integrity of the panels could be compromised. WJE developed temporary repairs to slow the rate of distress but recommended that the State plan to eventually replace the panels. The State implemented the temporary repairs and has since allocated funds for removal of the panels and replacement of the building envelope. WJE is serving as the exterior envelope consultant on the design team for the recladding project, which is currently in progress.
