PROJECT PROFILE

State Route 2/Interstate 5 Connector

Investigation of Fire Damage | Los Angeles, CA

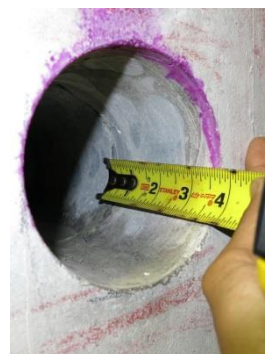
The investigation determined that the walls and soffit of the underpass exhibited significant visible damage from the fire, consisting of spalling up to 4 inches deep. The two columns within the underpass also suffered a significant amount of visible spalling, exposing reinforcing steel at a few areas. IE testing and observations at core holes identified possible delaminations and heat damage. The upper deck had only minor fire damage with small areas of shallow spalling and material damage. However, compressive strength results indicated that the undamaged concrete appeared to significantly exceed the original design strength requirement.

For the areas of damaged concrete, WJE provided general repair recommendations, including removal of damaged concrete by water-blasting or chipping and replacement with a cementitious structural-repair mortar, concrete, or shotcrete, as appropriate.
