## Investigation of Staining of Newly Coated Steel Framing

**STEPHEN W. FOSTER**, Wiss, Janney, Elstner Associates, Inc., Austin, Texas, USA

*Reddish-brown staining appeared on pre-primed steel framing members soon after the application of the topcoat. Despite the primer manufacturer's early hypothesis that surfactant leaching of the topcoat may have been the cause, field and laboratory investigations indicated that water-soluble corrosion products were being mobilized and deposited on the surface due to the presence of moisture. Pre-primed steel delivered to jobsites can begin to rust before receiving the topcoat. Areas of latent corrosion where the primer thickness was low, along with the framing that had been stored outdoors, likely led to corrosion staining after topcoat application.*

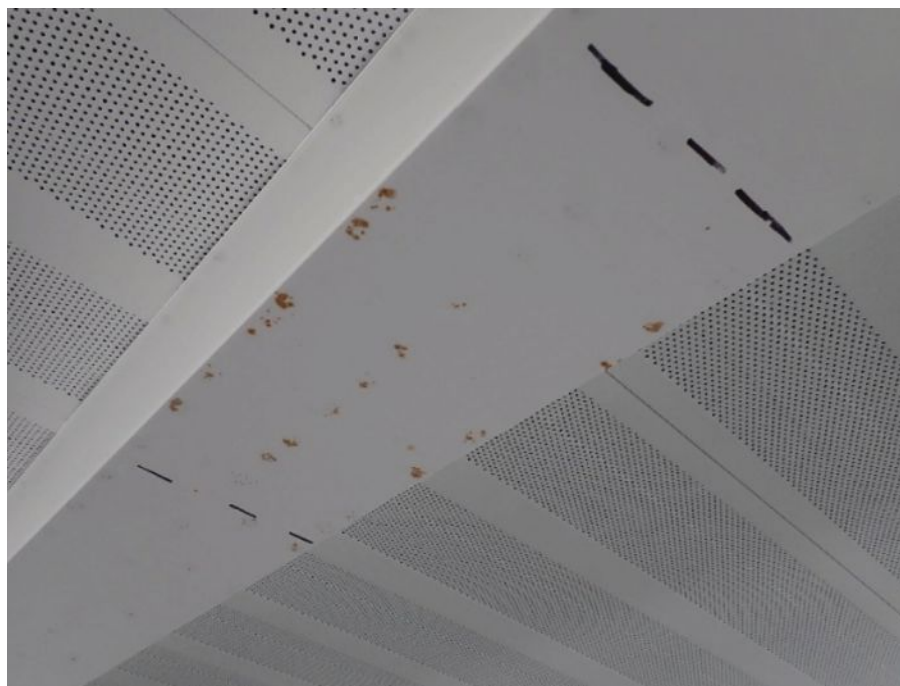
ture was introduced to the coating along the bottom flange at an area with and without staining. A paper towel wetted with distilled water was placed onto the bottom surface of the bottom flanges and covered with a plastic sheet taped to the flanges. After a 24-hour dwell-period, the wet paper towel was removed, and the surface of the coated flanges was observed. The area without prior staining exhibited minor brown stains near the edges of the bottom flange and one stain near the middle of the bottom flange. The stains at the area with prior staining became more pronounced, having turned noticeably darker, which is reflected in Figure 3. Moreover, the stains had leached onto the moist paper towel, which was collected for laboratory testing.

**FIGURE 3** Staining after moisture testing.

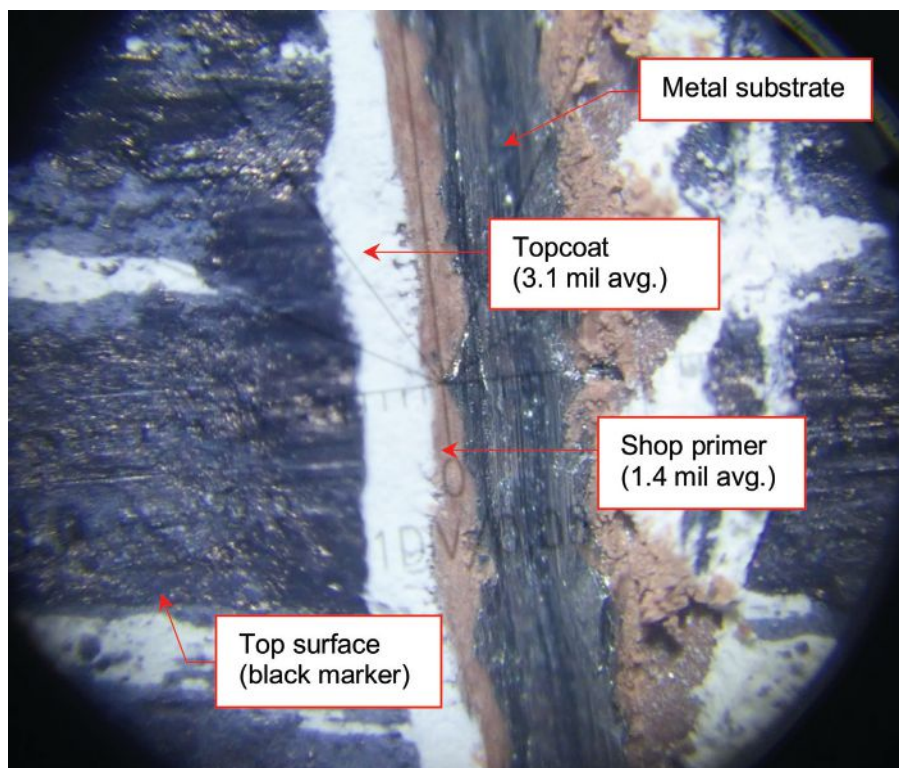
Nondestructive measurements were also performed using a magnetic thickness gauge. At each selected element, a total of four 25.8-square-centimeter (4-square-in) spots were selected on each surface, and five measurements were performed at each spot location for a total of 20 spot measurements. Table 1 summarizes the minimum, maximum, and average thicknesses. A representative paint inspection gage reading is illustrated in Figure 4.

**FIGURE 4** Representative measurement at stained area of bottom flange.

The shop primer application did not meet the specified minimum thickness of 76 microns (3.0 mils) in several areas. Average thickness measurements for the shop-applied primer were consistently below the required minimum in regions where staining was present at the coating. The primer thickness at the underside of the bottom flanges was consistently less than the primer thickness at the webs, which is reflected in Table 1. At the moisture testing location, results clearly indicated lower primer thickness at the area with staining

(approximately 35 microns or 1.4 mils) compared to areas without staining (approximately 89 microns or 3.5 mils). The field-applied topcoat typically met the minimum specified thickness. In many cases, the topcoat thickness was more than double the amount required.

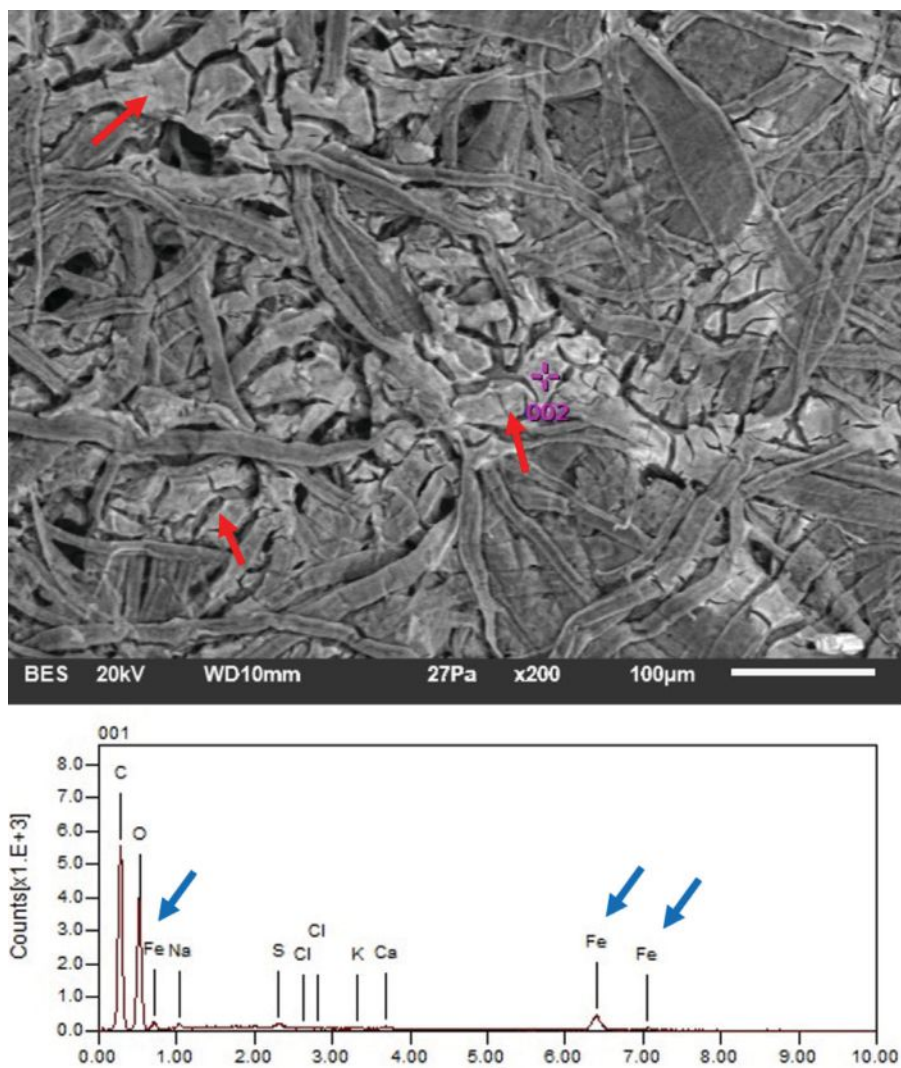
areas of the staining of both Samples 1 and 3, as reflected in Figure 5. However, iron was not detected on the unstained areas of the paper towel of these samples. Additionally, SEM/EDS analysis of control sample C2, where no

Based on the results of SEM/EDS testing, the staining was most likely attributable to water-soluble corrosion products. The moisture testing results indicate that the observed reddish-brown stains are initiated and exacerbated by the introduction of moisture to the coating system, indicating that a water-soluble substance such as underlying water-soluble rust is being extracted and deposited onto the surface of the coating system as reddish-brown stains. The source of moisture can be from the liquid phase of the topcoat itself during application or later from sources such as condensation as simulated by the wet paper towel used during testing. This staining mechanism would tend to manifest itself in areas where the primer is relatively thin and a less-effective barrier to moisture and migration of rust-solutes, more prone to development of pinholes or sim-

**FIGURE 5** SEM image of Sample 1 taken in area of staining. Red arrows point to some of the stained areas on the paper towel. The spectrum shown in the lower portion of the illustration is an area analysis of the entire image, showing the presence of iron (Fe) peaks at 0.705, 6.398, and 7.057 keV (blue arrows).
