Second Chances: Maintaining Architectural Aesthetics With Timber Repairs

BY TIMOTHY M. CROWE, ALA, SE, PE
WISS, JANNEY, ELSTNER ASSOCIATES, INC.

Project 1: King Post Truss Reinforcing in River Forest, Illinois

Project 2: Bell Tower Restoration in Chicago, Illinois

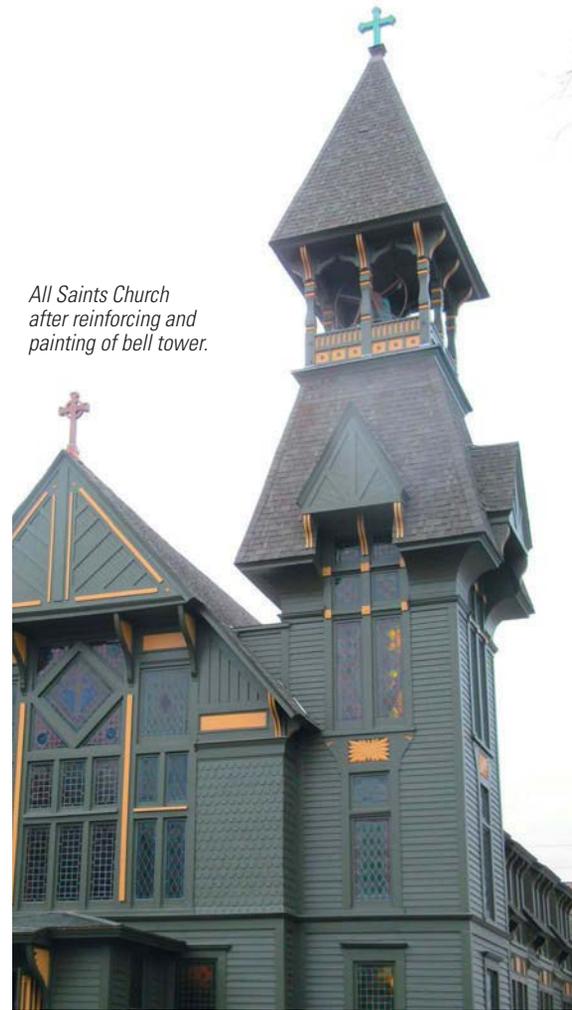
All Saints Church after reinforcing and painting of bell tower.

components. New flatlock lead-coated copper roof and flashing was also installed at the belfry floor. Finally, the tower and belfry railing walls were painted to mimic the aesthetic and color scheme of the historic bell tower.

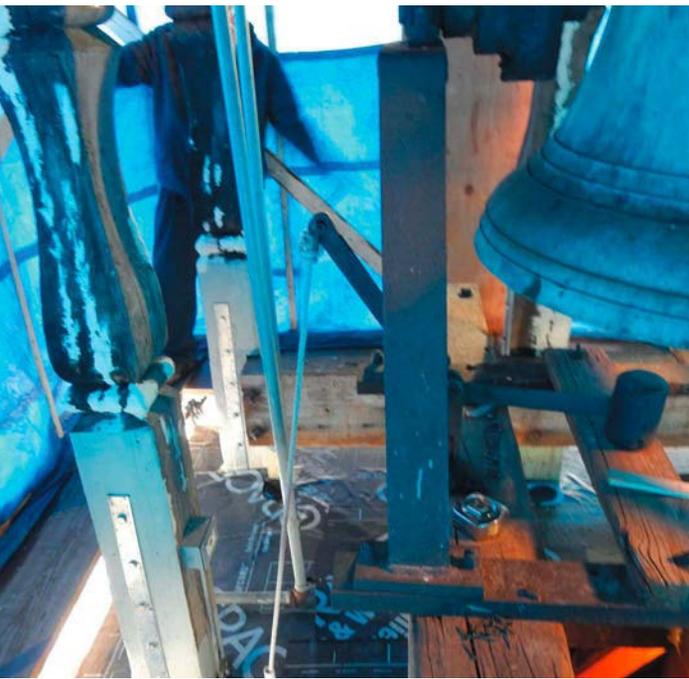
The investigation determined the tower base was generally intact. Past remediation efforts, including selective member replacement and cladding repairs, had effectively protected the underlying structure. The belfry framing included eight decoratively carved 8 inch by 8 inch timber posts, extending from the structure below, to the belfry roof. The posts, were over-clad during a prior repair, were in poor condition. The wood was identified as Red Pine (*Pinus resinosa*) with severe decayed. Insect damage was also noted, most likely by roundheaded beetles (commonly known as old house borers). The post over-cladding restricted ventilation contributing to the distress. Although, a small portion of restoration, these findings were devastating to the project, and raised questions whether the belfry could be restored within the construction budget.

Epoxy repair and steel reinforcing work in progress at base of belfry at bell tower.

First, epoxies were used to consolidate decayed wood elements. Epoxy, which modifies the hygroscopic behaviour of the wood material (its tendency to shrink and swell with changes in humidity), need to be performed systematically to prevent differential movement with wood elements exposed to environmental changes. To achieve this, epoxy treatment was applied along members to create more monolithic elements with uniform treatment. The second tactic was to ensure proper anchorage of the belfry was provided to the tower base.

This was performed with steel straps properly anchored the epoxy-modified belfry structure that continued down to intact tower framing. The third reinforcing tactic incorporated a rigid “belt frame” element within the reconstruction of the belfry railing walls. This was achieved with the introduction of heavier railing frame elements clad with plywood sheathing. The railing assembly was through-bolted at each of the belfry posts to provide continuity of the frame around the belfry. The belt frame significantly reduced the effective length, and flexibility, of the decorative belfry posts, and provided adequate stiffness for the final assembly. New timber railing elements were constructed with treated timber satisfying AWPA use category 3B or better to resist exterior conditions. At salvaged timbers, field applied preservative treatments were used to help control future decay and insect damage, and enhance the long term serviceable life of these

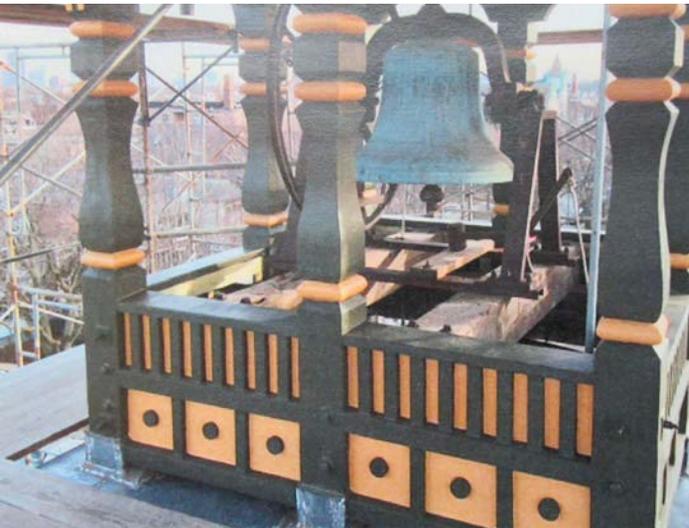
Rebuilt railing (belt-frame) at base of belfry at bell tower.

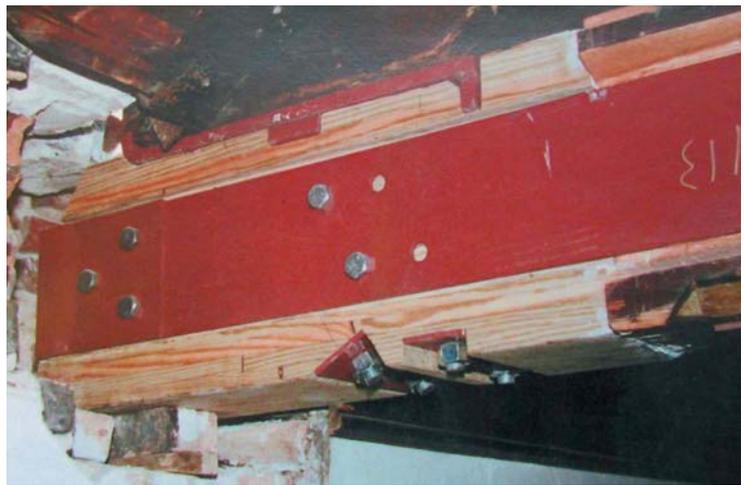
Initial inspections revealed advanced wood decay at the truss bearing. The remaining roof trusses were subsequently examined. Original drawings provided information regarding the truss assembly, and our investigation permitted more accurate documentation of the members, utilizing drills, probes, and moisture meters. Material analysis

Reconstructed truss end with new preservative treated glulam in position.

Consequently, option 2 was explored further. The decay, which was limited to the truss ends, could be removed without losing the decorative painting. Low member stresses within the truss accommodated concealed connections splices to the replaced portion, a preservative treated glulam member modified to accept the original bent-plate connection to the top chord. Minor top chord decay was treated with preservative and epoxy. The repair was clad with Douglas Fir stained to match the original finish.

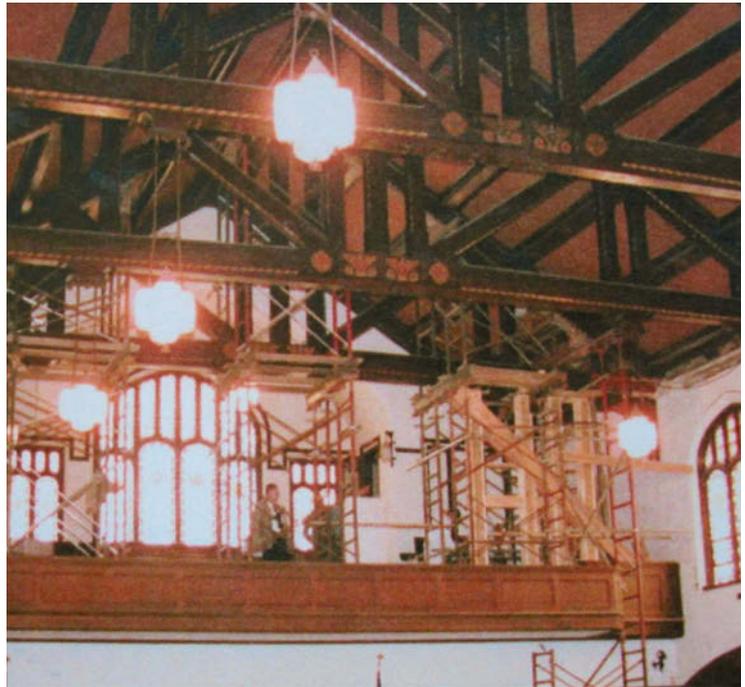
The First Presbyterian Church is a large 1920s masonry complex in River Forest, Illinois. The church includes seven decoratively painted trusses that span 45 feet across the nave. Ornamental wood brackets are located at truss bearings at the exterior walls. This project was in response to a failed support that dropped several inches at a decorative wall bracket. Roof purlins near the failed support were also pulled apart.

Partial view of church sanctuary with temporary shoring in place at failed truss. Closer view of truss end reconstruction in progress with new preservative treated glulam.
