Assessment and Repair of Historic Plaster Systems (Part 1)

BY TIMOTHY M. CROWE, ALA, SE, PE AND KENNETH ITLE, ALA, AIA

Nebraska State Capitol Library

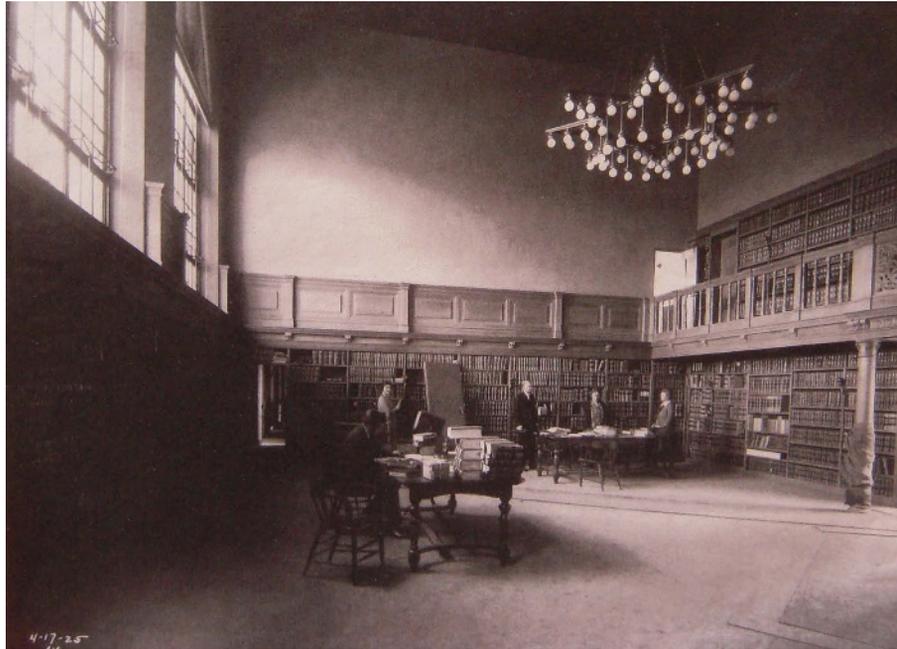
Nebraska State Library
Figures N-1 top, and N-2 bottom. Historic photo from Capitol archives (left) looking west, and view of plaster distress conditions at library wall.

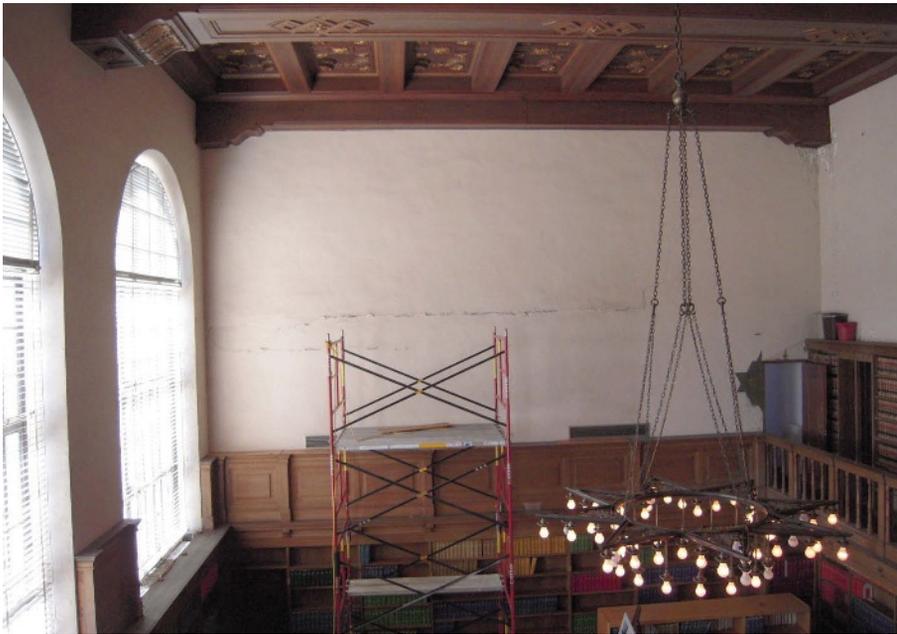
However, the horizontal cracking shown in Figure N-2 and N-5 was a recurring phenomenon that needed to be addressed to confirm that the cracking would not recur after finish restoration. To help determine the cause of the cracking, field examination of the finish materials and assemblies was performed. Laboratory microscopy of extracted finishes was also performed to review the coating layers and composition. Given that the cracks were located in line with the stack storage floor, a structural analysis was also performed to assess movement within the floor assembly.

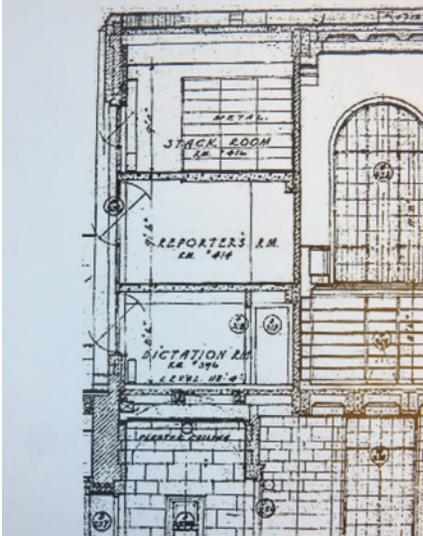
Figures N-3 left, and N-4 right. Partial section through library (left) from the original drawings. A view of the concealed ornate gilded finish is shown to the right in Figure N-2.

room at the east and west sides. A section through the reading room and adjacent storage and support areas is shown in Figure N-3. The wall construction consists of scored terra cotta tile with direct-applied plaster, supported by steel framing and concrete floors. The plaster walls were initially painted a plain color, as seen in Figure N-1. Decorative finishes were subsequently applied to the walls as the Capitol construction progressed.

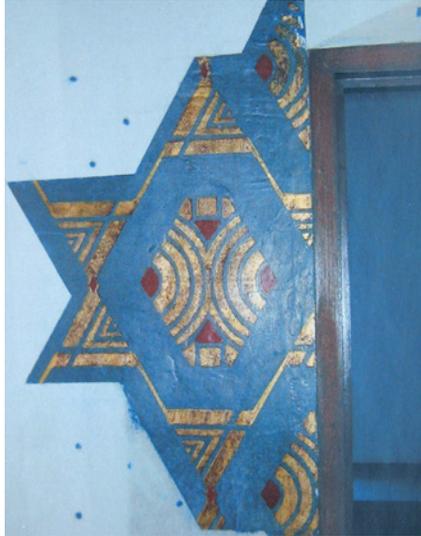
in selected areas to expose painting schemes) revealed the historic green paint and gold stenciling shown in Figure N-4. The ultimate goal was the restoration of this historic finish throughout the room.

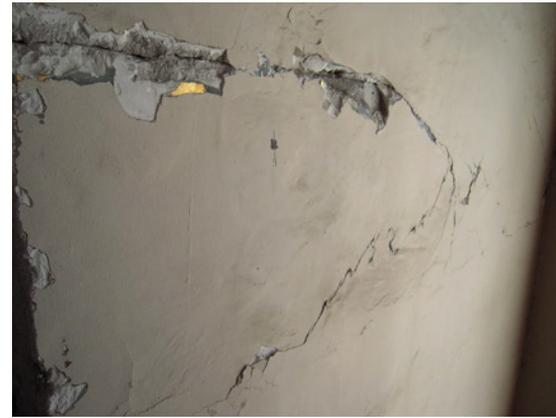
Inspection openings confirmed that the cracks in the plaster corresponded to the top and bottom surfaces of the encased beam within the wall. The cracks on both sides of the room generally ran parallel to the top and bottom edges of the encased beam but converged to a single crack before reaching the south wall. To the north, the cracks along the top of the beam turned upward,

N-5. Closer view of cracks on east wall of reading room toward the south (left). Note how the cracks parallel to the top and bottom edges of the encased beam converge to a single crack near the corner of the room. View of similar cracking on west wall of room (right).

were applied, although vibration of the roof framing occurred with this mobilization. It was apparent that cracks resulted from restrained deflections and vibration of the structure under changes in loading, given the lack of differential movement accommodations at the roof and floor. The patches remained in place for several months and cracking was observed to worsen, clearly demonstrating that this movement is active and would recur in a restored wall if appropriate repairs were not implemented. Accordingly, repairs were developed to accommodate differential movement and avoid transfer of vibrations.

Repair of the horizontal cracks (at the floor beams at the stack room levels) required that existing plaster be removed for a distance of approximately 8 inches above and below the beam. The underlying masonry and concrete were examined and repaired, and new plaster was applied over metal rib lath that spanned vertically across the floor structure. The lath was secured to the masonry above and below, and to the concrete at the floor. Repair of cracks away from the stack room floor level also included removal of damaged plaster to underlying masonry, and

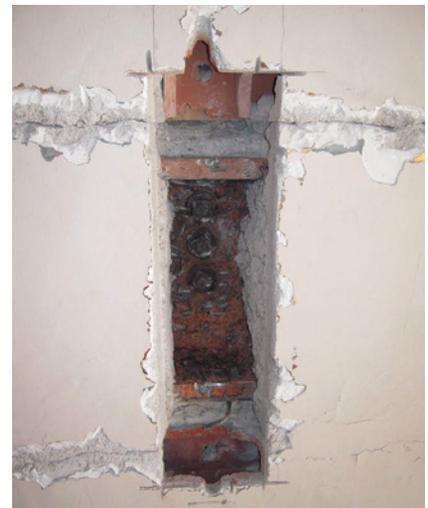
and the cracks along the bottom of the beam continued to the north wall of the reading room (Figure N-6). The upward-turning cracks corresponded with perpendicular masonry walls on the opposite sides of the east and west walls at this location.

The tile walls above and below the beam were built tight to the structural framing, with no accommodations for floor deflections or differential movements beneath the floor or roof framing. The plaster was a two coat system applied directly to the clay tile masonry and the concrete encasement of the beams. The two coats consisted of a 1/2 inch

N-6. Inspection opening at east wall of Reading Room. Note the underlying concrete-encased steel beam and terra cotta tile walls above and below.

to 3/4 thick brown coat (gypsum plaster with lime, sand, and animal hair), covered by an approximately 1/4 to 3/16 inch thick finish coat (gypsum plaster and lime). No lath was included in the system. Total plaster thickness varied between approximately 3/4 and 1 inch.

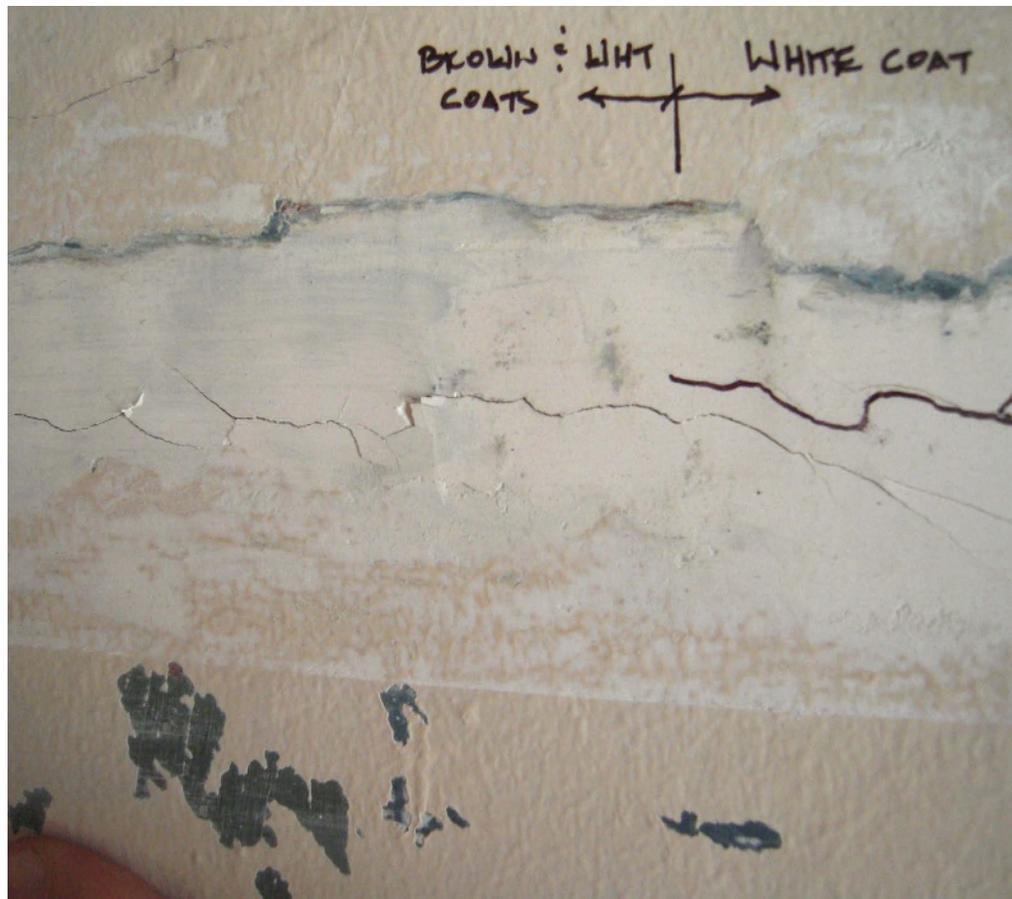
To assess whether the cracks remained active, plaster patches were installed, cured, and monitored. Loads applied to the stack storage were maintained at a constant value, and the patches were periodically inspected (Figure N-7). Cracks recurred within two months. During this period, mobilization for roofing work had occurred above the reading room. No excessive loads

N-7. New cracks in patch at east wall observed after two months, with no changes in floor loading.

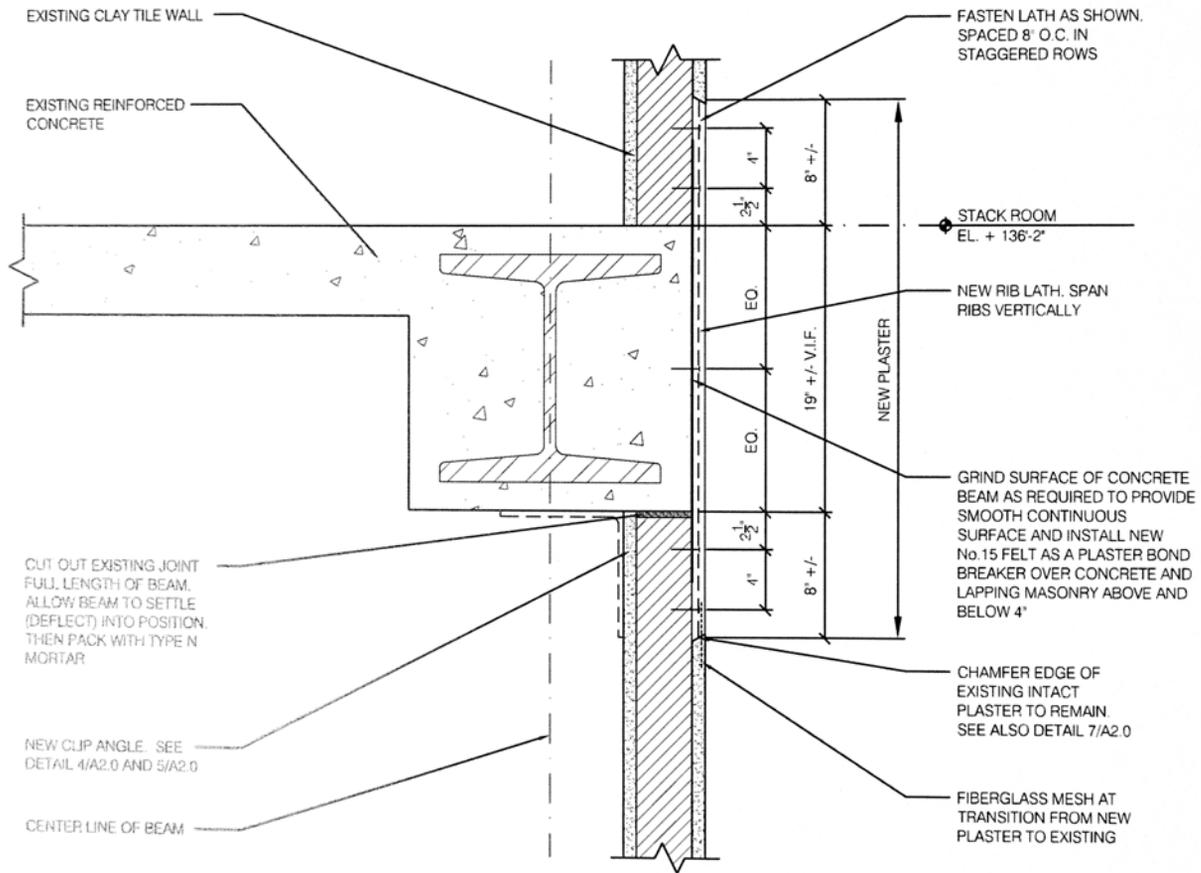
N-8. Repair details for plaster installation over floor framing system.

Restoring the historic plaster required that the wall plane remain continuous. Thus, a third approach was developed to relieve wall stresses and avoid a soft joint beneath the floor. This approach included cutting continuous joints through the wall beneath the floor and roof framing, to isolate the wall from the structure above. Lateral connections were installed at the top of the wall sections. A compressible joint was provided beneath the roof framing similar to Approach 1; however, the joint beneath the floor

framing was repointed after time had passed, to accommodate restrained deflection and then provide a sound substrate to receive a plaster finish (Figure N-8).

installation of an expanded metal lath secured to the masonry. A multi-coat plaster system was then installed and blended into existing intact finishes, and is currently awaiting final repairs to finishes.

This repair will not entirely accommodate future vertical floor deflections; however, the addition of the rib lath provides ductility to better control cracks from changes in floor loading. The isolation of the roof structure reduced the transfer of vibrations and load effects from above. This repair was installed on a trial basis to allow monitoring over an extended period of time, prior to commencing a complete restoration of the interior plaster and conservation of the
