BY JEFFREY S. LEVINE

Wiss, Janney, Elstner Associates, Inc.

Frost Patterns—Survey Aid

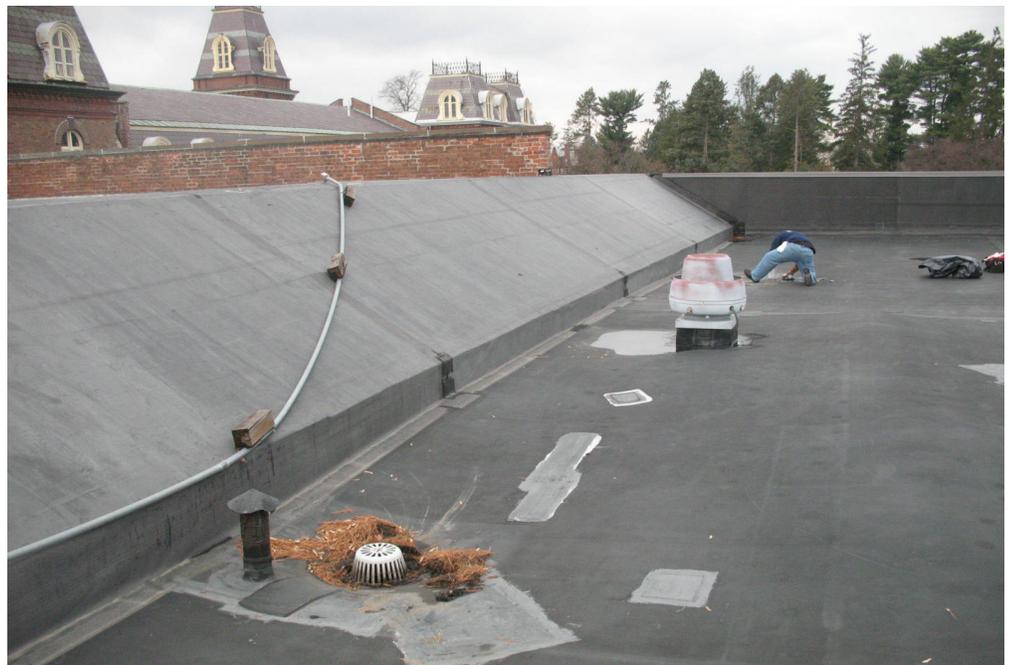
Overall view of the roof on a typical afternoon

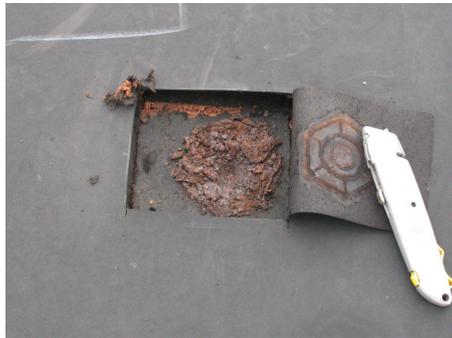
Corroded fastener plate

To help prevent the problems illustrated from recurring, several remedies were specified in the bid documents for roof replacement, including drying out of the concrete roof decks; installation of a continuous air/vapor retarder membrane

at roof/wall interfaces and parapet walls; and installation of two layers of polyiso insulation plus a cover board, with the first layer of insulation mechanically fastened and the second layer of insulation and cover board adhered using spray foam

adhesive. In addition, joints between the layers of insulation and cover board were staggered to further mitigate air movement and heat loss.

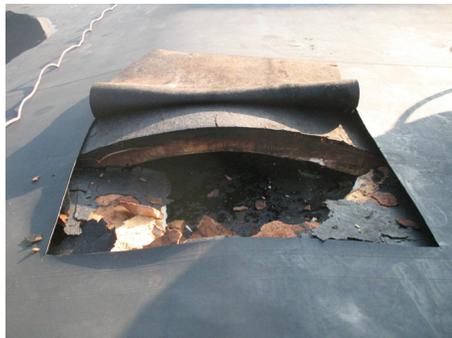
Single layer of polyisocyanurate insulation. The insulation warped as a result of condensation on its underside and fastener corrosion. The source of the moisture was interior air.

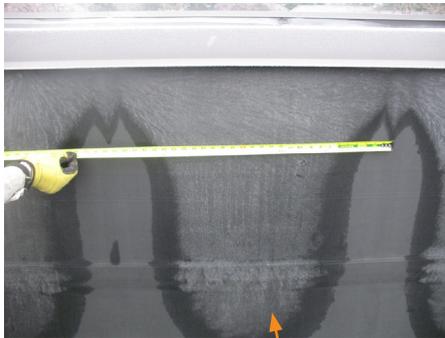
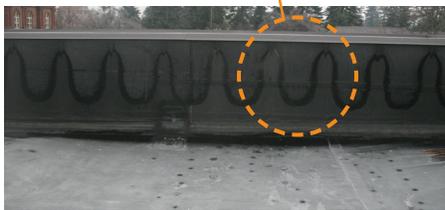
Frost patterns on the EPDM clad parapet walls formed a perfect sine wave. The distance between the peaks of the nonfrosted areas matched the width of the insulated metal wall panels exactly, confirming our earlier observation of air movement from the interior into the roof system, but also vividly showing the degree of heat loss through the joints between panels.

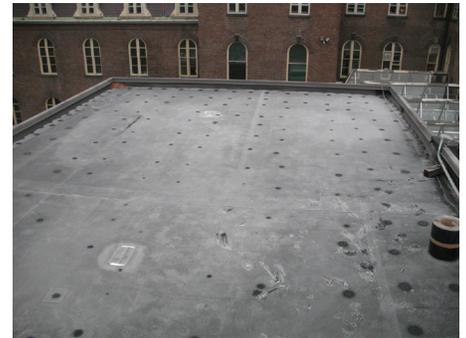
The dark round circles in this photo indicated the insulation's fastener pattern. The fastener plates are frost-free due to thermal bridging. It is estimated that thermal bridging of fasteners reduces the R-value of insulation by eight to ten percent.
