# HIBERNIA BANK BUILDING

## *Historic Renovation and Seismic Retrofit*

*By Kelly Cobeen, S.E., Terrence Paret, and Owen Rosenboom, Ph.D., P.E., S.E.*

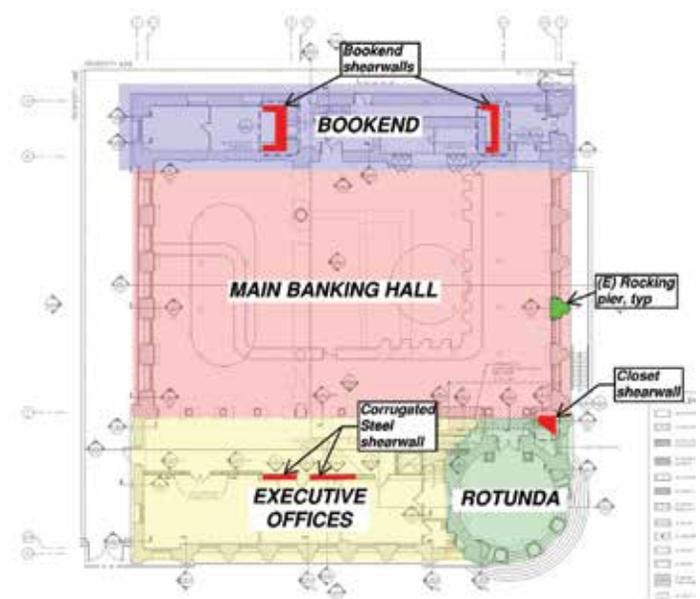
ran analytical studies that corroborated the observed good behavior. Key to this behavior was the existing massive masonry walls that served to limit drift to modest levels in spite of the tendency towards torsional response (Figure 3). These indications of good seismic performance, combined with the adopted historic preservation objectives, were the primary justification for a focused, surgical seismic retrofit approach.

Figure 3. Hibernia Bank Building floor plan with shaded masonry walls. Diagonal hatched walls are of combined granite and brick masonry.

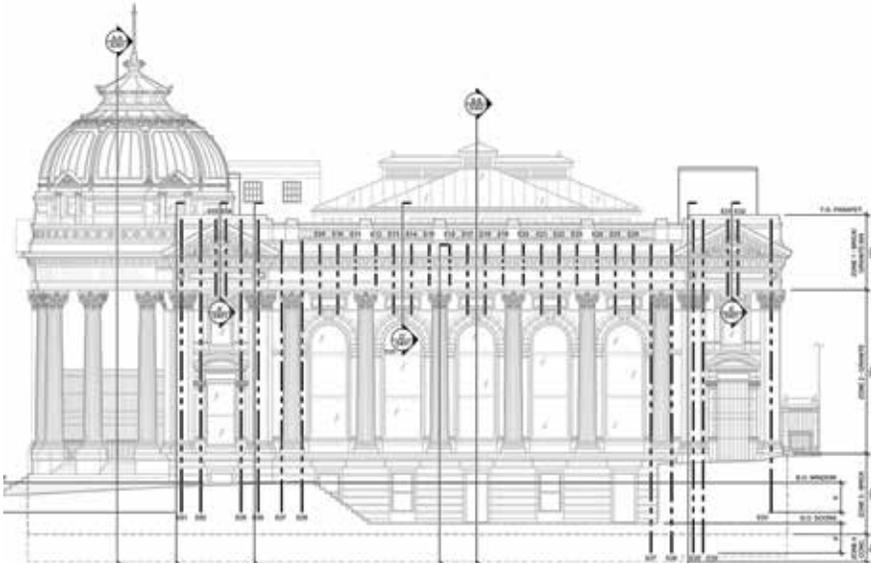
Figure 4. Center coring at Jones Street elevation. Heavy dashed lines indicate center core location and extent.

Center coring of the granite and brick masonry walls and piers was included to provide general connectivity and limit slip in masonry joints. The retrofit involved the coring of holes, installation of high strength steel rods as reinforcing, and grouting with a high-strength, low modulus polyester resin-based grout custom designed to reduce

shrinkage and heat build-up during curing. The center coring of walls for this project was more difficult than usual due to the unpredictable mix of brick masonry and much harder granite masonry over the height of each core. Figure 4 shows center cores on one of the exterior wall elevations.
