BY JEFFREY S. LEVINE

Wiss, Janney, Elstner Associates, Inc.

Up Close: Slate Headlap and Offset

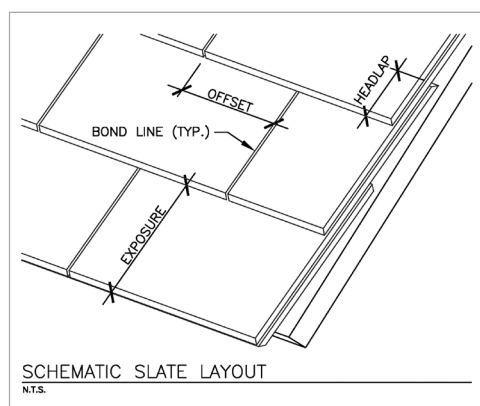
Critical dimensions for slate headlap and offset.

Slate headlap and offset are depicted in the graphic below. Headlap is dependent on roof slope. For roof slopes between 8:12 and 20:12, a three-inch headlap is standard.

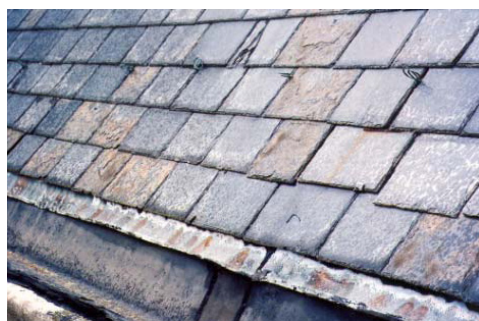
The roof below leaked for years after replacement of its built-in gutter liner with a new EPDM (never a good idea) liner. Everybody suspected the EPDM liner. Nobody

bothered to check the slate above, which had been removed, salvaged, and reinstalled to permit the gutter replacement work.

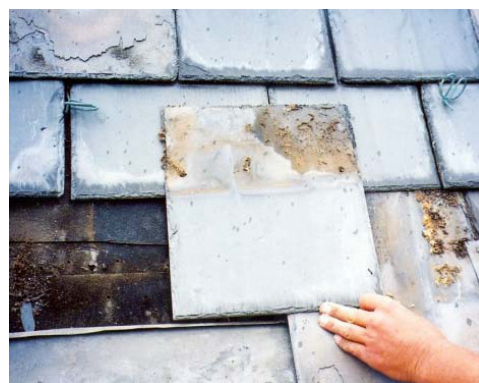
A test opening revealed that slate in the second course had been trimmed—or replaced with shorter, reclaimed replacements—the result of which was no headlap (see photo below)! Rainwater was free to enter the roof system at each and every side joint between slates in the course above.

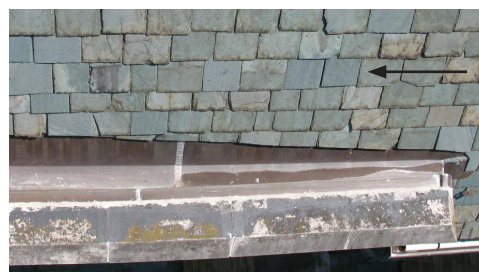
That's no optical illusion; the exposures of the slates in the fourth course above the copper gusset in the photo below taper from left to right. They should not taper. The result is minimal to no headlap at the far left end.

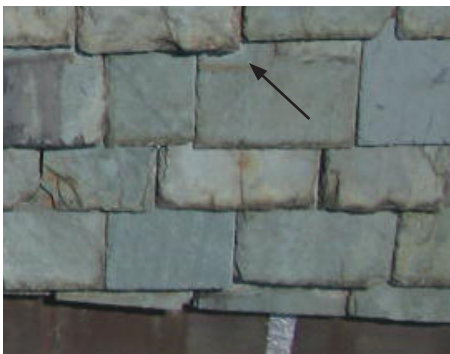
In addition to enlarged exposure, look for butt-line ghost-lines (arrow below) that are too low in reinstalled slate, as these can indicate inadequate headlap.

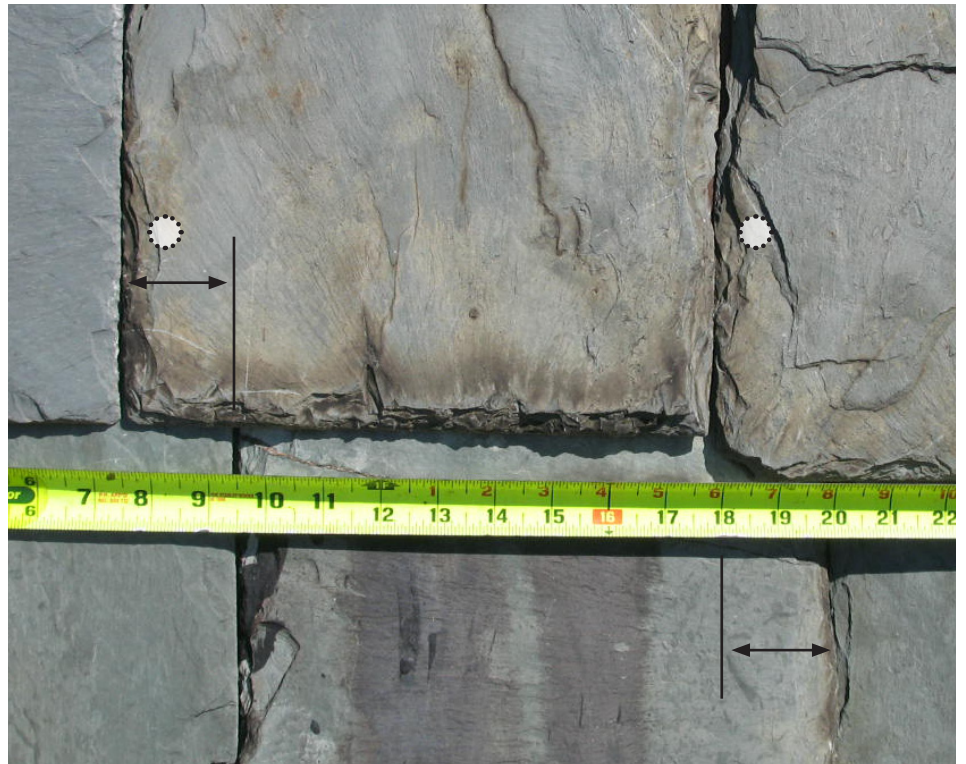
Photo to right: These slates were reinstalled with a two-inch offset. This places the nail holes in the slates below too close to the bond lines (joint between slate shingles). The nail holes, thus, become susceptible to water infiltration during heavy or wind-blown rains.
