St. Paul's Union Depot: Revitalization of a Historic Concrete Train Depot

BY ARNE JOHNSON, JONAH KURTH AND KEVIN MICHOLS

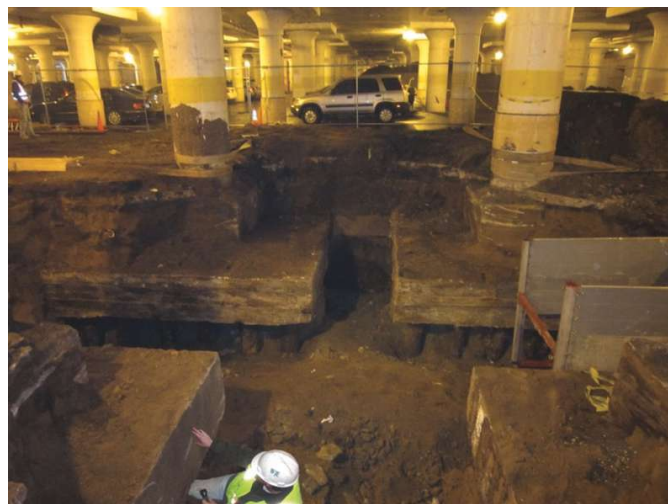
A field investigation exposed 54 timber piles through exploratory test pits (Fig. 2), or about one-half of 1% of the approximately 9,000 timber piles. Locations of the test pits were guided by a comprehensive visual inspection and elevation survey across the underside of the track deck to locate any struc-

Considering the small sample size of exposed piles and the variability in conditions identified, Monte Carlo statistical simulations were performed considering pile diameter, wood species, and percent of cross sectional area loss due to decay to estimate the probability that any pile cap on the site had a certain vertical-load-carrying ability. The simulations predicted that only about 30% of the pile caps could reliably support heavy Class 1 rail loading now, and only about 5% would be able to do so after 50 years (considering a rough extrapolation of future pile deterioration). On the other hand, roughly 80% of the pile caps should be able to reliably support the light rail and bus loading in 50 years.

Based on the results of the investigation and analysis, it was concluded that the timber pile foundations supporting the southern third of the track deck should not be relied upon to support the heavy Class 1 rail loads programmed for that portion of the rehabilitated facility. In this area, the majority of the deck and foundations were demolished and reconstructed to replicate the original historic appearance. For the northern two-thirds of the track deck where the pile conditions were better, it was concluded that the existing foundation should have sufficient capacity to support the anticipated light rail, bus and vehicle loads for the next 50 years. Accordingly, the existing concrete structure was repaired and the existing timber pile foundations were left undisturbed to support the rehabilitated facility.

Fig. 2: Test pit exposing concrete pile caps and timber piles

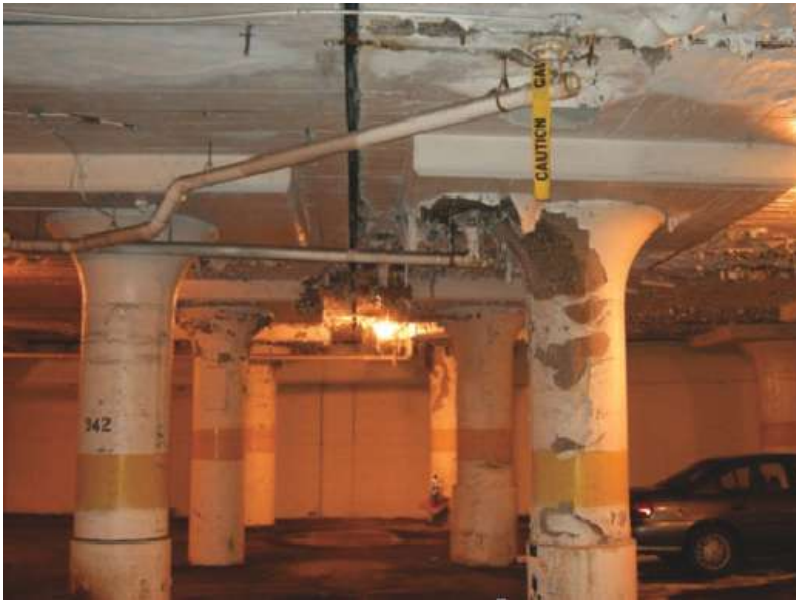
Fig. 3: Representative conditions at underside of track deck before rehabilitation

The existing approximately 260,000 sf (24,155 sm) concrete superstructure was assessed through a combination of visual inspection of the entire structure, detailed examination and field testing at representative study areas, laboratory testing of material samples, and structural analysis. The concrete superstructure exhibited deteriorated conditions (Fig. 3) in varying degrees, including:

- Cracks in the track deck and retaining walls, some with efflorescence deposits and leakage;
- Delamination and spalling of original concrete at the deck underside, columns, and walls;
- Delamination and spalling of 20-year old shotcrete repairs at the deck underside and walls;
- Exposed and corroded reinforcing steel at most spalls;
- Scaling and disintegration of concrete surfaces, especially at deck edges and column bases;
- Water staining, efflorescence, and leakage at drains and original construction joints in the deck.

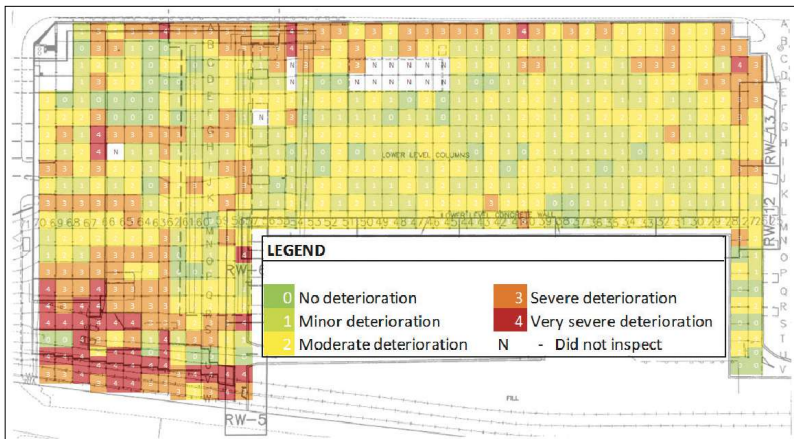
Fig. 4: Visual condition survey ratings

To efficiently assess the overall condition of the large-area track deck, visual observations of conditions at the underside of every bay were documented in detail, and a visual condition rating ranging from 0 to 4 was assigned to each bay based on the types and quantity of deterioration noted. The visual inspection data were then used to calculate the quantity and frequency of the deterioration conditions. Using these data, an algorithm was developed to calculate a numerical condition rating ranging from 0 to 100 for each bay. The calculated and visual field ratings showed the same overall pattern of deterioration (Fig. 4) and provided a basis to select representative bays for in-depth investigation, as well as a means to infer the condition of the top of the deck, which was covered by 3 ft (0.9 m) of fill and pavement.

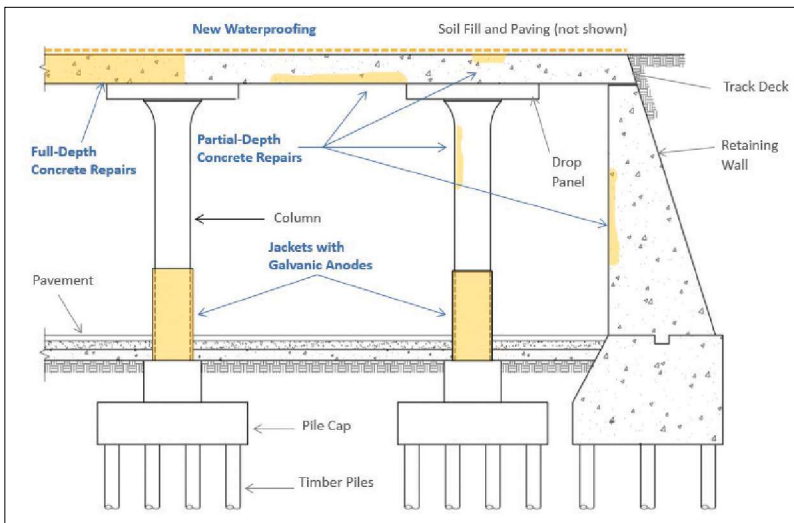
Fig. 5: Typical section through track deck structure showing concrete repair scope

The investigation determined that the primary causes of the concrete deterioration were long-term water leakage through cracks and joints, localized chloride-induced corrosion of reinforcing steel from exposure to deicing salts, localized carbonation-induced corrosion, and freezing and thawing of saturated concrete, which is not air-entrained. While the concrete deterioration was widespread and advanced in some areas, the investigation concluded that the structure could be repaired. The driving forces of future deterioration are corrosion of the reinforcement and freeze-thaw damage of the concrete, both of which require moisture and are accelerated by chlorides, so the repair strategies included protecting the concrete against water and chloride ingress (Fig. 5).

to match existing. Full-depth repairs were necessary along expansion joints and around drains. For the deck topside, to mitigate water and deicing salt infiltration, heavy duty waterproofing systems, expansion joint seals, crack and construction joint sealing, and improved drainage were specified. For the deck underside, a breathable coating was utilized to slow future carbonation. These repairs were deemed sufficient for the 50-year service life extension, with recognition that some localized concrete repairs should be anticipated over time.

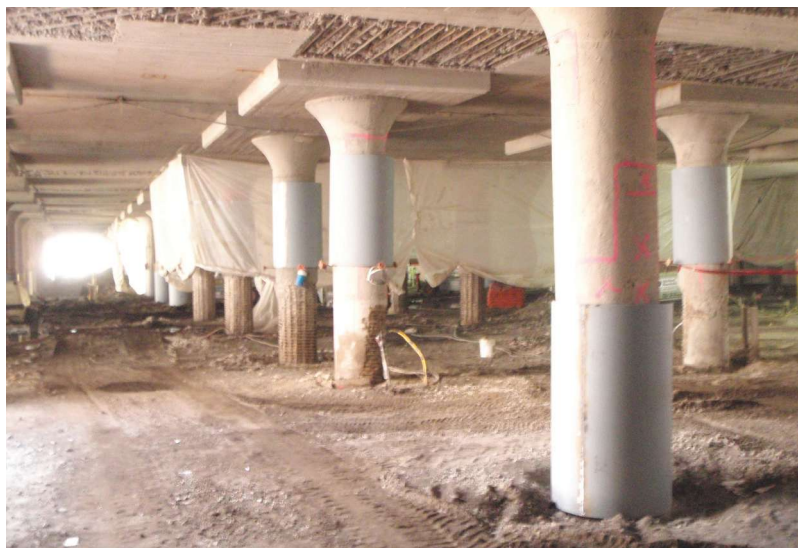
Fig. 6: Repairs in progress

Partial-depth concrete repairs extending beyond the near surface reinforcing steel mat were specified for the deck underside and perimeter walls (Fig. 6). Given the volume of concrete removal required, hydrodemolition was utilized and proved to be cost-effective for repair area preparation. Shotcrete was utilized for overhead and vertical concrete repairs and included a form-board finish

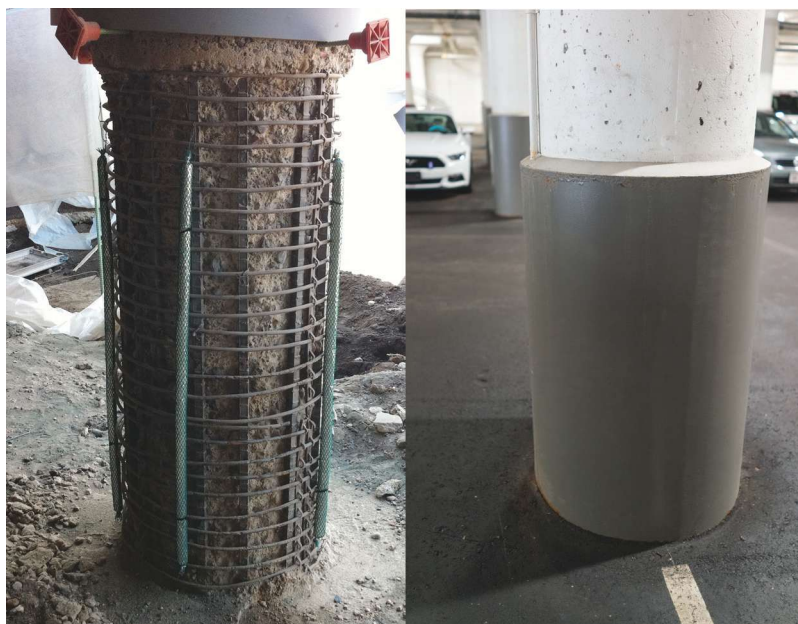
Fig. 7: Column jacket repairs during construction (left) and five years after rehabilitation (right)

Because of advanced corrosion and chloride contamination at the column bases down to the pile caps, as well as the difficulty in making these repairs in the future with the facility in service, column repair included removing all existing jackets and concrete cover to the vertical reinforcing bars, installing distributed galvanic anodes for corrosion control, and encapsulating the repair with new, fully grouted steel jackets (Fig. 7). The new jackets are a

barrier against additional chlorides, and the galvanic anodes mitigate corrosion in the underlying already-chloride-contaminated concrete.
