# Targeted Vibration Control During Internal Construction

## The Neue Galerie New York

By Arne Johnson and Mark DeMairo

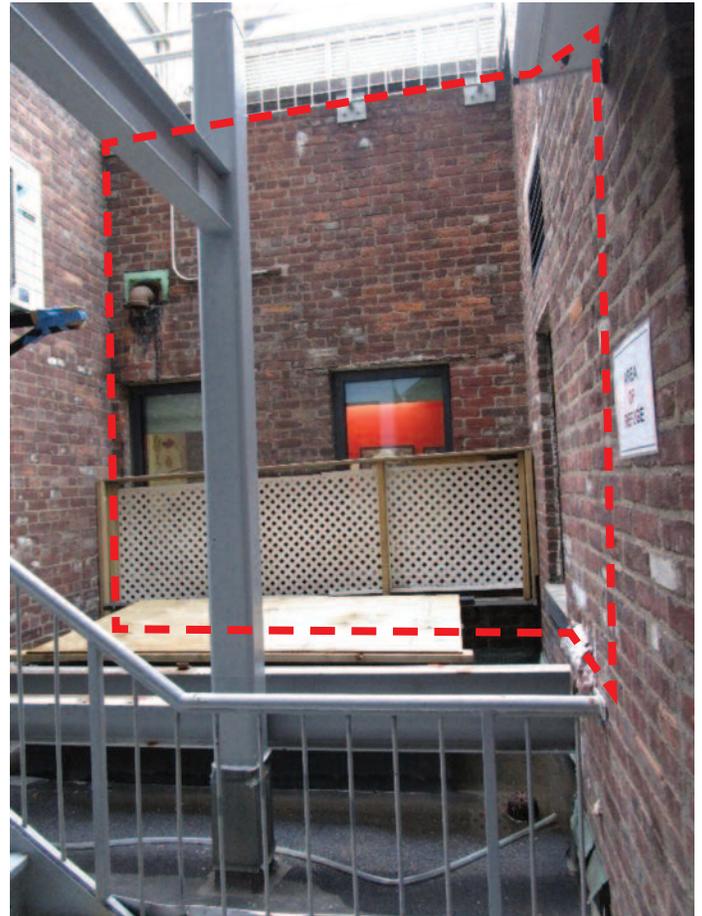
Figure 2. Brick masonry removal area at fifth floor, adjacent to new chiller location.

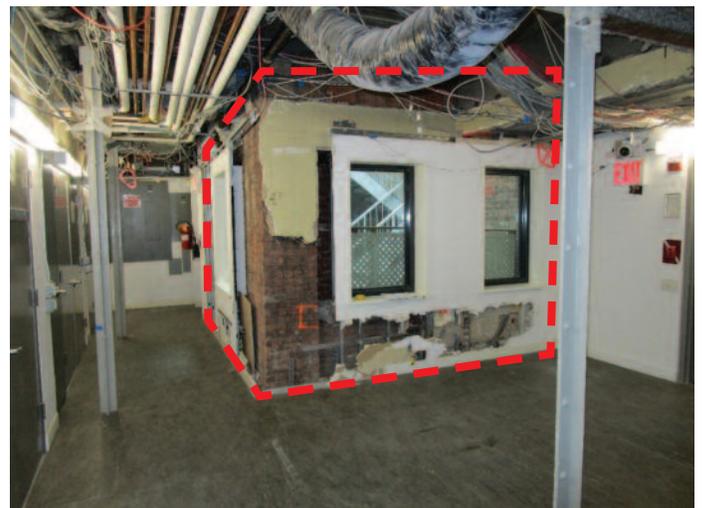
Figure 3. Interior view of load-bearing masonry walls to be removed on fifth floor.

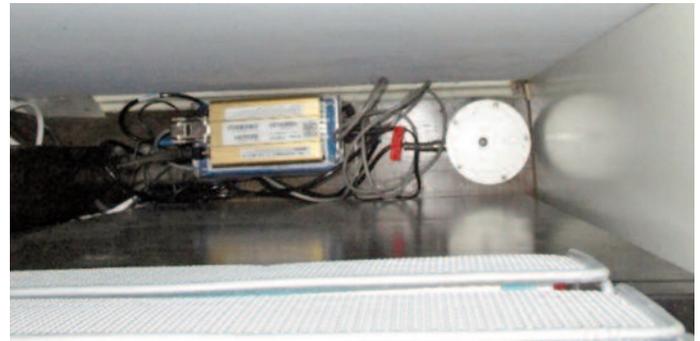
**Ambient vibration monitoring.** First, WJE installed vibration monitors (Figure 4) at key locations in the museum, and collected ambient (background) vibration data for approximately one month. Ambient levels ranged from 0.02 to 0.07 in/sec PPV<sup>5</sup>—common values for buildings of this type. For comparison, human perception of vibrations begins at approximately 0.03 in/sec; a conservative limit for the protection of art objects in reasonably sound condition is 0.10 in/sec; and a limit for protection of buildings from threshold cracking in plaster wall finishes is 0.50 in/sec.

Figure 4. Looking down at typical vibration monitor installation.

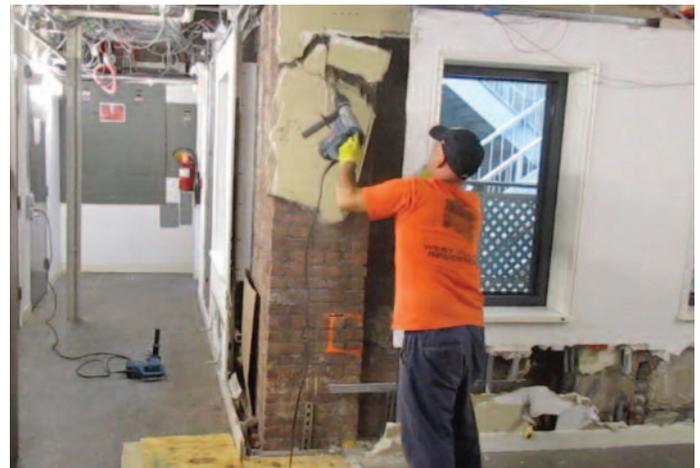
**Vibration trials.** To confirm that vibration transmission would be within acceptable limits, WJE recommended specific field trials at the beginning of the work. The contractor simulated work using actual equipment and methods, while vibrations were measured using multiple sensors placed temporarily on each floor level. As summarized in Table 2, the most significant vibrations measured during the trials were 0.085, 0.044, and 0.021 in/sec PPV on each of the floors. The largest vibrations were caused by dropping heavy debris and the impact of a sledgehammer. Work by chipping hammers produced lower vibrations (0.02 in/sec PPV maximum). The trials verified that vibrations at the location of the nearest work of art on the second floor would be well below the art-protection limit of 0.10 in/sec PPV that the museum had adopted.

Figure 5. Dropping terracotta blocks with plaster finish from a height during vibration trials.

\*Based on high values, the impacts of sledgehammers were restricted to softer materials such as terracotta and plaster or brickwork that had already been broken up using chipping hammers.

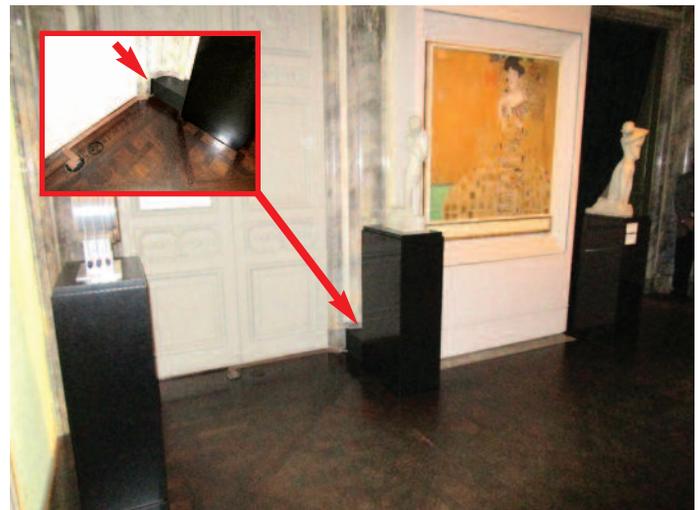
floor, one on the third floor, and one on the second floor near the installed art (see Figure 6). The monitoring system was networked, remotely accessible in real time, and programmed to provide immediate notifications of any above-limit measurements. Two alert levels were utilized: a lower level of 0.075 in/sec PPV to serve as a caution to

Figure 6. Enclosure (red arrow) constructed around vibration monitor in second-floor gallery.

The maximum vibration amplitude recorded on the second floor, where works of art were present, was approximately 0.03 in/s PPV—a small margin of the art-protection limit. The vibrations recorded at the fourth floor exterior wall demonstrated that any vibrations transmitted to the abutting residential building were well below disturbing levels. Vibrations at the fourth-floor monitor, directly below the fifth floor demolition, occasionally exceeded alert levels, which served as a useful caution to the contractor.

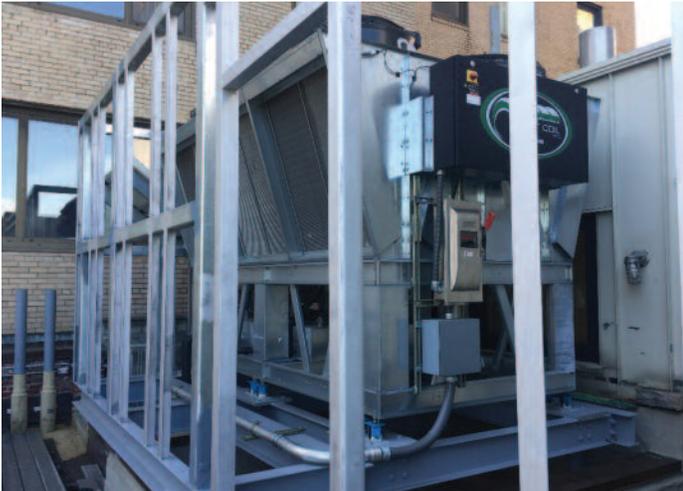
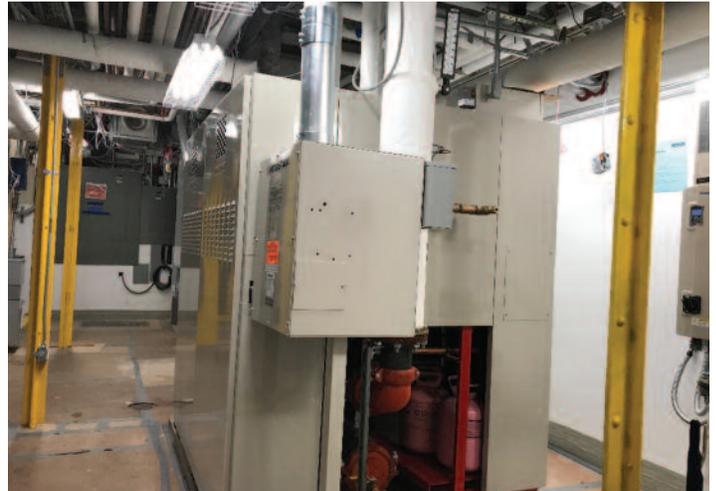
Figure 7. Completed chiller installation: from roof (left) and in new fifth-floor mechanical room (right).
