Teak Window Restoration

Material Issues at the Salk Institute

BY TIMOTHY CROWE ALA, SE, PE

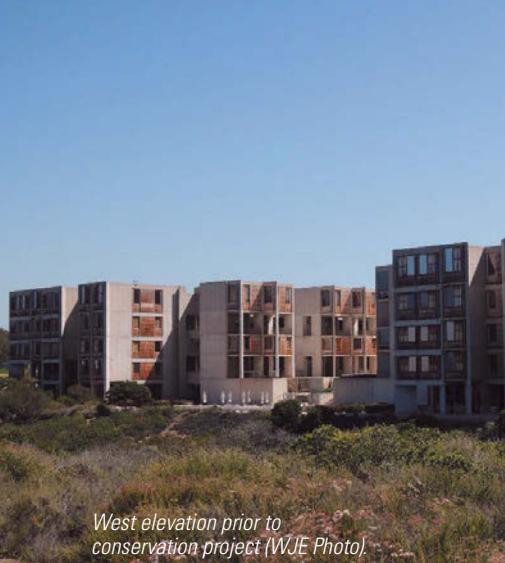
West elevation prior to conservation project (WJE Photo).

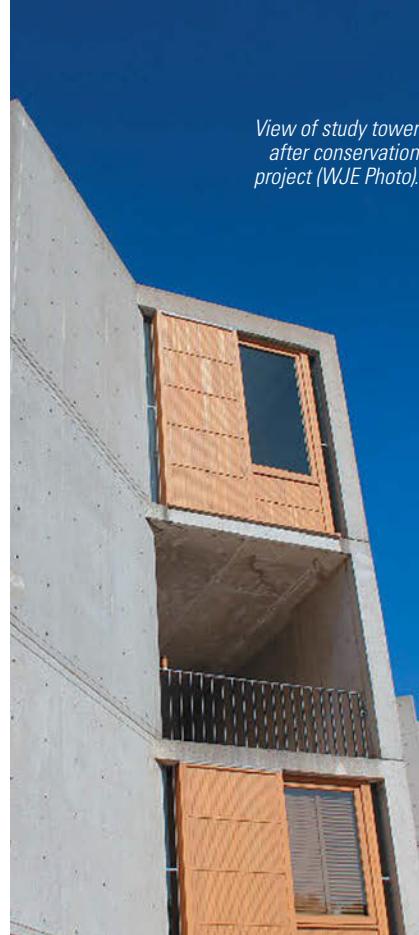
View of study tower after conservation project (WJE Photo).

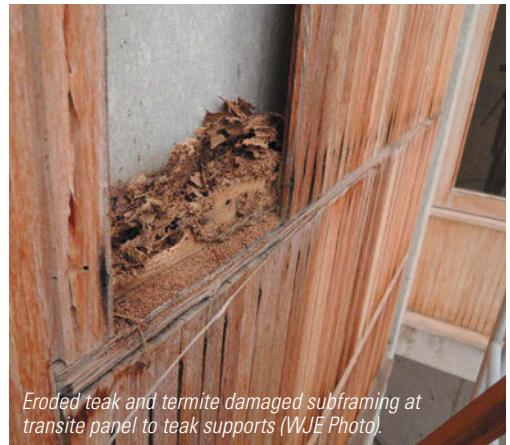
Distress conditions included erosion of tongue and groove teak panels where over 1/4 inch of thickness had been lost, exposing the ferrous metal nails which had corroded as a result of the sea salt from the coast. Teak damage was attributed in part to ultraviolet ray degradation, where lignin breaking down over time undermined the bond of the cellulose, resulting in gradual surface erosion. However, the majority of the section loss was attributed to abrasive cleaning methods that utilized wire brushing and harsh chemicals with refinishing. Frequency of teak cleaning was greatly influenced by mildew growth prevalent on the site from local vegetation. Though not detrimental to the wood, the biofilm has been an aesthetic concern since the original construction. Consequently, gentle

Eroded teak and termite damaged subframing at transite panel to teak supports (WJE Photo).

Drywood termites, notorious along the southwest coast, were another source of damage. In particular, the open nature of the study towers proved particularly vulnerable to these insects. Unlike subterranean termites, drywood termites can enter through open windows and do not require shelter tubes or high-moisture content within the wood; although a preference for the warmer south and west building facades was apparent. As the transite panels and teak are well suited for this environment, termite damage was primarily at the pine subframing. In isolated areas, bore holes through the teak cladding were apparently created by termites to access the subframing.

Where they could not be salvaged, numerous transite panel replacements were studied, including metal and precast cementitious materials. Budget and detailing steered us toward a wood product, and panels fabricated with 2x6 Accoya were selected. Accoya is manufactured by Accsys Technologies located in Arnhem, the Netherlands, and is a treated radiate pine. The process, initially studied in Germany in 1928, with continued research at the Forest Products Lab in Madison, Wisconsin and Europe, utilizes an acetic acid treatment that modifies the wood cells on a molecular level. The modification increases acetic anhydride molecules, replacing hydroxyl molecules (hydroxyl molecules facilitate the wood moisture content fluctuation under changes in humidity) creating cell
