Second Chances: The New Roof is Still Leaking?

BY TIMOTHY M. CROWE, ALA, SE, PE AND ANDI MELE, EIT

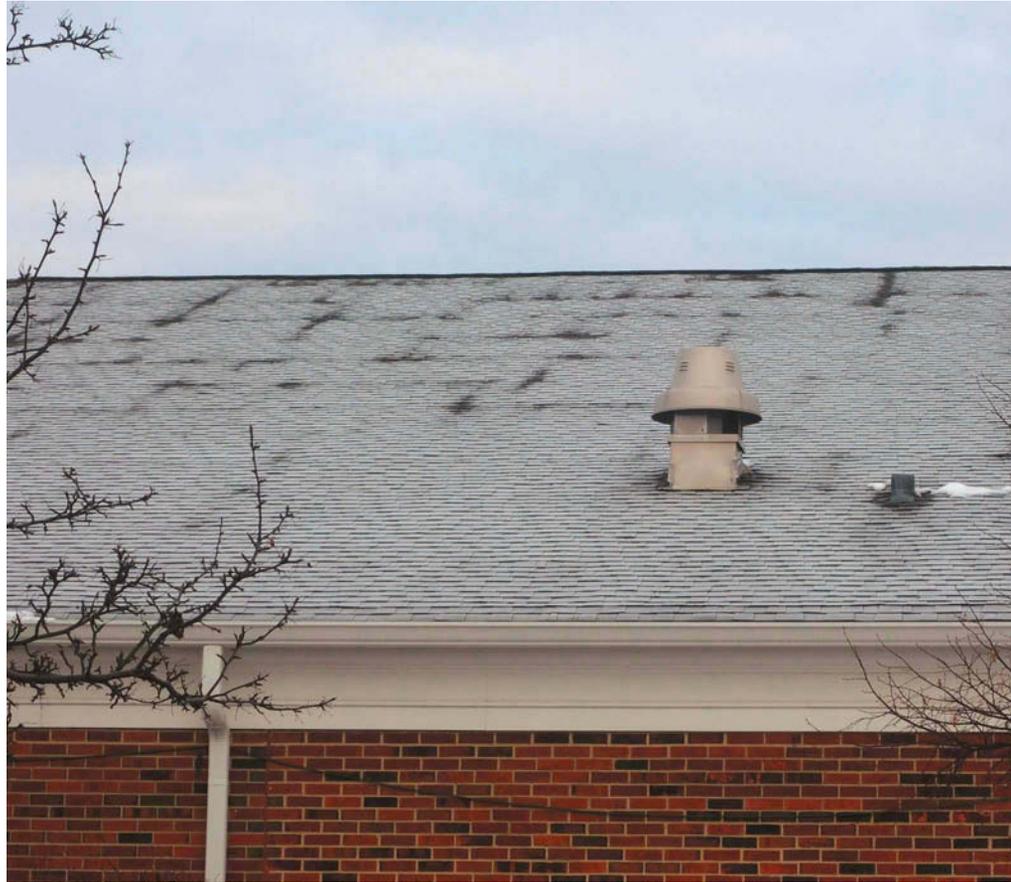
Patterns of frost-melt on roof surface.

Our inspection revealed that the new shingles were in good condition. However, melted frost observed on the roof surface demonstrated active heat loss through the building envelope, telegraphing joints between the underlying sheathing panels. The owner mentioned that ice accumulated near roof edges after some snow events. Ice accumulation within these areas was present during our visit. The observed heat loss and ice accumulation is consistent with ice damming.

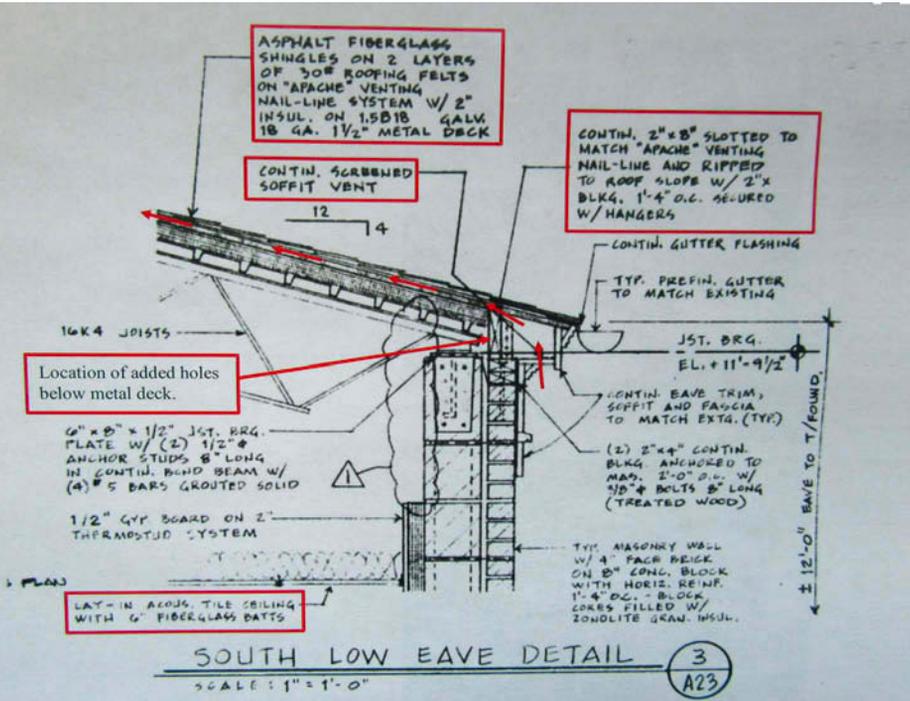
Original roof with theoretical venting illustrated by red arrows.

The 1996 design intended soffit-to-ridge venting of the roof above the metal deck, between the insulation and sheathing. This system ideally allows air to escape from beneath the shingles (during hot exterior temperatures) to prevent overheating the shingles. However, the air-flow through this cavity is not adequate to maintain cool temperatures (avoiding snow-melt) during colder months. The efficacy of the insulation was compromised, being separated between the ceiling and roof levels. In addition, the presence of ductwork (even insulated) separated from interior conditioned spaces with ceiling insulation, is not advisable, as warm air escaping ductwork joints can add unwanted heat and humidity into this space. These conditions lead to condensation and ice dam formation at the building.

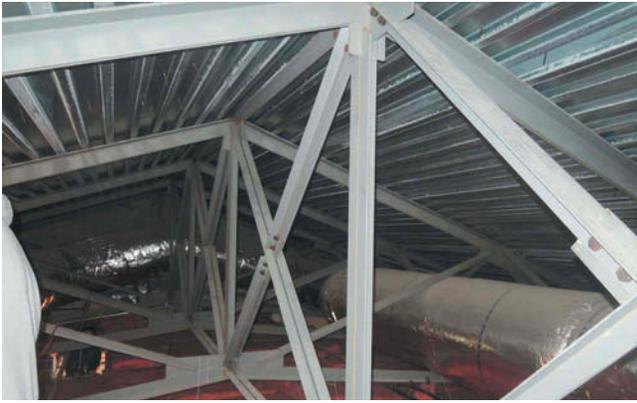
Condensation: Gaps between the sheathing panels and corresponding rigid insulation compromised the continuous layer of insulation and allowed exterior air to contact the metal deck. In addition, the segmental layer of batt insulation, separating the attic from conditioned spaces below, lacks a continuous air/vapor barrier and allows conditioned air from below to enter the attic. Warm air was also free to enter the attic through joints in the insulated ductwork above the ceiling. With colder exterior temperatures, the deck was cooled below the dew-point temperature of the interior air. As deck temperatures dip below this dew point, condensation occurs. When deck temperatures are below freezing, frost can built-up in areas where interior air flow is more stagnant and later melt during warmer periods. This melting resulted in observed water stains on interior finishes.

Lose-fitting and displaced insulation in attic.

To prevent condensation and ice dams, a continuous layer of insulation and air and vapor barriers along the roof was recommended. The warm air seepage within the attic exacerbated these conditions, thus the ceiling insulation was removed and the attic was treated as a conditioned space. This included insulating and integrating the upper wall portions with the roof to create a continuous air and vapor barrier. Two options

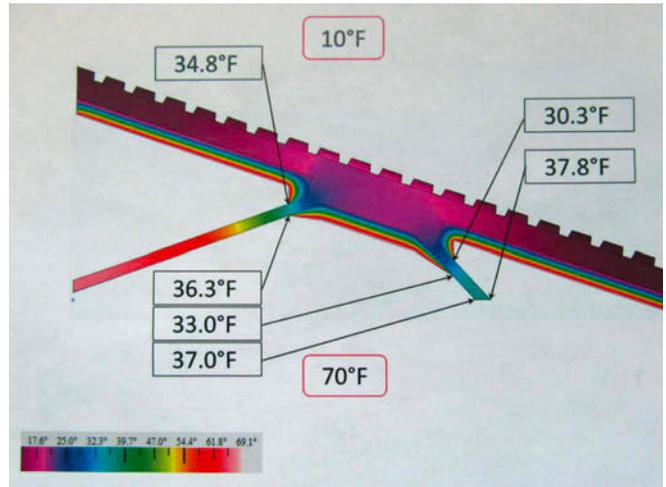
THERM model with temperature gradient across insulated truss.

Option A utilized a closed-cell spray polyurethane foam (SPF) insulation on the interior face of the metal decking. An SPF product with an integral fire retardant that satisfied the ASTM E84 and UL 1715 testing criteria was used to satisfy IBC requirements for ignition and thermal barriers. This insulation was installed in two layers to encase the truss top chords and control potential thermal bridges. Using THERM software, two-dimensional computer models

of the assembly were evaluated to identify temperature gradients and condensation potential while assessing insulation coverage. In addition, component additive methods were used in conjunction with THERM to demonstrate that the resulting R value satisfied the IECC requirements for the assembly. Available fire-test data for the SPF did not include configurations with continuous SPF installed with horizontal-to-vertical transitions. Consequently, an alternate materials (foil-faced mineral wool) insulation were used at wall transitions.

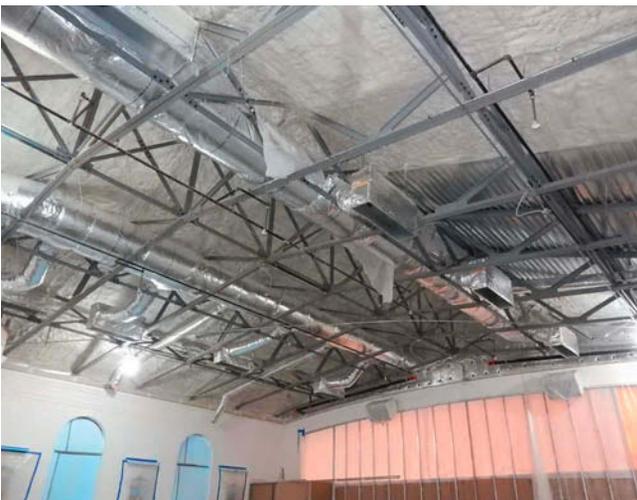
SPF Installation partially completed.

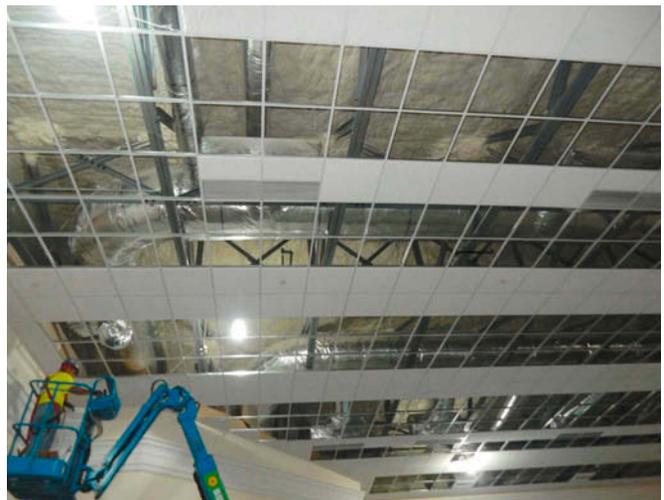
Ceiling reinstatement without the fiberglass insulation.
