STRUCTURAL REHABILITATION

Timber Truss Bolted Connection Repair and Full-Scale Load Testing

By Zeno Martin, P.E., S.E.
and F. Dirk Heidbrink, P.E.

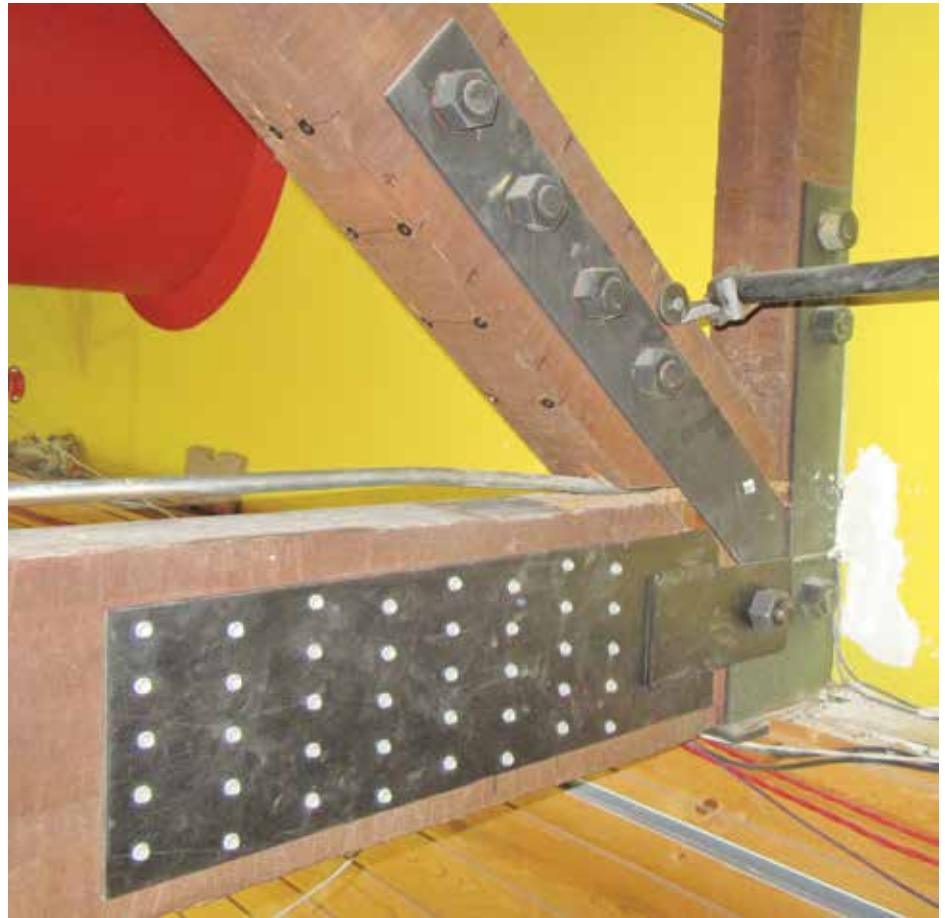
New heel plate connection at the bottom chord and supplemental HeadLOKs installed on the diagonal bottom surface.

- 2) Where design demands exceeded allowable bolted connection capacities by more than 50% (there were no results between 30% and 50%), steel plates were added to bypass the original bolted connection. This occurred at all truss heel connections and all first truss verticals inward of the heel. This new steel plate was bolted to the existing steel gusset plate using AISC 360-10 *Specification for Structural Steel Buildings* design provisions and screwed to the existing wood using Simpson Strong-Tie SDS screws.

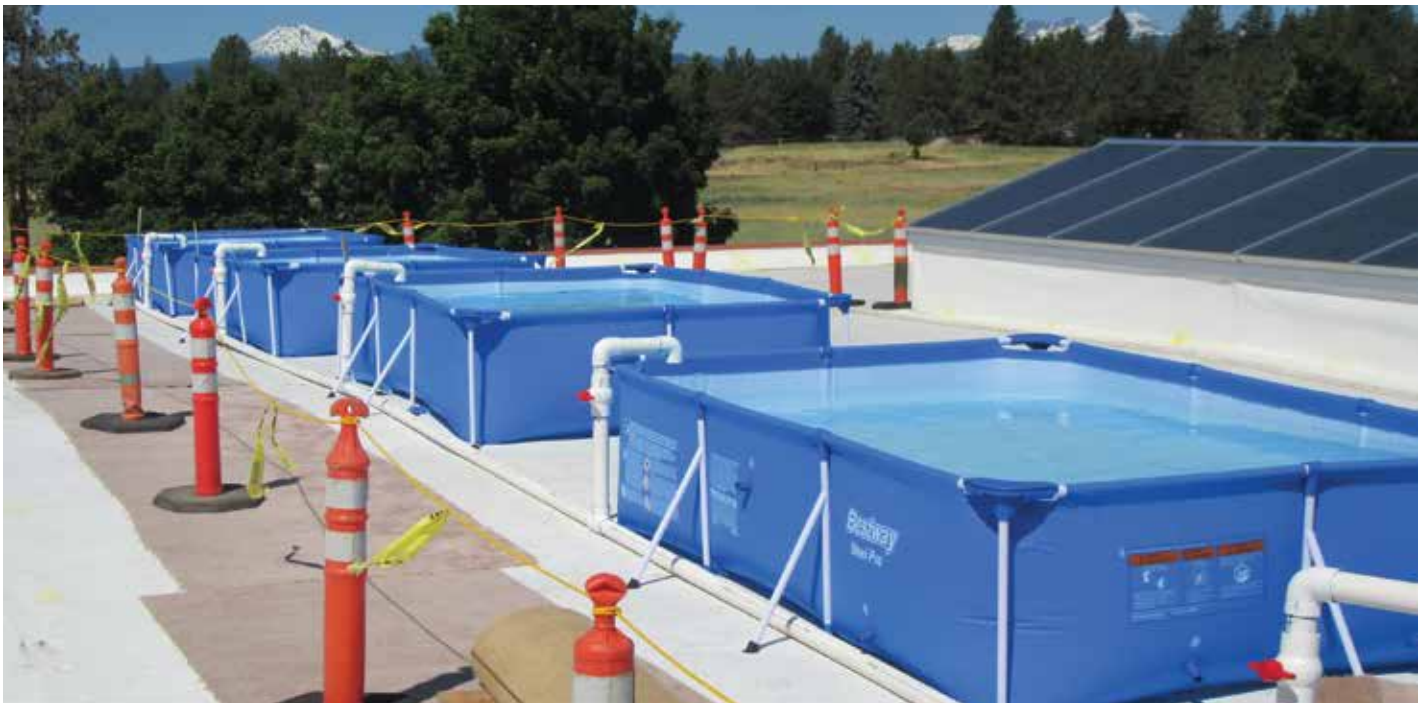
Pools filled with water on the roof during load test of the repaired truss.

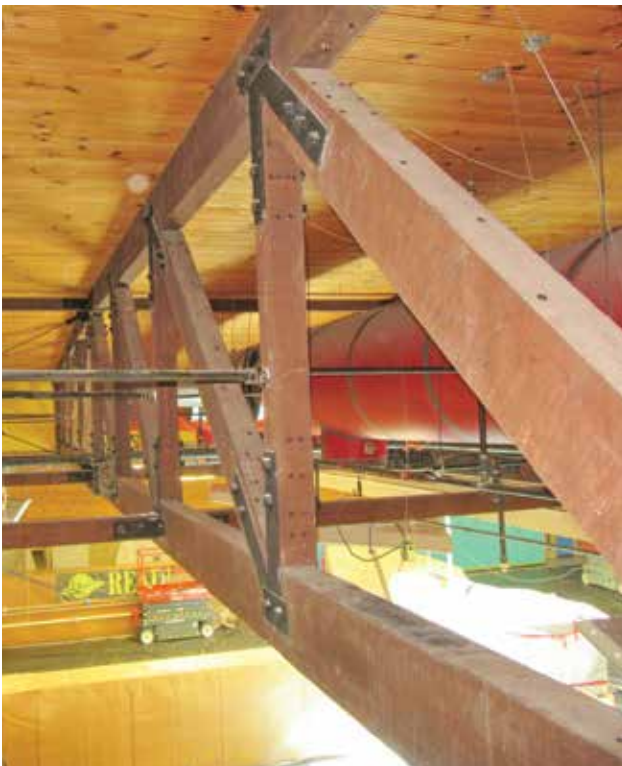
Repaired truss.
