STRUCTURAL REHABILITATION

Timber Truss Bolted Connection Repair and Full-Scale Load Testing

By Zeno Martin, P.E., S.E.
and F. Dirk Heidbrink, P.E.

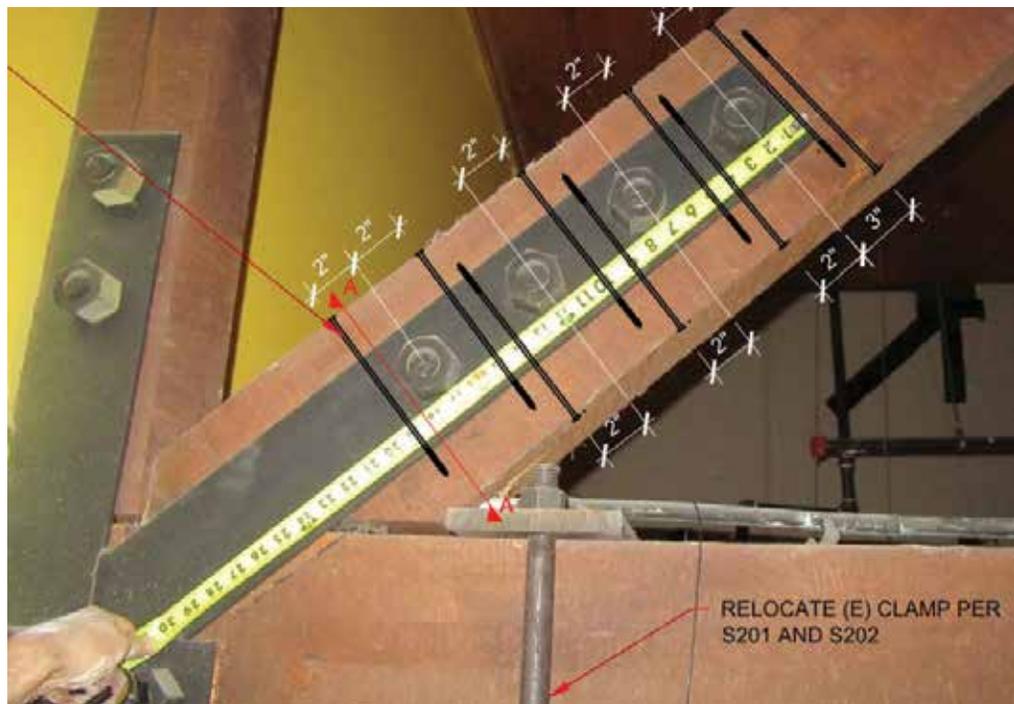
Excerpt from design drawings for added HeadLOK screws placed around existing bolts to clamp wood and resist splitting.

- 1) Where design demands exceeded allowable bolted connection capacities from 1% to 30%, then supplemental HeadLOK timber screws by FastenMaster were added around the bolted connection to resist potential tension perpendicular-to-wood-grain splitting induced by the large diameter bolts. The HeadLOK was chosen for its small diameter shaft (0.19-inch), large diameter head (0.625-inch), and short thread length (2-inch). The small diameter shaft does not promote splitting and the large head separated from its threads by several inches serves to clamp the glued wood laminations

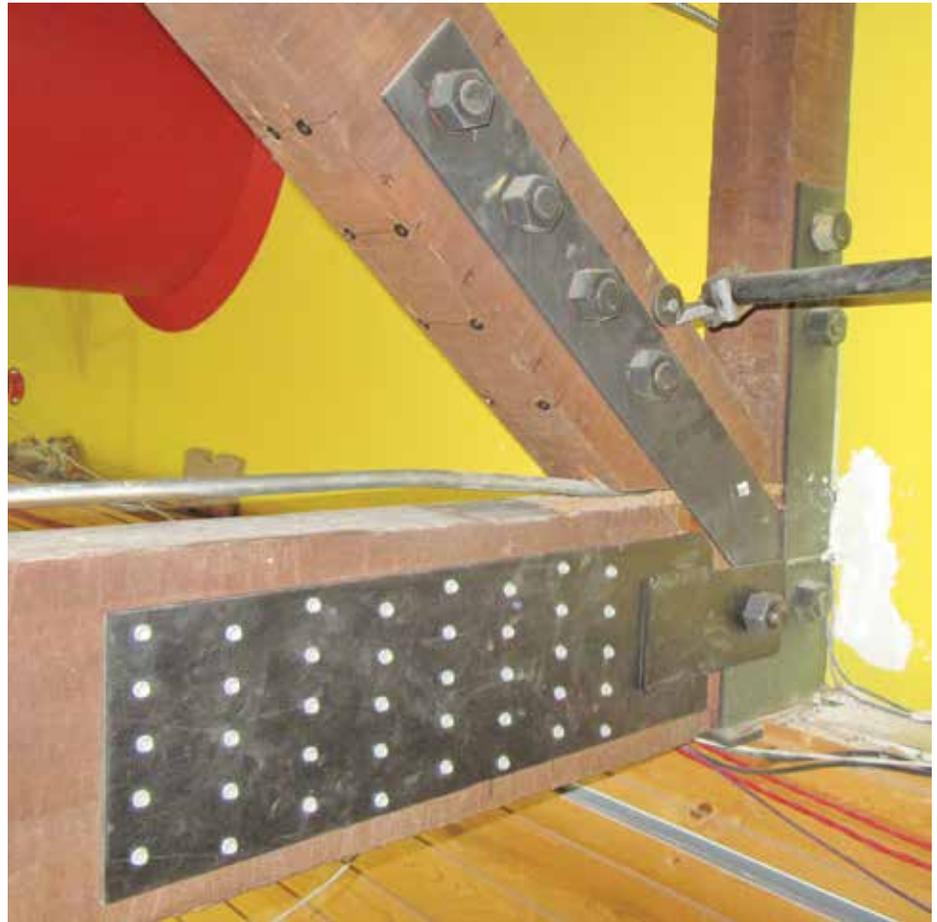
New heel plate connection at the bottom chord and supplemental HeadLOKs installed on the diagonal bottom surface.

- 2) Where design demands exceeded allowable bolted connection capacities by more than 50% (there were no results between 30% and 50%), steel plates were added to bypass the original bolted connection. This occurred at all truss heel connections and all first truss verticals inward of the heel. This new steel plate was bolted to the existing steel gusset plate using AISC 360-10 *Specification for Structural Steel Buildings* design provisions and screwed to the existing wood using Simpson Strong-Tie SDS screws.

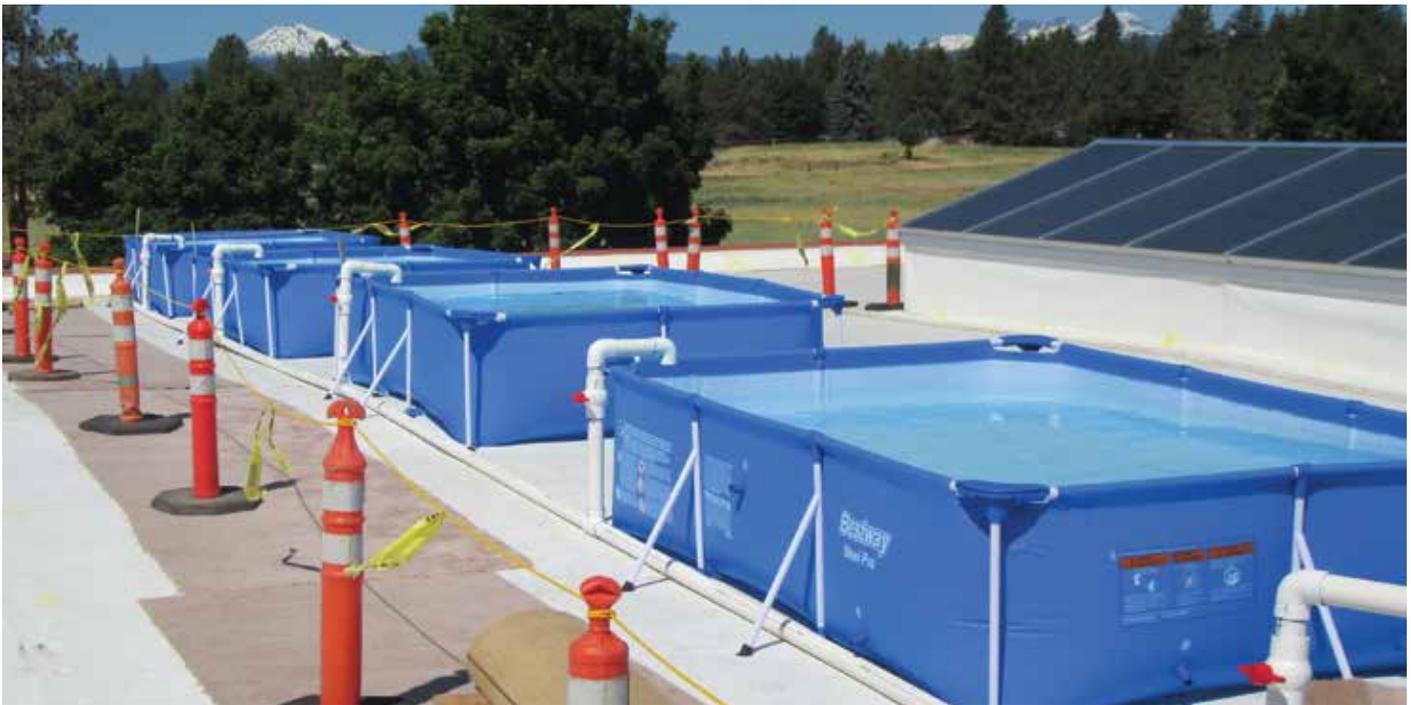
Pools filled with water on the roof during load test of the repaired truss.

pots) anchored to the floor and extended to the bottom of the truss. Maximum deflection at the center of the truss from testing was 0.825 inches, which equates to about L/1090 and was significantly less than building code-allowable deflections.

The repaired truss passed the load test by meeting both the maximum deflection criteria and the residual deflection criteria and had no distress or failure during the test.

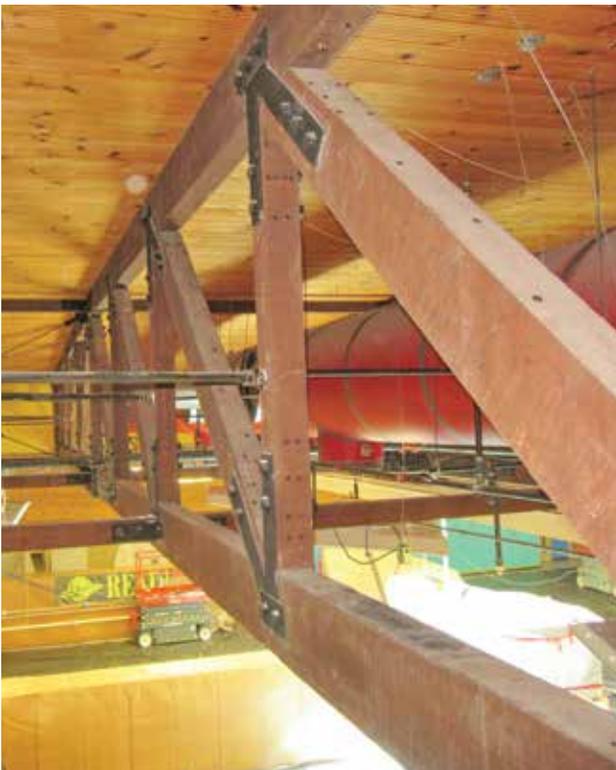
Repaired truss.
