Wood Serviceability and the Unexpected

BY: TIMOTHY CROWE, RA, SE

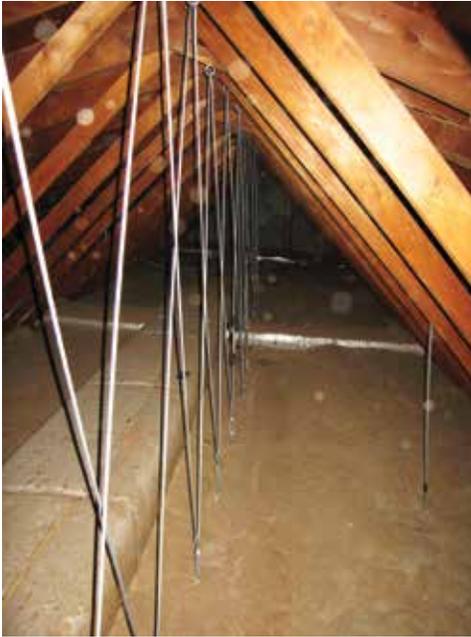
Figure 3. Steel cable reinforcing introduced at roof trusses from Indiana community center.

cables that engaged the top chords and bottom chords of adjacent trusses. This reinforcing approach to enhance the load-carrying ability of the truss bottom chords applied perpendicular-to-grain tensile stresses on the top chord members at the split-ring connectors. Wood does not provide any appreciable strength perpendicular to grain. The National Design Specification for Wood Construction (NDS) specifically states that designs that induce tension stresses perpendicular to grain shall be avoided, unless mechanical

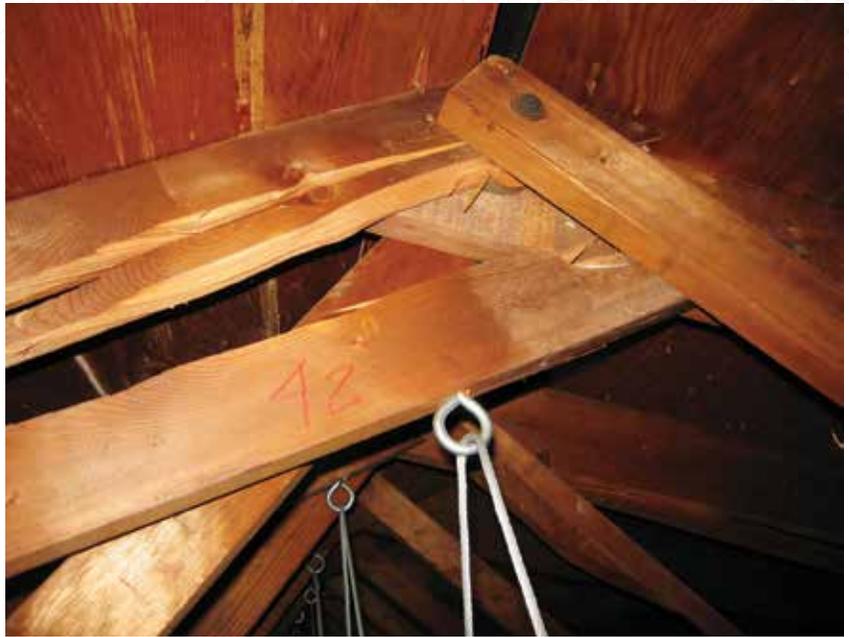
Figure 4. Fractured roof truss members at split-ring connectors attributed to high perpendicular-to-grain loading of members.

reinforcement to members is provided to resist all such stresses. In this case, no mechanical reinforcement was provided and, consequently, the cable provided to reinforce this roof structure actually pulled the top chord member connections apart over time. This resulted in multiple connection failures of the roof trusses leading to the corresponding deflections.

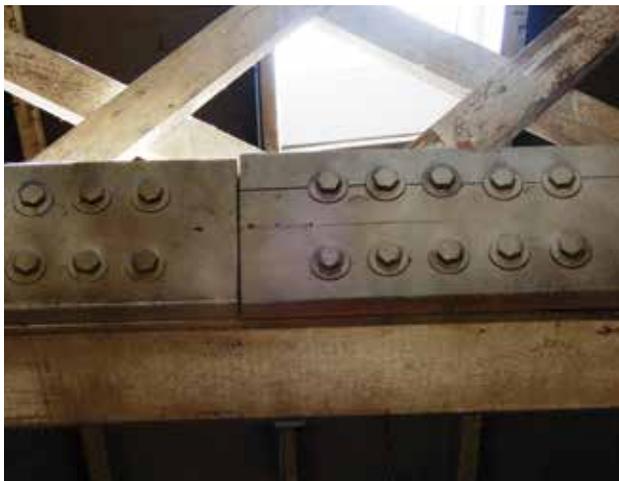
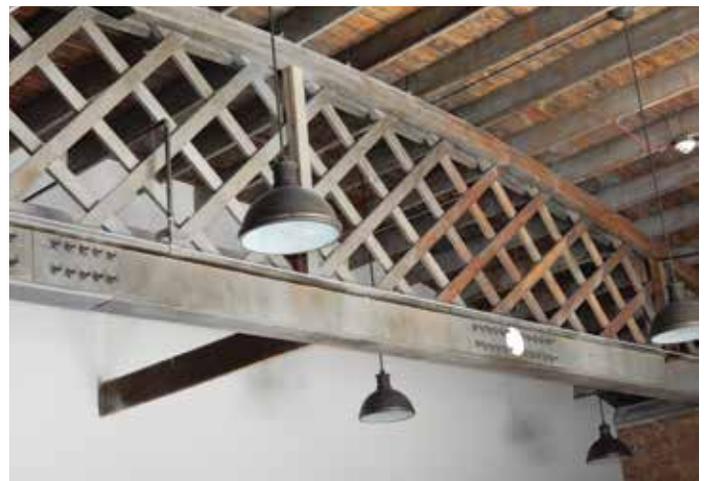
Figure 5. Partial view of lattice truss within the roof structure above the administration building.

Figure 6. Partial view of lattice truss within the roof structure above the administration building.

Excessive truss deflections and localized crushing at the tops of interior partitions were observed by the owner within a year after the remodeling work had been performed. It was apparent that the crushing at the top of the interior partitions was attributed to inadequate accommodations of differential movement of the

roof structure, as the partitions were built tight to the bottom of the trusses. Roof structure deflections will fluctuate over time with changes of loads and temperatures. With wooden trusses, deflections can further fluctuate with changes in relative humidity resulting in moisture content changes in the chord members. Generally, framing practices accommodate this differential movement. Our investigation revealed that another significant factor related to these deflections had to do with the truss modifications implemented during the remodeling project. In particular, supplemental 2x10s were added to the lattice truss bottom chords in an apparent attempt to strengthen them. However, this reinforcing was not continuous along the truss length and the specified bolted attachment of the reinforcement actually created holes, reducing the net cross section of the original bottom chord. The

reduced section resulted in increased tensile stresses in the bottom chords under gravity loads. Under sustained loads, these stresses can result in an increase in deflection. Other connections of this bottom chord reinforcing included welding of new steel components to existing bolts at the ends of these trusses, raising additional questions regarding the appropriateness of these repairs. Thus, this reinforcing approach actually weakened the roof structure.

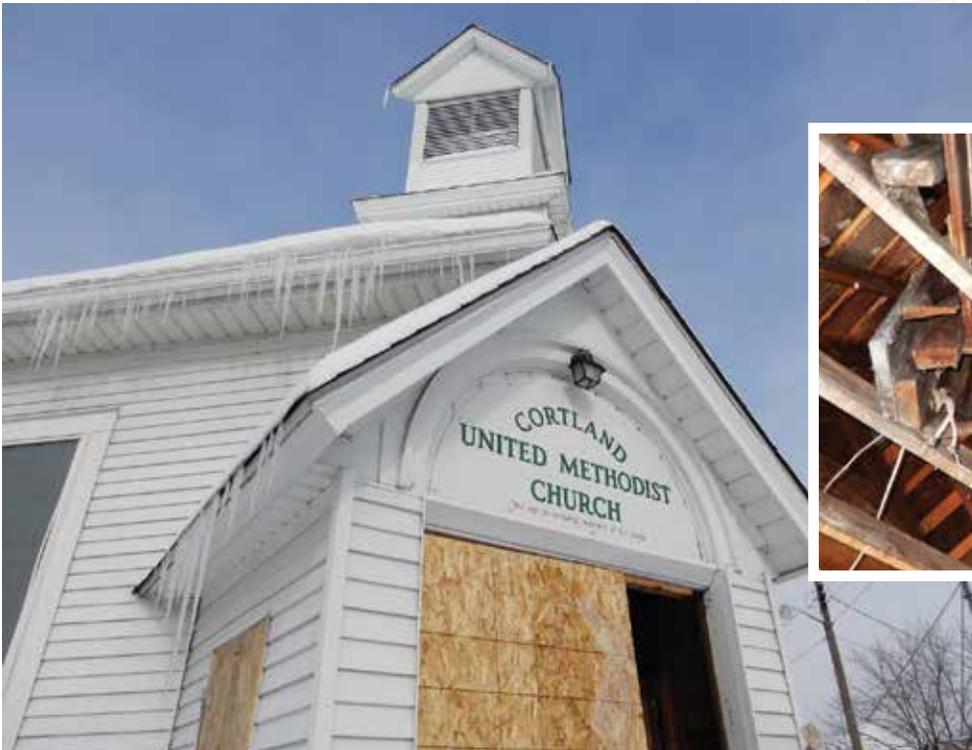
Figure 7. Partial view of corner entrance added to the 1890s church in central Illinois.

The third example is a historic church located in central Illinois that was constructed circa 1890. This modest, balloon-framed structure is set on a masonry foundation, is rectangular in plan, and measures approximately 31 feet by 50 feet. In the early 1900s, a new building entrance was created at the corner of the original church. Building damage at the entrance attributed to a more recent motor vehicle impact initiated an assessment of the structure.

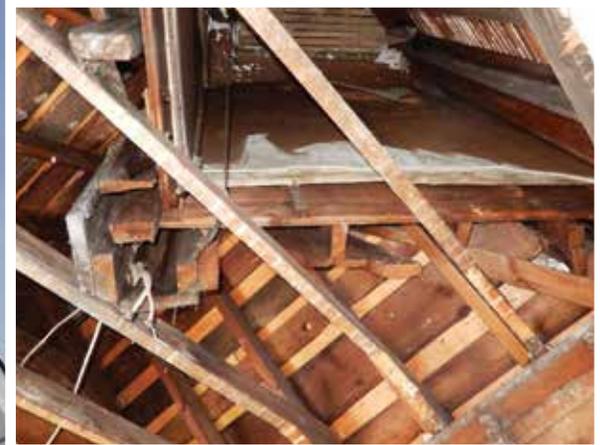
Figure 8. Partial view of framing above corner entrance added to the 1890s church in central Illinois. Note that the wall studs and corner framing was cut away without provision of any supplemental support.

This assessment revealed that framing modifications performed to accommodate the corner entrance simply cut out the wall stud framing at the building corner without providing any support for the framing above the opening. As peculiar as this sounds, this framing seemed to perform without incident, as the horizontal plank sheathing and interior plaster finishes on the balloon-framed assembly provided the support of the building construction above it. Interior and exterior finishes had also been added to these walls, masking any distress and movement within the framing such that minor settlement of these unsupported elements would have gone unnoticed. Longer-term repair recommendations included incorporating a resolved support and load paths for the framing around the repaired entrance. But these conditions again demonstrate the unpredictable nature of prior remediation work on these structures. You don't always know what you are working with until you perform a proper assessment.
