## JACKSON CONDOMINIUMS WATER INFILTRATION: *Understanding Expectations and Intent*

BY RACHEL WILL AND FRANK HALSEY

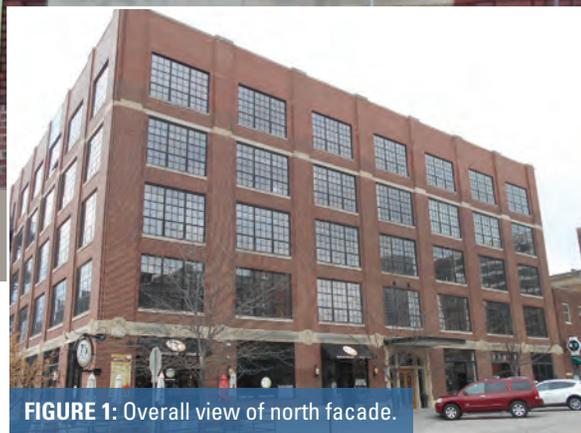
**FIGURE 1:** Overall view of north facade.

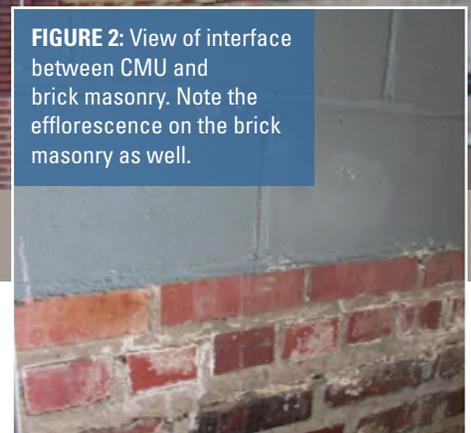
**FIGURE 2:** View of interface between CMU and brick masonry. Note the efflorescence on the brick masonry as well.

lowest four floors and the fifth floor of the south facade and a 12-inch wall comprised of brick and CMU for the fifth floor at the north, east and west facades. (Figure 2) The fifth floor was added to the warehouse building sometime in the 1950s, without any

consideration for weatherproofing or flashings. The outer wythe of the main facades (along Jackson Street-north and 11th Street-east) consists of face brick and limestone detailing. The outer wythe of the west wall is constructed of face brick and the south wall consists

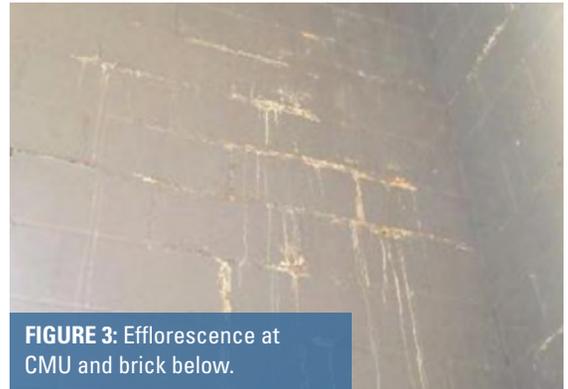
Prior to any current scope of repair work commencing, water infiltration and efflorescence (Figure 3) was reported at the exposed brick and concrete masonry units and metal deck ceiling in multiple units on the north, east and south facades. In order to gain a better understanding of the reported leakage and potential causes, WJE conducted an initial limited investigation of the existing masonry and roofing related to the reported ongoing water infiltration in June 2016. As part of that investigation, WJE recommended additional investigation with regard

FIGURE 3: Efflorescence at CMU and brick below.

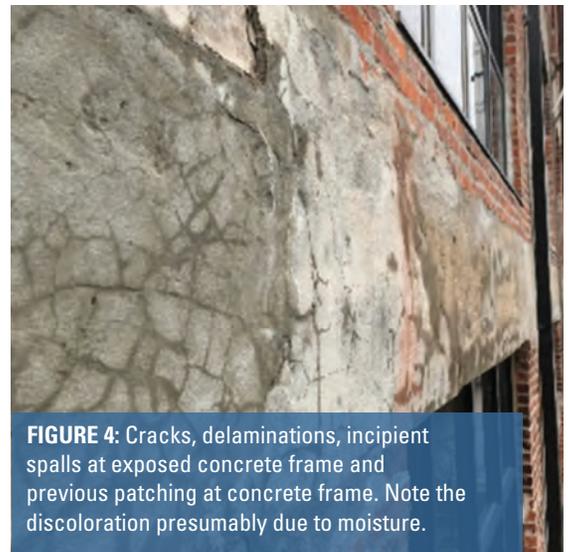
to the existing masonry walls at the fifth floor and roofing, including additional inspection openings and trial repairs with follow up water testing. The follow up investigation was completed in November 2016. The building has a reported history of water infiltration during rain events. Based on the observations from WJE's assessments, there were multiple potential sources for the infiltration, including conditions related to the brick masonry, the windows, and the roofing. (Figures 4 and 5)

FIGURE 4: Cracks, delaminations, incipient spalls at exposed concrete frame and previous patching at concrete frame. Note the discoloration presumably due to moisture.

- Rout and seal cracks at exposed concrete framing.
- Remove delaminated /cracked concrete at areas where the cast-in-place concrete frame is exposed and install a new formed and poured concrete patch.

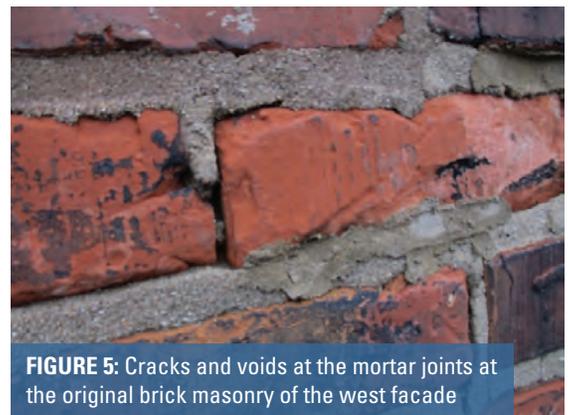
FIGURE 5: Cracks and voids at the mortar joints at the original brick masonry of the west facade

- Repoint 100 percent of mortar joints within the brickwork at the third, fourth and fifth floors at the north and east facades. as designated by the A/E within the brickwork at the first and second floors at the north and east facades. Repoint one hundred percent of all mortar joints within the brickwork at the west and south facades. Note: install backer rod and sealant in joints between brick and concrete framing at the south facade.

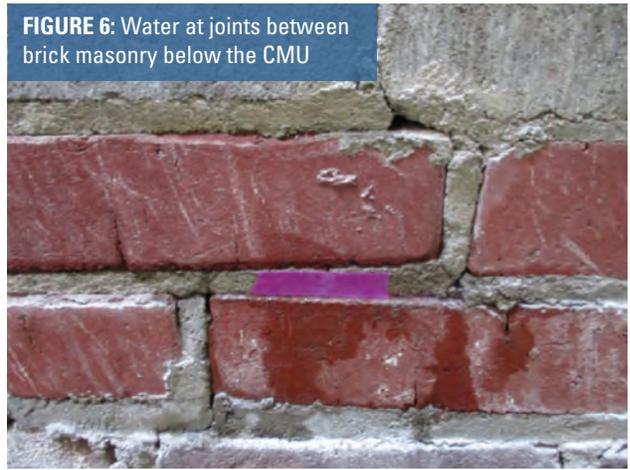
it is assumed that the previously added fifth floor also was intended to act as a mass wall rather than similar to the contemporary cavity wall construction. (Figure 6)

Based on the reported history of leakage, the existing walls were not performing as would be expected of properly functioning mass walls. Additional investigation of the existing masonry at the interface of the original wall construction and the new fifth floor, above a fifth floor window head and at location of the original wall construction at the location that brick passes in front of the concrete frame was necessary to determine the interface details and to review the conditions contributing the water infiltration. It is likely that the fifth floor was intended to be constructed as a mass wall in that no flashings were installed, yet based on our water testing it was determined that CMU was not grouted and there were significant openings/ voids in the collar joint behind the brick masonry and the CMU as well as the joints in the backup.

**FIGURE 6:** Water at joints between brick masonry below the CMU

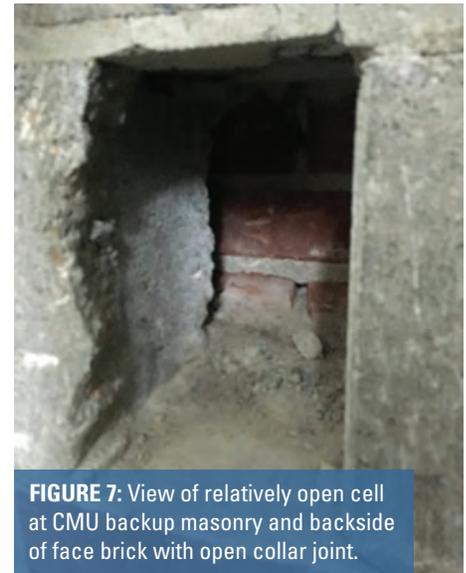
The open collar joint behind the outer wythe of brick masonry and the CMU causes the wall to function more like a modern cavity wall where water

run freely down in the cavity space. (Figure 7) This is particularly true where the outer wythe passes in front of the cast-in-place concrete frame. The voids in the as-built wall disrupt the mass and function more as a cavity space, allowing water to flow instead of being held. However, cavity wall systems are designed with the anticipation that water will reach the cavity and are designed and constructed with a flashing system that collects this water and directs it to the exterior. In the as-built walls where the outer wythe is supported on shelf angles, the water can flow down to those shelf angles, collect on them, and run horizontally until it reaches a discontinuity in the shelf angle. There the water can migrate further into the wall. In some locations, these discontinuities align with the jambs of the windows. Thus, water can flow off the steel lintel and onto the metal frame of into the interstitial space between the masonry and leak to the interior of the building. Similarly, water can bridge the cavity and run down the face of

**FIGURE 7:** View of relatively open cell at CMU backup masonry and backside of face brick with open collar joint.

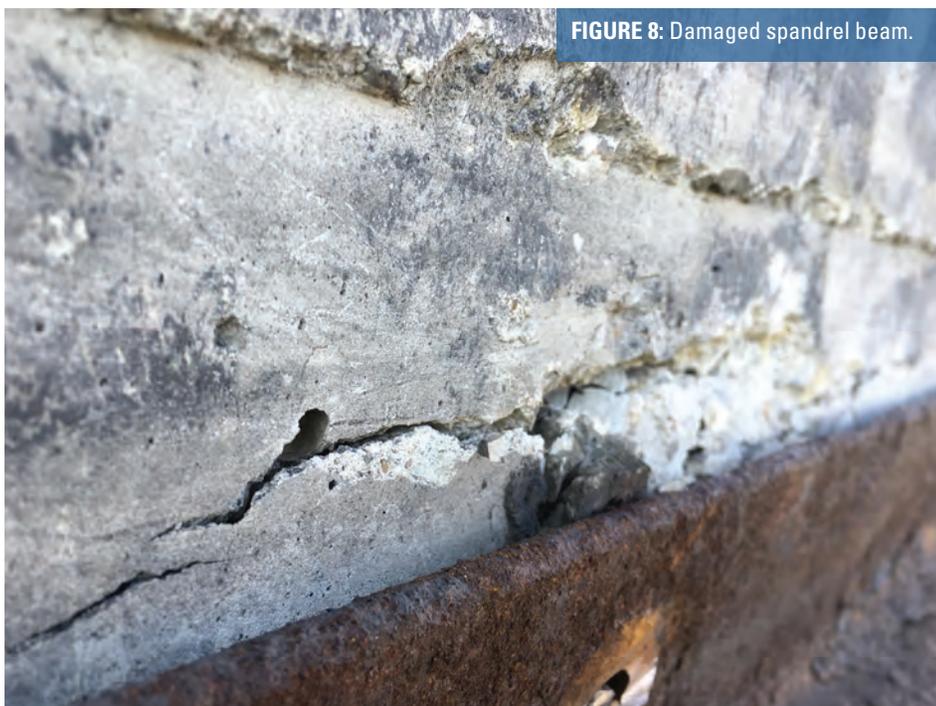
the spandrel beam, there it can pass behind the steel shelf angle and leak to the interior. (Figure 8)

**FIGURE 8:** Damaged spandrel beam.

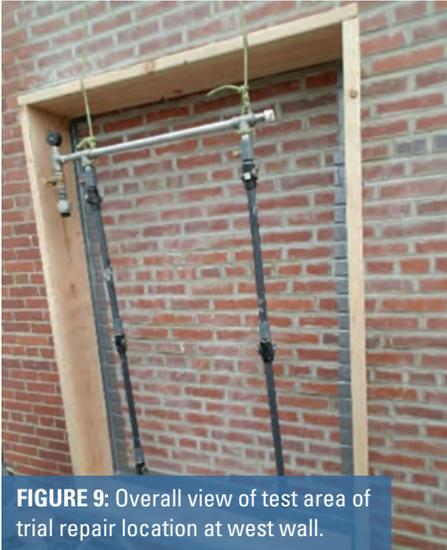
suggests, this test is designed to measure the volume of water that penetrates the outermost face of the wall. By performing the test on a portion of the wall, repointing that area and retesting, a quantitative comparison of the wall performance before and after the repointing can be

**FIGURE 9:** Overall view of test area of trial repair location at west wall.

made. (Figure 9) This information can assist the project team in assessing the anticipated improvement in the ability of the wall to resist water infiltration to the interior.

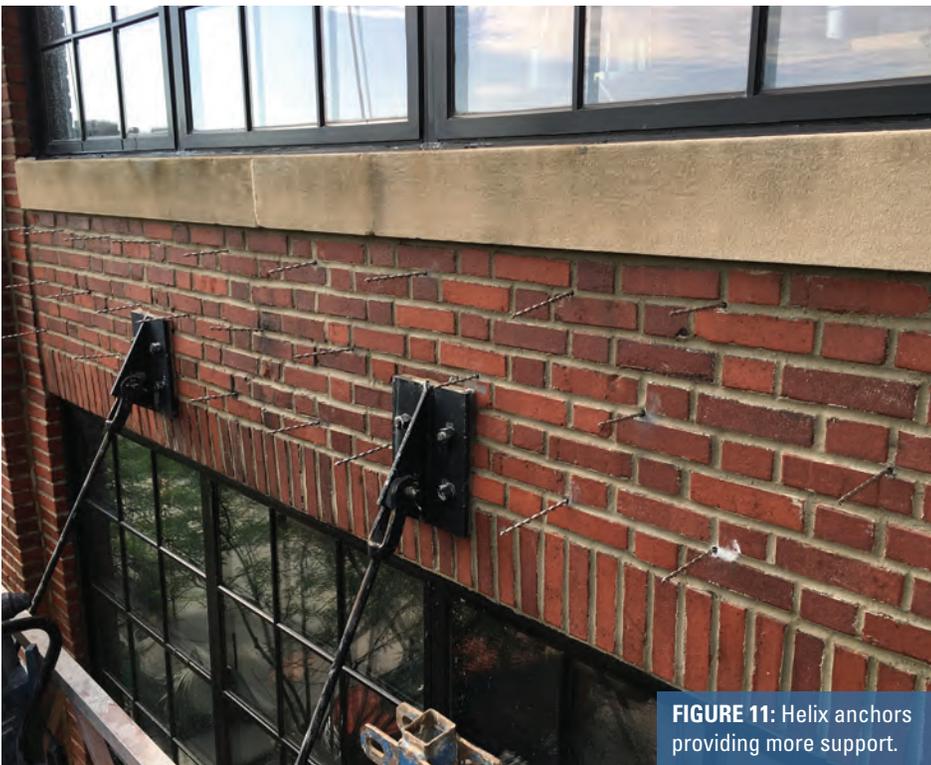
**FIGURE 11:** Helix anchors providing more support.

As discussed above, portions of the outer wythe of masonry walls pass in front of the concrete structure of the building. At these areas, many of the lateral ties provided to hold the outer wythe of masonry (functioning as a veneer) were missing or corroded. The differential movement between the concrete frame and the brickwork and is the result of the brick cantilevering past the face of the column and only being laterally anchored on one side. Supplemental lateral anchorage was recommended and installed. based on the review of the inspection openings at select locations. (Figure 11)

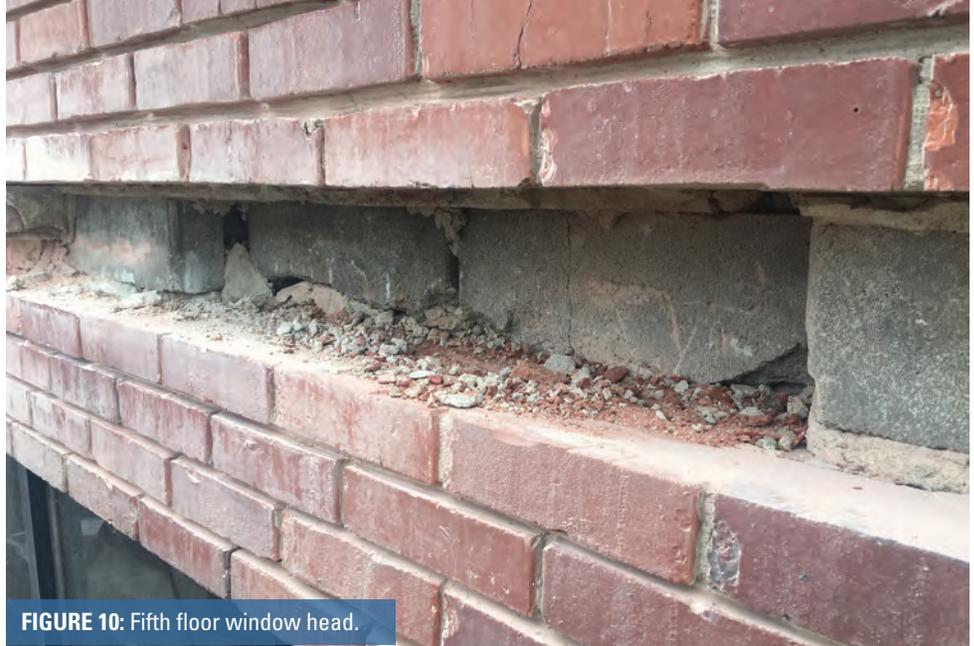
**FIGURE 10:** Fifth floor window head.

Providing flashings at the window heads of the fifth floor and at the interface of the original wall construction and the added fifth floor to collect water that does penetrate the outer wythe and directing out of the wall system, is also important to limit water infiltration into the interior and was included as an alternate repair option. (Figure 10) This repair exposed the existing steel lintels so that they could be cleaned of corrosion scale and painted to prolong their service life. Shelf angles that exhibit significant section loss, if

any, were removed and replaced as well. The flashing system aided both in controlling water infiltration and limiting the steel shelf angles from future exposure to water.

- At all fifth floor window head locations, expose all shelf angles by removing four courses of the existing brick masonry, clean and paint, and install stainless steel sheet metal pan flashing with self-adhered membrane flashing/termination bar.

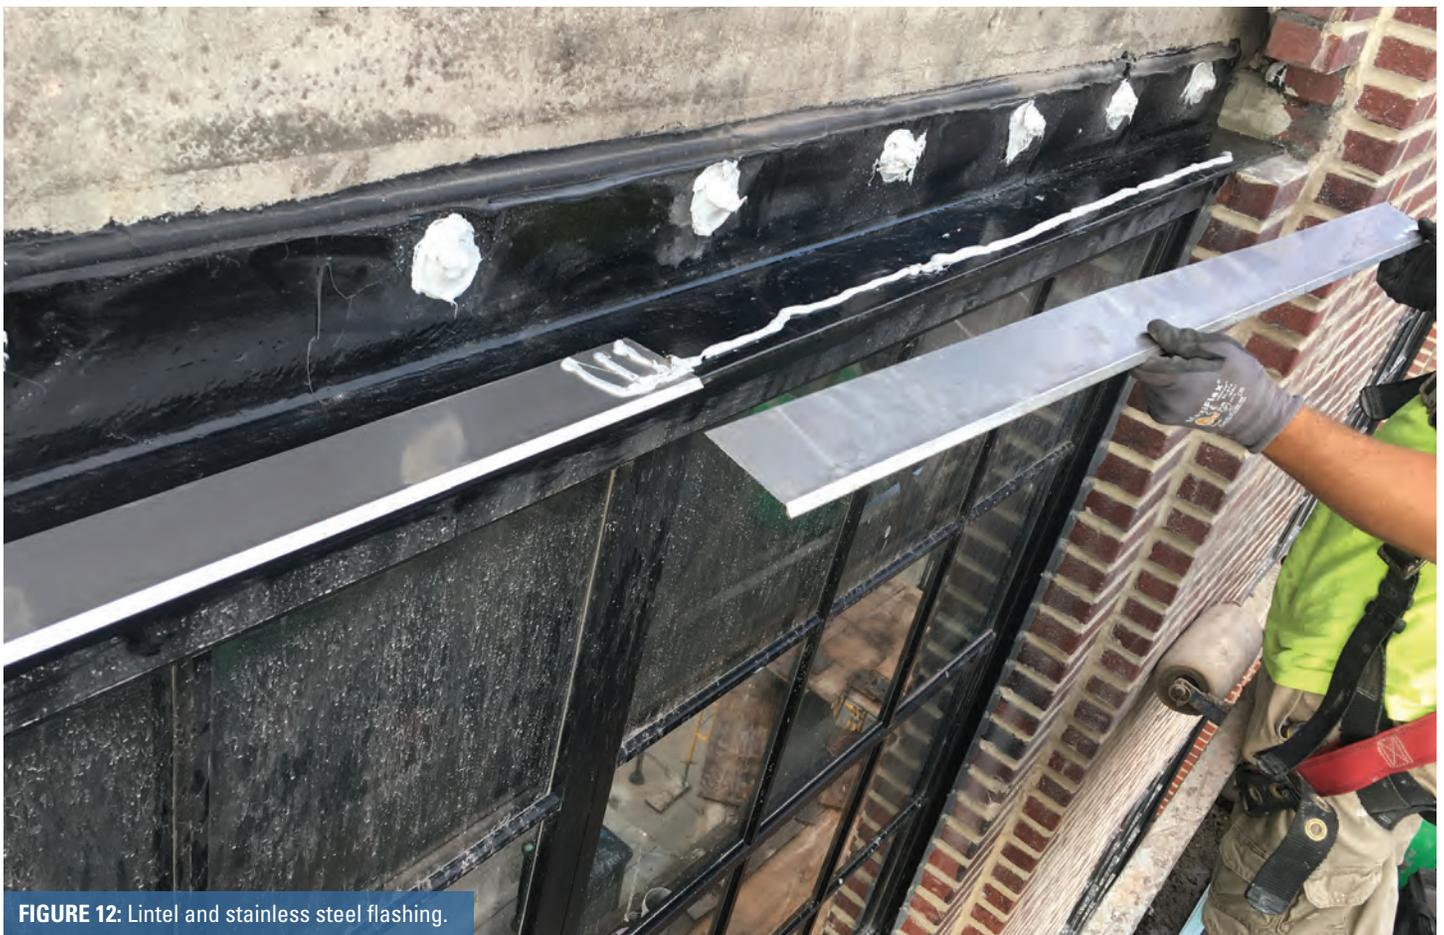
FIGURE 12: Lintel and stainless steel flashing.

It should be noted, as part of the initial investigations and the review of the fifth floor construction, WJE had indicated that if the repointing trial repairs were not successful at limiting the water infiltration, the repairs may need to be more invasive. One of the options recommended included removing one hundred percent of the outer wythe of face brick at the fifth floor, pointing the voids in the CMU backup, installing stainless steel pan flashings with self-adhered membrane at the interface of the original mass wall construction at the sills of the fifth floor and the steel lintels at the heads of the fifth floor windows, installation of a liquid applied weather resistive barrier on one hundred percent of the CMU backup stripped into the new through-wall flashings, and reinstallation of the face brick with stainless steel lateral anchorages. (Figure 12)

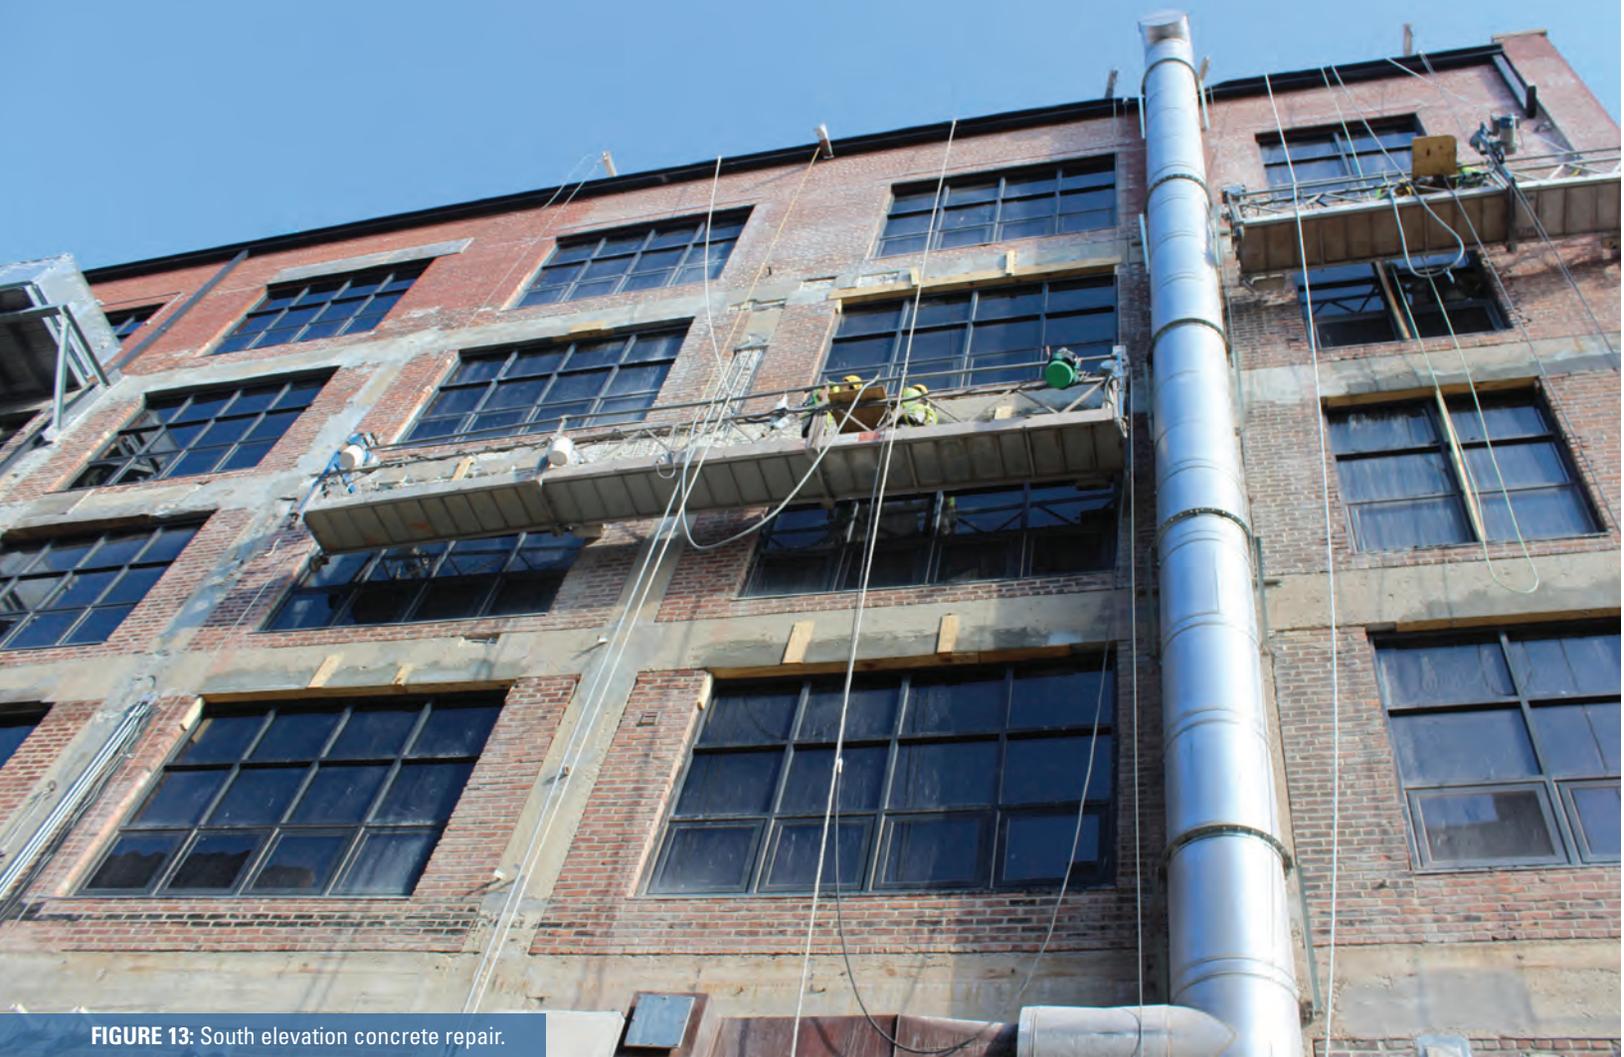
**FIGURE 13:** South elevation concrete repair.

The repairs started in early April 2018 (*Figure 13*) and clouds of dust

were experienced inside units almost immediately, despite OSHA required dust collection efforts being utilized during the repointing process. During our efforts to mitigate the dust, it was discovered that the building was acting like a vacuum with negative air pressure actually pulling dust through the solid masonry walls. While investigating this issue, with a mechanical engineer, it was indicated that a typical code required air exchange could be value engineered out of adaptive reuse projects, due to the inclusion of sufficient operable windows in the original adaptive reuse design. If only the operable windows were open, all the time to provide for the sufficient air exchange. These observations, were extrapolated by the team to infer that if dust was being pulled into the interior of units, the same issues would exist with moisture in the walls, even after repointing. To address this issue during construction, temporary modifications were made

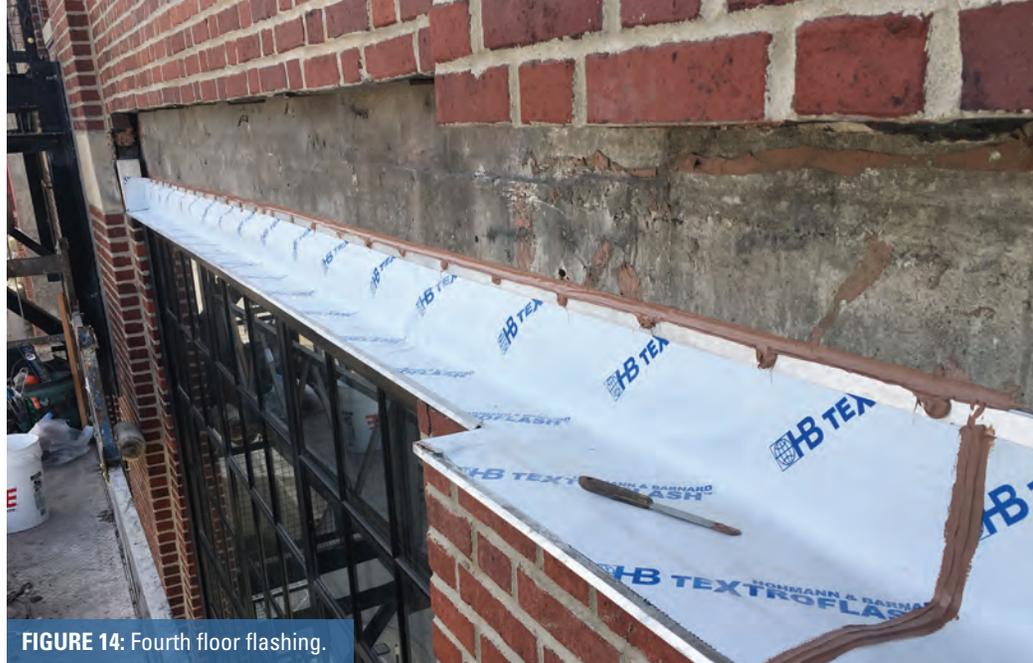
On August 20, 2018, as the project was approximately fifty percent complete, the Omaha area experienced near record rainfall, with 6.16 inches of wind-driven rain, in less than twenty four hours. Portions of the building, where exterior façade repairs had already been completed, experienced significant water infiltration at the fourth floor window heads, with a similar incident occurring again on December 1, 2018, one week after the project had been fully completed and demobilized. At one point, following one of these incidents, when the frustrated Owner asked how we could guarantee against water infiltration, we responded that they could cover the building in plastic. That comment did not go over well, but it helped to reiterate to the owner the challenges associated with waterproofing a building, with masonry walls and all of the unforeseen conditions, as previously described, that had never intended to be a fully occupied space, much less a residence.

FIGURE 14: Fourth floor flashing.

These incidents prompted discussion, and eventually a change order, to address the installation of thru-wall flashing above all the fourth floor window openings. (Figure 14) The flashings at these locations were originally included in the bid documents as an alternate due to the findings from the trial repair location, without experiencing leakage during water testing following repointing
