## CSX Bridge QDC 1.71

Emergency Response, Inspection, and Mechanical Design | Buffalo, NY

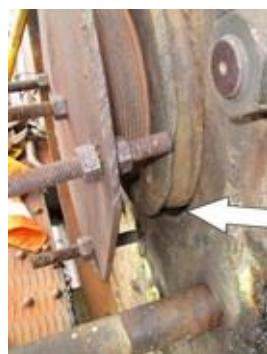
WJE provided an emergency response to investigate an issue affecting operation of the bridge. The north rack and pinion teeth were "skipping" which prevented the movable span from opening. While WJE was able to diagnose the cause of the skipping and quickly implement a temporary repair to resolve that issue, a limited mechanical inspection identified that the north counterweight trunnion was in poor to critical condition due to severe wear at the span to pin connection, fractured sleeve retaining bolts, and misaligned lubrication ports.

WJE provided all required mechanical engineering services, including inspection, evaluation of repair options, preparation of plans, specifications and cost estimates, and construction services for the rehabilitation of the counterweight trunnion bearing.

The rehabilitation included a unique jacking system that used the structure as the support for the counterweight truss thereby eliminating the need for a costly and time-consuming temporary foundation. After the span was jacked, the bearing repair consisted of securing the truss to the existing pin, removal of the sleeve bolts, installation of temporary sleeve bolts, removal of the existing pin, replacement of the existing bearing bushing with modifications to facilitate assembly, field machining to restore fits between the pin and both the structure and the sleeve, installation of a new pin with proper fits, and installation of high-strength studs and dowels to prevent relative movement between the structure and the bearing assembly.
