PROJECT PROFILE

Cable-Stayed Roof Structure

Structural Cable Inspection | Midwest

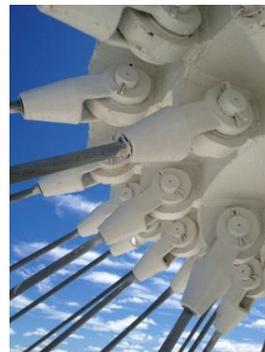
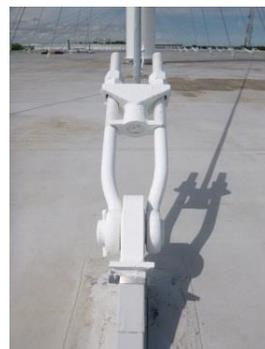
Each suspender cable is composed of many small diameter steel wires that are wound in a helical pattern. During WJE's inspection, some cables were noted to have localized discoloration or light surface corrosion beginning between the individual cable strands. Also, near the upper ends of several cables, water dripping from the top row of clevises onto cables anchored at the two rows below caused areas of the lower cables to experience prolonged exposure to moisture. Accelerated wear of the galvanized coating in localized areas and the onset of corrosion began as a result. Spreading of the individual wires of the cables in these areas was observed at one such location. Abrasion of the galvanized coating along the length of the cables was also observed to have caused moderate surface corrosion in localized areas.

The level of corrosion did not pose a structural concern. However, since these cables serve as the primary structural support for the roof, WJE recommended a more frequent inspection cycle to establish the rate of progression of the corrosion on the cables. To avoid the expense of constructing scaffolding around the cables to facilitate access for inspections, WJE was retained to utilize industrial rope access techniques to access the tops of the masts and to inspect the lengths of the cables and their anchorages. Climbing, rappelling, and ascending were utilized to provide arms-length inspection of the cable anchorages at the tops of the masts as well as at an assortment of cables during each inspection.
