PROJECT PROFILE

City Vista Garages

Post-Tensioned Slab Evaluation | Pittsburgh, PA

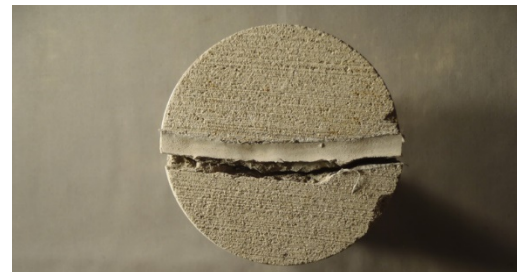
WJE No. 2016.4271
Sample ID CORE 4-F-2

WJE reviewed original construction documents, observed on-site conditions, and performed petrographic studies on several concrete core samples extracted from the elevated post-tensioned slab. Petrography indicated that the full-depth cracks through the elevated slab formed after the concrete developed a firm bond between the paste and the aggregates. Additionally, crack mapping of elevated slab conditions suggested one-sided restraint of two of the three garages. The crack patterns were consistent with the location of a lower-level retaining wall at the two affected garages. WJE concluded that the lower-level retaining walls were causing restraint of the elevated slab, which did not allow for adequate transfer of the post-tensioned forces. Repair recommendations were provided to repair cracks and reduce the amount of water leakage to the lower level of the garages.
