# Commerce Center

Investigation of Floor Slab Distress | Scottsdale, AZ

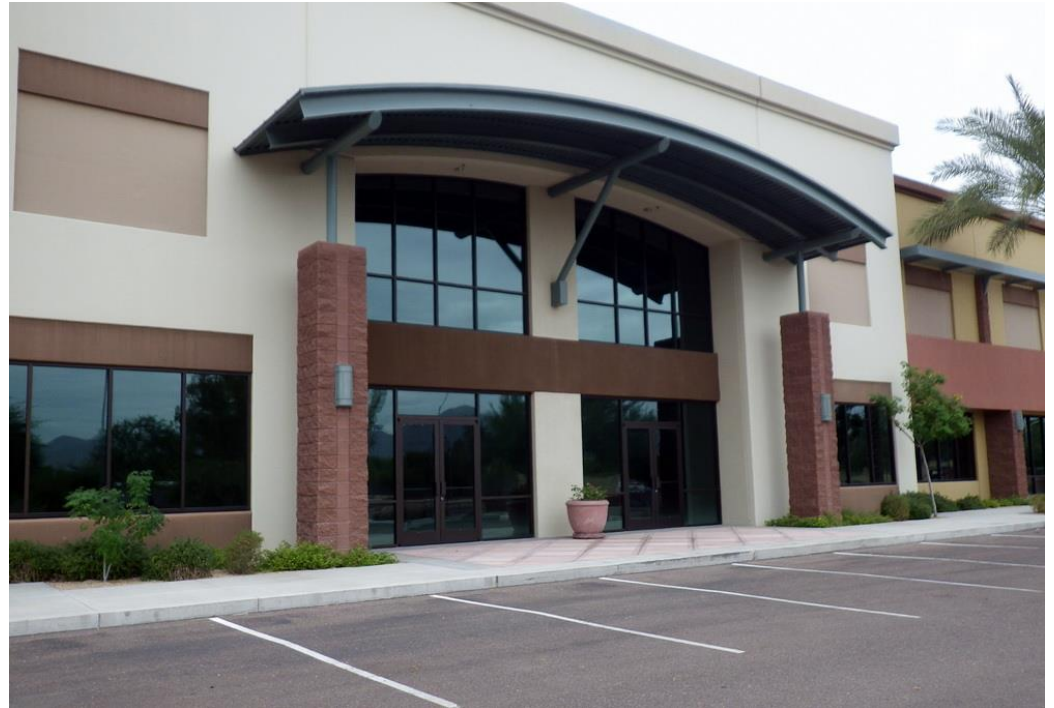
During preparations for the original tenant finish out, concrete slab surface distress was noted by the owner. This distress included localized delamination, spalling, and pop-outs at thousands of locations associated with white deposits and exudations from within the concrete. WJE was retained to investigate the reported slab distress, determine if the condition was ongoing and likely to continue, and provide recommendations for repair.

The concrete floor slab was found to exhibit signs of distress related to excessive amounts of sodium-potassium silicates in the near-surface region of the concrete slab, due potentially to an incorrectly applied surface hardener/densifier. These accumulations led to excessive stresses in the top surface of the concrete, resulting in pop-outs and exudations.

Options for repair and replacement were given to the client and portions of the slab were replaced, while some areas were repaired locally. WJE was asked to return to the site after replacement for an updated visual assessment of the floor slab.
