# Kenosha Medical Center Campus

Masonry Distress Investigation and Repair Design | Kenosha, WI

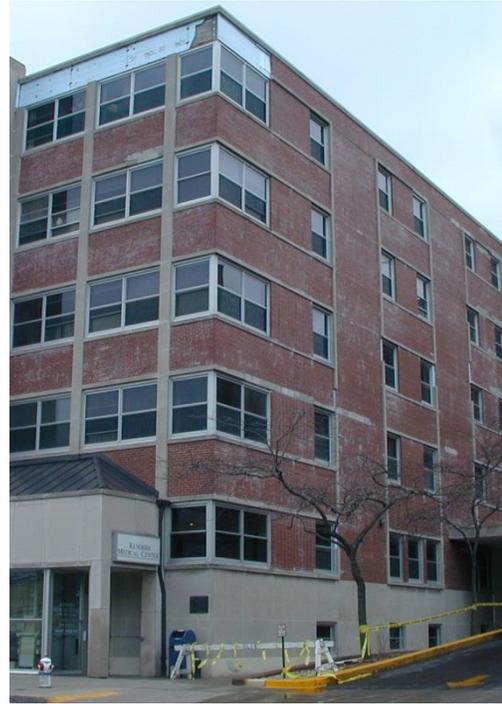
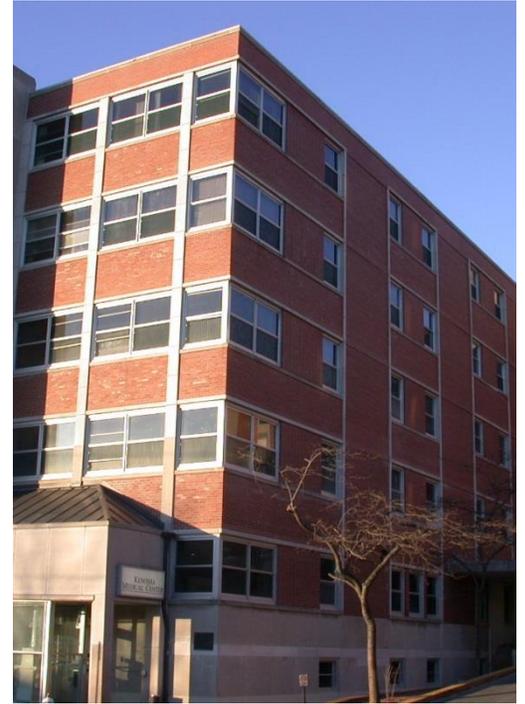
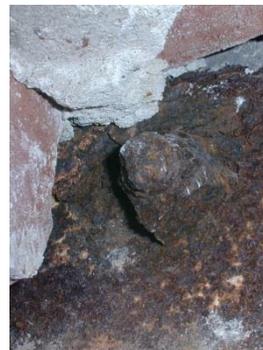
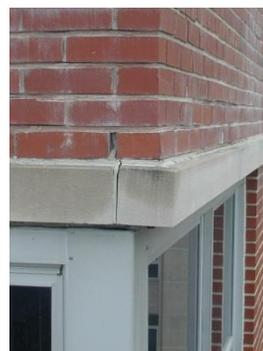
A masonry-clad hospital building experienced problems of moisture penetration, staining of exposed surfaces, outward displacement of masonry, and spalling of limestone trim pieces. The property owner sought to determine the cause of the distress and to implement repairs to restore the exterior walls.

- The mortar contained extremely high levels of chloride ions, at concentrations well above the threshold necessary to promote corrosion of embedded steel. The probable source of chlorides in the mortar was the use of calcium chloride as an accelerator during construction in cold weather.
- Advanced corrosion had developed on embedded steel elements in the masonry, including wall ties and shelf angles. Spalling occurred in the masonry as a result of forces generated by this corrosion.
- Poor flashing details allowed water to remain within the walls, compounding the vulnerability of steel to corrosion.

Remedial measures were developed to salvage most of the building's facade components. These included replacement of the embedded steel shelf angles and through-wall masonry flashings, remedial anchoring of the masonry veneer, selective replacement of limestone trim around windows and at other locations where spalling occurred, and tuckpointing of mortar joints to help minimize water penetration.
