# Planet Fitness

Water Leakage Investigation and Repair Design | Frankfort, KY

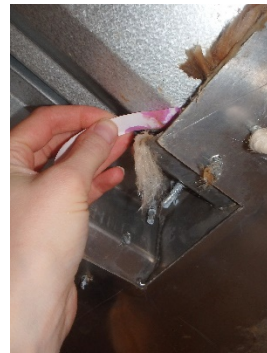
WJE performed water testing of suspect conditions to investigate the probable sources of water infiltration. Water testing was performed using systematic procedures to isolate the sources of leakage. Based on the observed conditions and water testing results, WJE determined that the likely sources of water infiltration were related to seals between the roofing panel laps and standing seams.
