# State Route 2/Interstate 5 Connector

Investigation of Fire Damage | Los Angeles, CA

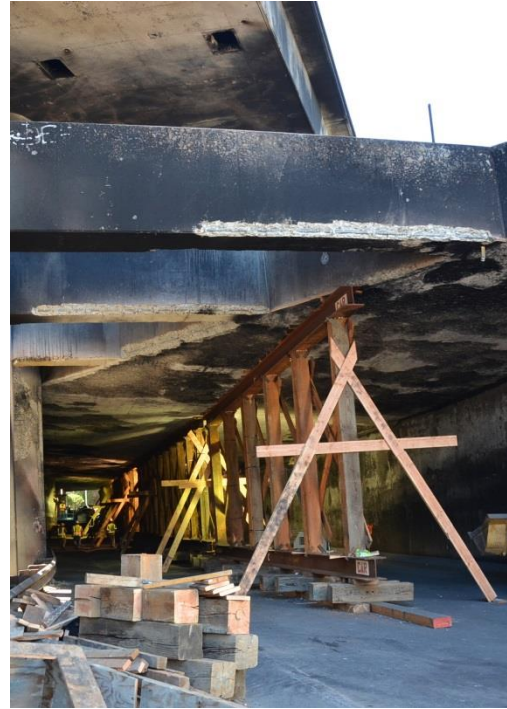
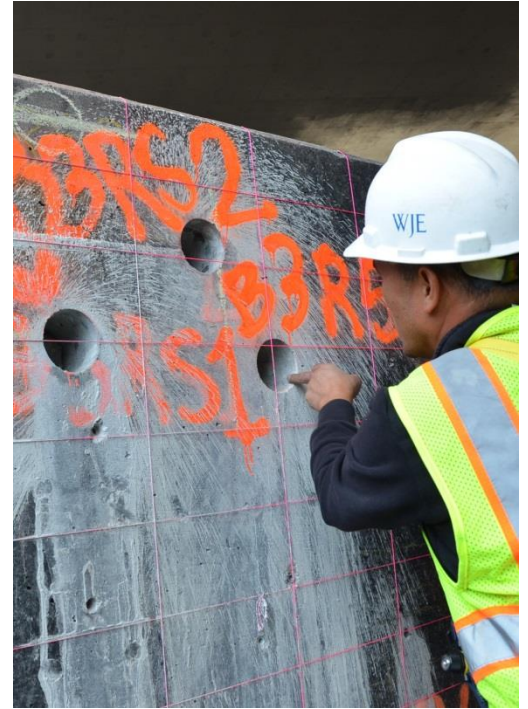
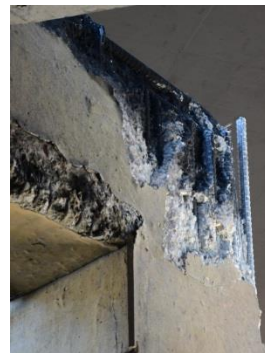
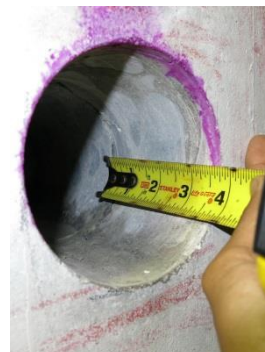
The investigation determined that the walls and soffit of the underpass exhibited significant visible damage from the fire, consisting of spalling up to 4 inches deep. The two columns within the underpass also suffered a significant amount of visible spalling, exposing reinforcing steel at a few areas. IE testing and observations at core holes identified possible delaminations and heat damage. The upper deck had only minor fire damage with small areas of shallow spalling and material damage. However, compressive strength results indicated that the undamaged concrete appeared to significantly exceed the original design strength requirement.

For the areas of damaged concrete, WJE provided general repair recommendations, including removal of damaged concrete by water-blasting or chipping and replacement with a cementitious structural-repair mortar, concrete, or shotcrete, as appropriate.
