PROJECT PROFILE

Trimont Condominiums

Facade Condition Assessment | Pittsburgh, PA

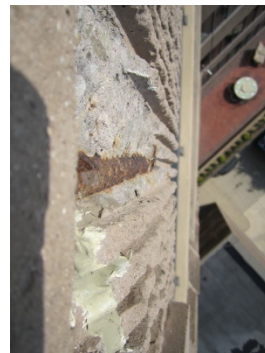
WJE performed a condition assessment of the exterior facades at Trimont Condominiums in Pittsburgh, Pennsylvania. The scope of services provided by WJE included a document review, field observations, drone photography, material sampling and testing, and discussions with on-site personnel. The condition assessment was prompted by facade materials that dislodged from the building and fell to the ground in mid-2015, with one piece of concrete falling through a skylight in the entry canopy.

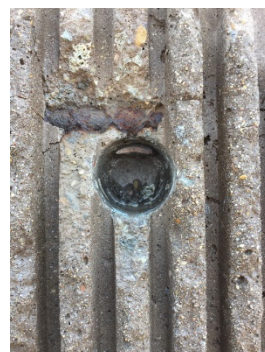
Six concrete cores and multiple concrete fragments were removed from the facade for testing and evaluation to characterize the concrete and to determine if any features could be contributing to the observed spalling and corrosion of embedded reinforcement. A limited petrographic examination—including depth of carbonation measurements and chloride content testing—was performed as part of the studies.

Concrete spalls throughout the facade appeared to be directly related to corrosion of the embedded reinforcement. The incipient spalls observed at many locations presented a risk of falling debris to pedestrian and roof areas below. Field observations of reinforcement cover dimensions revealed that reinforcement bars were located near the exterior surface of the concrete in numerous locations. The corrosion of the embedded steel reinforcement did not appear to be caused by chloride admixtures within the concrete, but rather by carbonation of the concrete from natural atmospheric exposure of the building.

Recommendations were provided to conduct a more detailed examination in preparation of developing a comprehensive repair program.
