PROJECT PROFILE

Zionsville Fire Department Station 93

Roof Assessment | Zionsville, IN

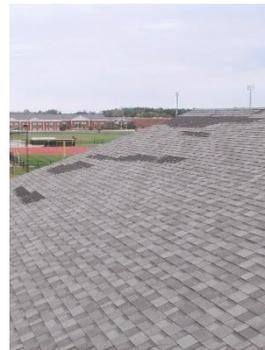
After construction of the Zionsville Fire Department Station 93, the roofing shingles began to blow off the roof as a result of moderate wind speeds. The Zionsville Fire Department engaged WJE to investigate the cause and provide recommendations for repair.

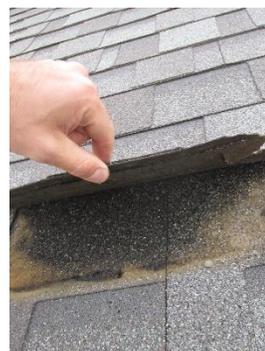
Based on WJE's observations and review of the architect field reports, the damage to the roofing was largely the result of installation-related deficiencies. The architect field reports indicated that the roofing shingles were installed during cold weather in the winter months, and WJE's visual observations confirmed that the shingle edges did not adequately seal to the underlying shingles due to the cold temperatures at installation.

Without repairs, the building would become susceptible to water leakage due to existing damaged areas and further wind-related damage from deficiencies in the existing system. WJE recommended removing and replacing the damaged shingles and installing asphalt roofing sealant at all edges to provide adequate sealing to the underlying shingles.
