## PROJECT PROFILE

# Zionsville Fire Department Station 93

Roof Assessment | Zionsville, IN

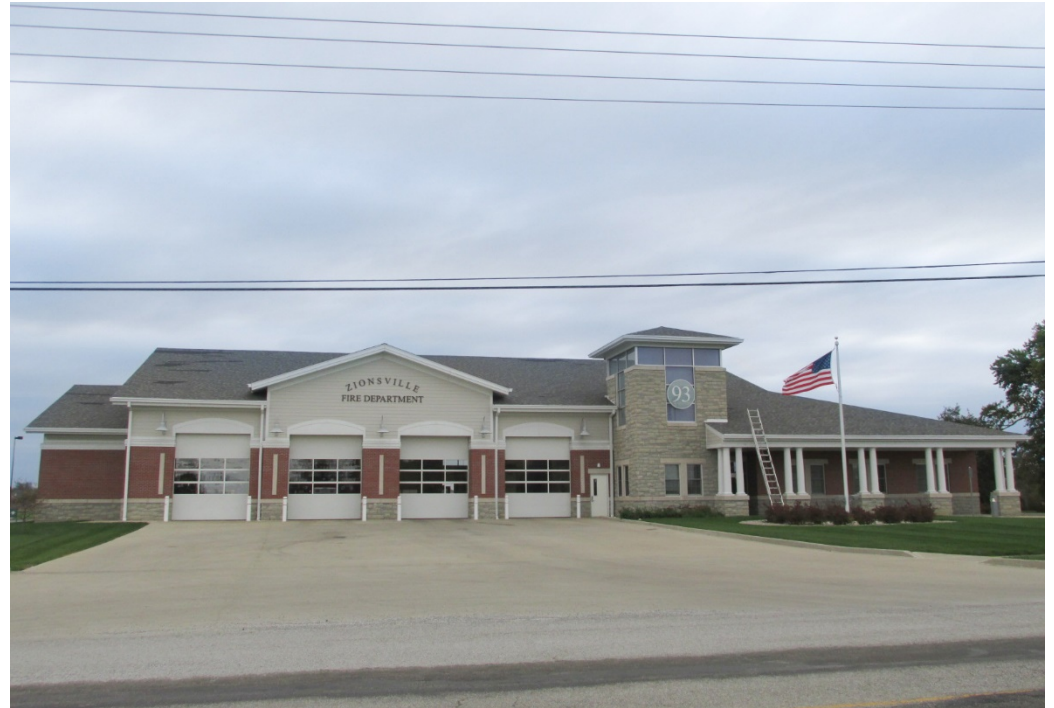
After construction of the Zionsville Fire Department Station 93, the roofing shingles began to blow off the roof as a result of moderate wind speeds. The Zionsville Fire Department engaged WJE to investigate the cause and provide recommendations for repair.

Based on WJE's observations and review of the architect field reports, the damage to the roofing was largely the result of installation-related deficiencies. The architect field reports indicated that the roofing shingles were installed during cold weather in the winter months, and WJE's visual observations confirmed that the shingle edges did not adequately seal to the underlying shingles due to the cold temperatures at installation.

Without repairs, the building would become susceptible to water leakage due to existing damaged areas and further wind-related damage from deficiencies in the existing system. WJE recommended removing and replacing the damaged shingles and installing asphalt roofing sealant at all edges to provide adequate sealing to the underlying shingles.
