## Tarrant County College Natatorium

Condition Assessment of Double Tees | Fort Worth, TX

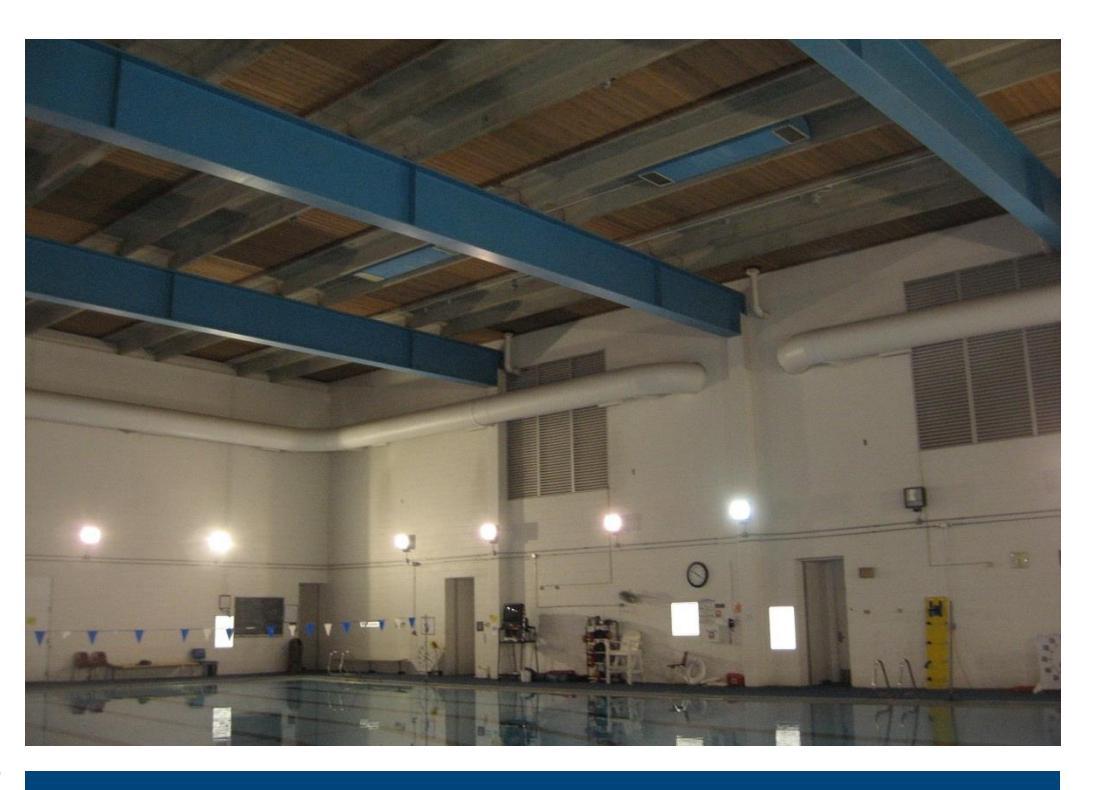
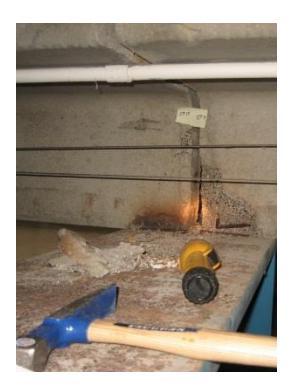
ENGINEERS Architects Materials scientists Concrete cracks, spalls, and corrosion stains were identified during a cursory inspection of the roof's underside in connection with planning for an overall renovation of the facility. The roof was located 30 feet above the pool and ground level viewing was obstructed by HVAC and lighting. As a result, the ability to assess the damage was limited. Concern existed regarding the possibility of concrete debris falling into the pool or adjacent deck. A detailed assessment was needed to help the architect and owner evaluate the feasibility of renovating the facility.

WJE performed a condition assessment to identify the extent, cause, and significance of distress in the roof double tees in the natatorium. One of the most challenging aspects was difficulty in accessing the bearing area of the double tees, where the majority of the distress was located. Scaffolding was installed over the entire footprint of the swimming pool to provide a working platform from which a detailed close-up, hands on inspection could be performed. At three locations, the distress was found to be structurally significant and in need of immediate remedial measures. At other locations the distress was less severe, but still in need of remedial measures to ensure satisfactory long-term structural performance. The majority of the distress was caused by restrained volume change due to welding of the bearing plates. WJE prepared drawings and specifications for remediating the identified damage. The remediation program included steel saddle assemblies, concrete patching, and corrosion inhibiting coatings.

The assessment determined that the structural damage was prevalent but relatively limited in severity. Conceptual studies were performed to provide an opinion of the cost of repairs. Based on these findings and results of other studies, the owner elected to proceed with a renovation program for the overall building.
