PROJECT PROFILE

Charles Street Jail

Roof Structure Investigation | Boston, MA

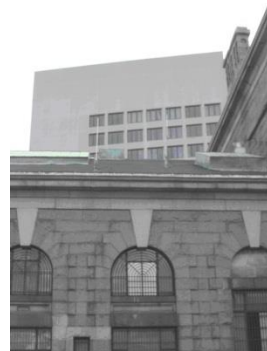
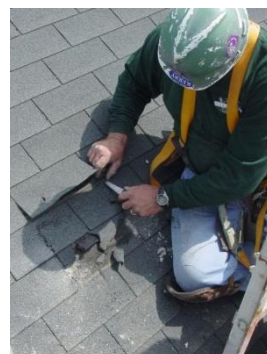
WJE performed an investigation to assess the condition of the roof trusses and roof deck and to determine properties of the steel and concrete materials. Existing conditions were documented for representative areas of the roof deck and for the eaves and bearing regions of the roof trusses. WJE removed material samples from the concrete roof deck and steel trusses for evaluation in our Northbrook laboratory. Petrographic analyses were performed to determine the composition and quality of the concrete material. Steel samples were analyzed to determine chemical content, mechanical properties, and weldability. While the steel trusses were found to be sound, the concrete roof deck was in such poor condition that replacement was warranted.
