BY LOGAN COOK

Wiss, Janney, Elstner Associates, Inc.

Addressing Your Building’s Winter Blahs

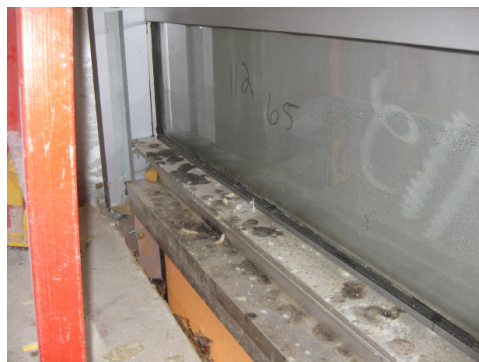
FIGURE 1

Under any weather condition, water vapor in the air travels from warm, humid air to cold, dry air. As exterior temperatures drop and the building heating system begins operating, building envelopes begin to experience changes in air and vapor movement. The warm humid inside air drives toward the colder, dryer exterior. If the warm humid air contacts cold surfaces, such as un-insulated window panes or thermally bridged frames, condensation can occur. Unaddressed condensation can result in water-related damage to interior finishes and, in extreme cases, organic growth. There are many tools available to properly diagnose the factors

leading to condensation issues (e.g., infrared thermography, thermal analysis, and temperature and humidity monitoring). Proper diagnosis of these factors help determine the level of effort recommended for addressing condensation issues, which can range from simple adjustments to interior conditioning parameters up to intrusive system retrofits. See Figure 1.

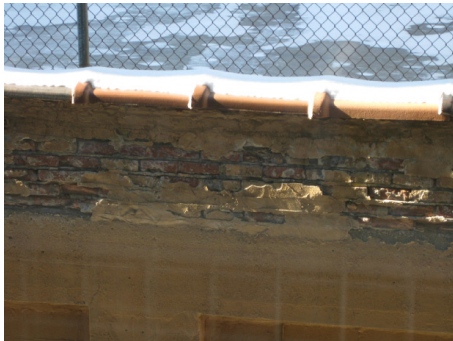
FIGURE 2

Cyclic freezing and thawing is a commonly encountered mechanism of deterioration for exposed building materials such as masonry

or concrete. When water absorbed in materials is exposed to freezing temperatures, the water freezes and expands. During warming periods the water thaws and mobilizes. Repeated cycles of freezing and thawing of the water in the materials can result in deterioration (e.g., spalling and cracking) that can affect aesthetics, material strength, and structural stability. In many cases, freeze-thaw deterioration is related to ineffective or failed water management components or systems. Solutions to freeze-thaw deterioration should look beyond the resulting effects of deteriorated materials and focus on the wall or roof system in its entirety. See Figures 2–3.
