PROJECT PROFILE

Courthouse Square

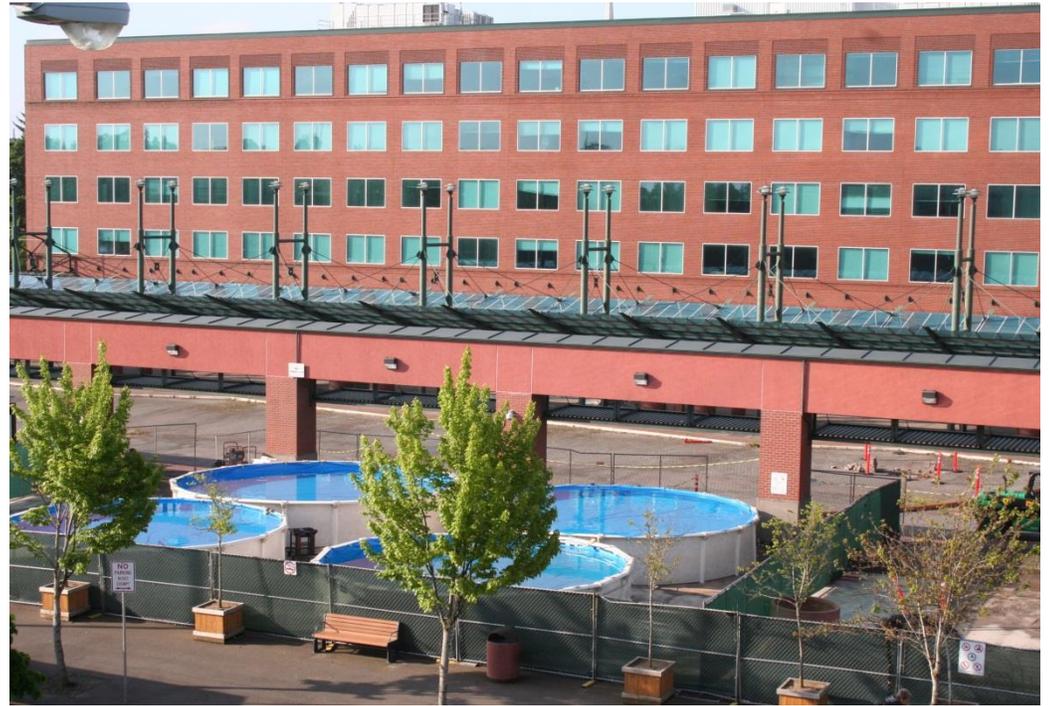
Investigation of Damage Claims | Salem, OR

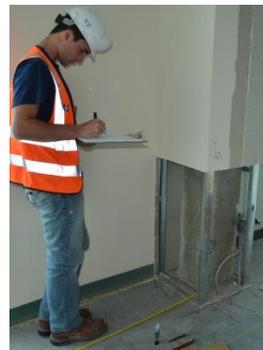
Due to an increasing number of reported problems, the County filed a lawsuit against the original contractor and other parties, including the designer. Litigation continued for several years. When engineers working for the County concluded that the structures were unsafe due to low strength concrete, punching shear overstress in the floor slabs, and inadequate column capacities, the County vacated the property. Affiliated FM, the property's insurance carrier, contacted WJE and requested a thorough investigation of the property and claimed damages.

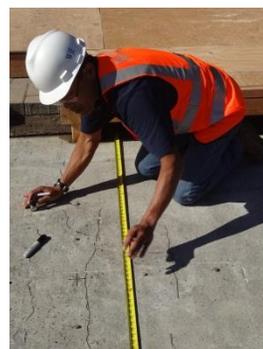
Overall, the post-tensioned slabs of each of the three structures were adequate to support their design loads. Serviceability issues were found to be predictable outcomes of the original design and construction, which included improper shoring practices and a post-tensioned slab design that accounted for twice the dead load of the slabs.
