PROJECT PROFILE

Fresenius Building

Slab-on-ground Assessment | Oregon, OH

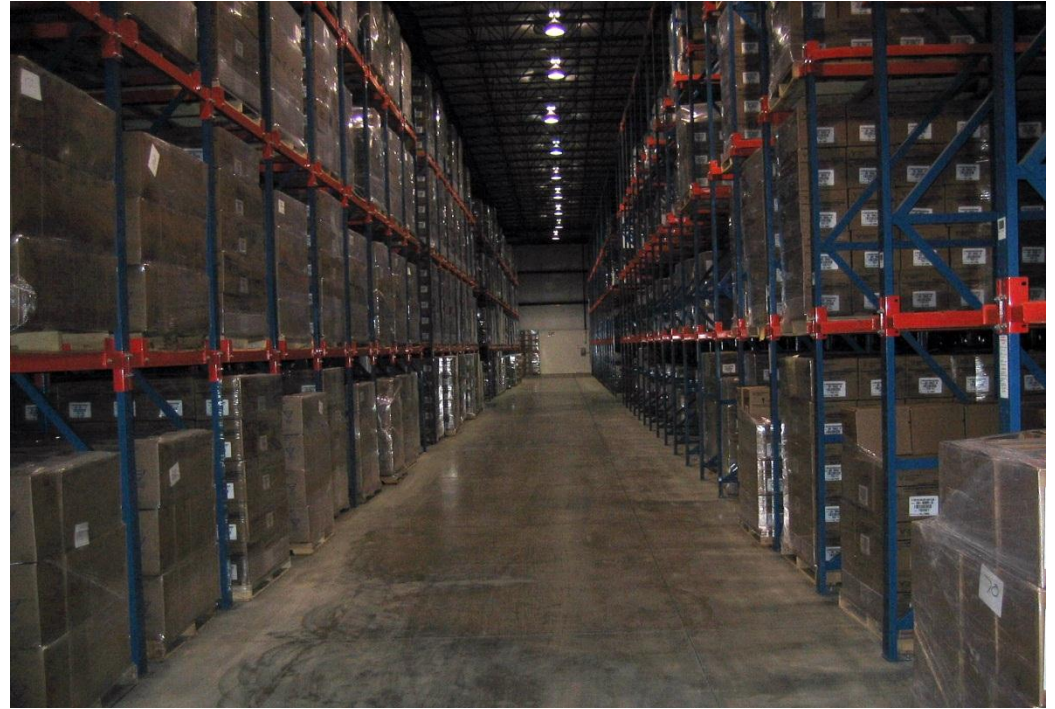
The Fresenius Building is an industrial warehouse building with a 6-inch-thick concrete slab-on-ground. After less than three years, the slab exhibited widespread cracking, wide joint openings, and excessive surface undulations.

Premature distress in a concrete slab-on-ground led to concerns regarding its long-term durability.

A review of the slab system indicated that it was generally well suited for the loadings that existed at the time of our evaluation. We also concluded that the observed distress was due primarily to curling with some evidence of localized soil problems; future distress related to these problems should not be extensive. Since, in general, the distressed areas of the slab system remained serviceable, we developed a series of recommendations to improve their stability and reduce the potential for future deterioration.
