# Minneapolis Central Library

Icicle Formation Investigation | Minneapolis, MN

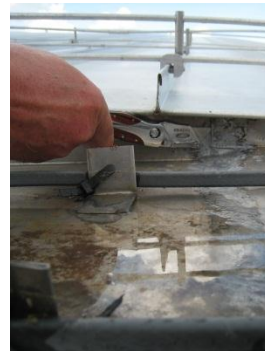
WJE completed field work and water testing to evaluate the water tightness of the existing gutter assembly. WJE’s water testing isolated suspect details including cracked soldered gutter seams and joints not designed to withstand a submerged condition during ice damming or standing water. Water leakage testing induced leakage at multiple test locations within minutes and produced water seepage in quantities and at locations in accordance with the reported icicle formation.

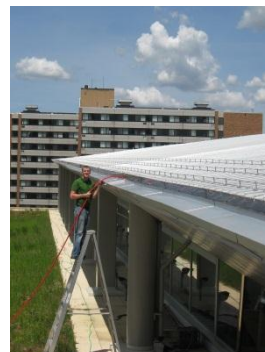
The proposed repair design focused on the built-in gutters constructed along the south edge of the wing roofs. The proposed repair included building up the outboard edge of the gutters to prevent the snow and ice from reaching the roof edge where it would melt, run over the edge, and refreeze on the soffit.
