Office Tower

Davit System Evaluation, Testing, and Design of Repairs | Houston, TX

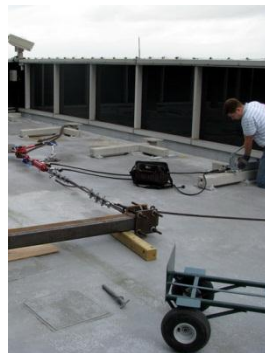
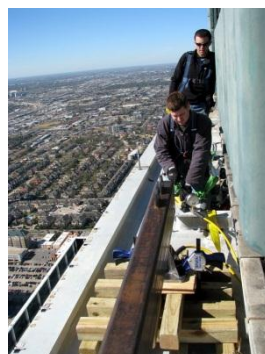
Ten davit bases, one davit, and all three fall arrest anchors failed during the testing. Most davit bases failed at a load much lower than the required OSHA test load. WJE designed repairs, created repair documents to address the failed davit bases and davit, and retested the repaired davit bases to verify compliance with the OSHA load capacity requirements. Based on the testing, repairs, and retesting, the permanently dedicated davit bases and davit arms now meet OSHA load capacity requirements. The client immediately placed the failed fall arrest anchors out of service.
