PROJECT PROFILE

Park Regency Condominiums

Balcony Wall and Handrail Repair | Atlanta, GA

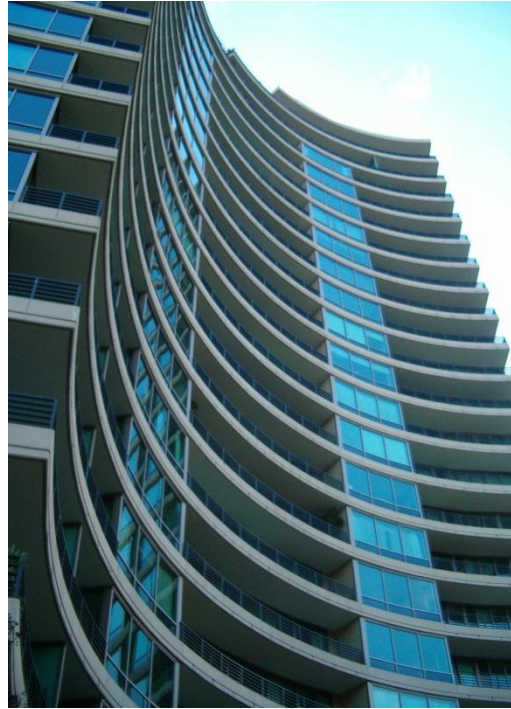
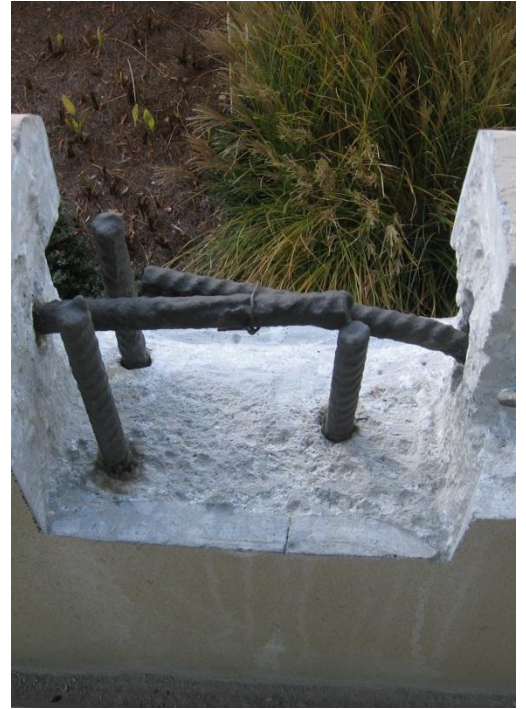
Shortly after construction of this high-rise condominium building, cracks developed in the concrete at the bases of the balcony handrail posts. Initial repairs were attempted by others but proved ineffective as the distress worsened and concrete began to stain and spall from the balconies. In order to develop effective repairs, the cause of the distress had to be determined.

WJE engineers documented existing distress conditions and collected samples of the grout material used to fill the post pockets in the concrete balconies. In-house laboratory studies revealed that the grout was a gypsum-based product that, when exposed to the elements, created expansive forces in the post pockets and promoted corrosion of the mild steel reinforcing in the concrete. The engineers also analyzed a typical railing system to show that thermal stresses did not contribute to the distress. In order to effectively address the grout pocket problems, WJE recommended that the gypsum-based grout be removed from each post pocket, that damage to the reinforced concrete balconies be repaired using conventional repair methods, and that the railing posts be surface mounted rather than set in pockets. The WJE engineers subsequently prepared repair drawings and specifications for this work and provided construction period services, including periodic observations of repair work.
