Sears Crosstown

Condition Assessment of Building Facade | Memphis, TN

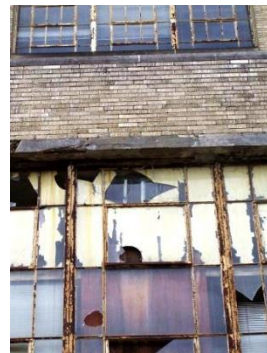
To understand the extent of deterioration and scope of repairs required to restore the facade, the client sought a facade assessment specialist to complete a condition survey of the Sears Crosstown building. Years of neglect produced a building exterior exhibiting spalled concrete, corroded embedded reinforcing, and masonry distress consisting of cracked and displaced masonry and deteriorated mortar joints. Corrosion of steel window frames, widespread glass breakage, staining, and graffiti also detracted from the appearance of the building.

Using information gathered during the assessment, WJE engineers determined the extent and causes of deterioration to the brick masonry, stone accents, exposed concrete elements, and window assemblies. Engineers recommended repairs including patching of concrete, repointing of masonry joints, installation of horizontal and vertical expansion joints in the brick masonry, repair and replacement of window assemblies, masonry cleaning, and supplemental anchoring of brick veneer.

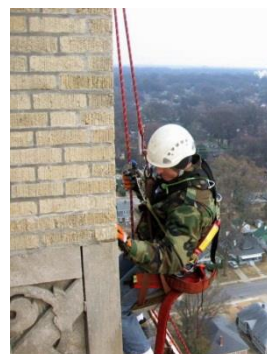
By using boom lifts and specialized rope access techniques, WJE engineers provided an economical solution to access critical facade elements for close-up evaluations and visual surveys. WJE engineers also performed destructive and nondestructive testing to evaluate concealed conditions within the masonry walls.
