THE SEISMIC STRENGTHENING OF TEMPLE SHERITH ISRAEL

By Terrence F. Paret, Gwennyth R. Searer, and Sigmund A. Freeman

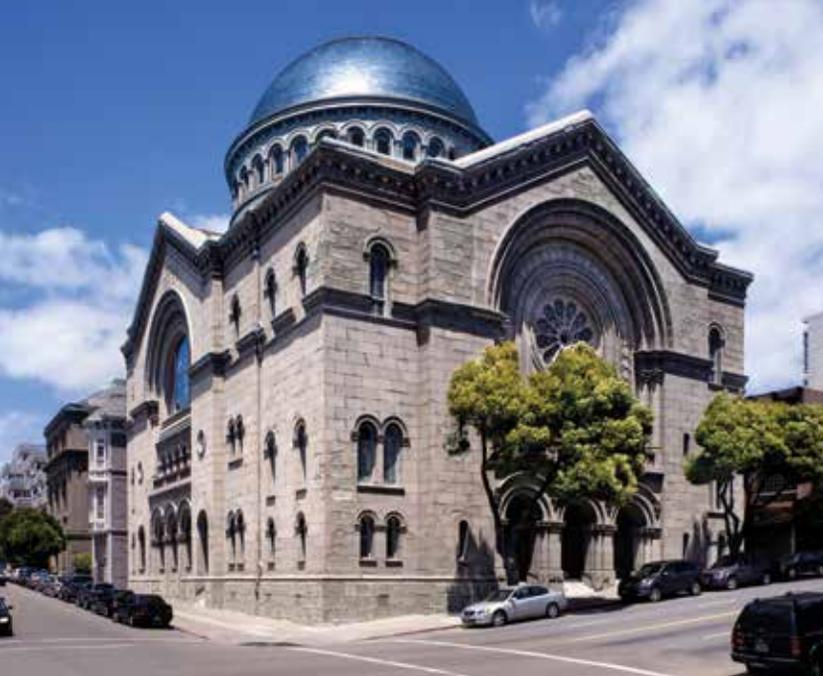
Figure 1. Sherith Israel exterior. Courtesy of David Wakely.

Constructed in 1904, Temple Sherith Israel was designed by Albert Pissis, a prominent San Francisco engineer/architect trained at Ecole des Beaux-Arts, and is on the National Register of Historic Places (Figure 1). The ornately painted interior of its vast sanctuary is one of the last surviving mural interiors by turn-of-the-century artist Attilio Moretti. The sanctuary space is framed by large opalescent stained-glass windows designed by Albert Pissis's brother, Emile (Figure 2). The building also houses one of the last surviving Murray Harris organs. The vast sanctuary and the room in which the machinery and pipes for the organ are housed together occupy more than 90 percent of the plan area of the building, which created a significant challenge for establishing seismic improvements.

The building shell consists of thick, multi-wythe brick masonry bearing walls that rise to roughly 75 feet at the gables and are clad with Colusa sandstone. The east, west, and south walls are articulated in plan and incorporate large corbelled arch substructures that span over large openings and provide out-of-plane stability. The north wall is nearly planar, without significant openings or ornamentation. The sanctuary

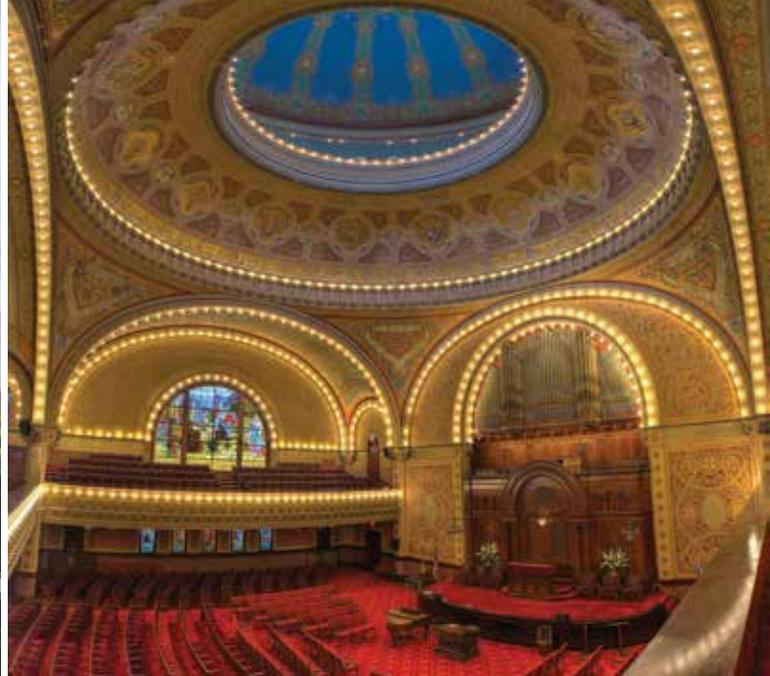
Figure 2. The sanctuary of Sherith Israel. Courtesy of Bruce Schneider.

In contrast, preservation of this behavior would eliminate the need for supplementation of story shear strength and was made a design priority, second only to the goals of preserving the historic fabric of the building and complying with the City's seismic requirements. In California, the *California Historical Building Code* (CHBC) is permitted to be used for qualified historic properties. In recognition of the special conditions encountered in dealing with archaic materials and construction, the CHBC contains fewer prescriptive requirements and provides broad discretion for the use of alternate materials and methods of construction. Based on the provisions in the CHBC, the prior performance during the 1906 earthquake was used to benchmark the strengths and weaknesses of the structure. A number of alternate strengthening methods were identified which, as part of the overarching "do no harm" project philosophy, could be installed with little or no disruption to the structure's character-defining features. In the end, the sanctuary was left undisturbed, despite it occupying the vast majority of the building plan. Everything visible in *Figure 2* is original; other than some localized repairs to correct prior water damage, this post-retrofit photo is indistinguishable from the pre-retrofit condition of the sanctuary.

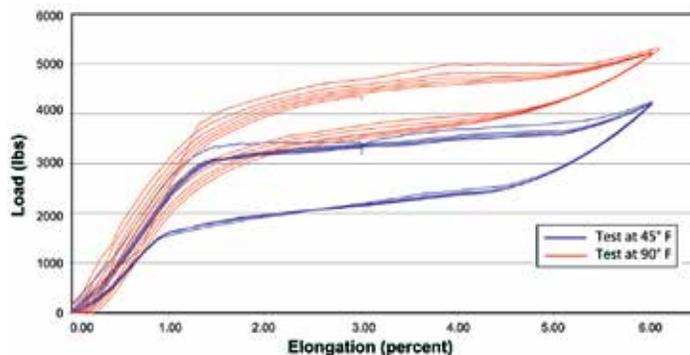
Figure 3. Stress-strain curves developed from testing of nitinol subassemblies.

structural engineers selected an off-the-shelf product that provided the desired properties within the normal temperature range of the attic – fully recoverable strain to roughly five percent to assist in re-centering and a “yield stress” of approximately 80 ksi at a strain of 1 percent – and identified a technology for installing it within the balance of the tension tie system. Prototypes of the nitinol subassembly were subjected to testing in laboratories to confirm that these “fuses” would perform as intended. Figure 3 shows the stress-strain curve of the nitinol.

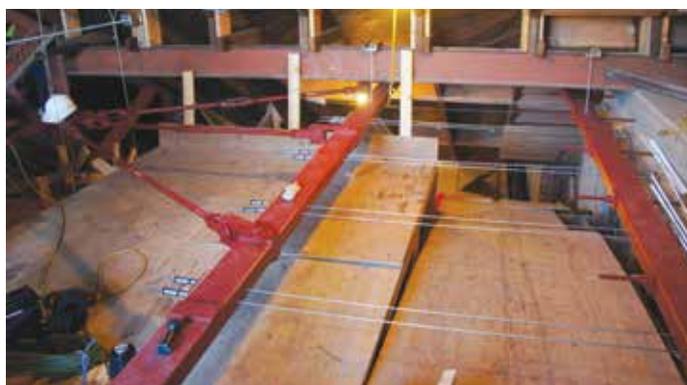
Figure 4. View of nitinol fuses as installed in the attic of Sherith Israel

Gable end walls are known to be susceptible to out-of-plane failures in relatively modest ground motions and, in the 1906 event, out-of-plane gable end wall failure at the south wall was underway. To reduce the vulnerability of the gable end walls, an octagonally-configured tension tie system with super-elastic nitinol "fuses" was added in the attic to promote re-centering and control out-of-phase, out-of-plane behavior of the gable end walls and the main arches that support them.

passage of the tension ties through the murals on the interior dome and across the sanctuary interior was judged to be too disruptive. To circumvent the sanctuary interior completely, a “tension ring” concept was implemented using steel Dywidag rods that run parallel to and hang from each of the eight original riveted plan-octagonal structural steel trusses that support the main drum and dome. The structural steel nodes of the octagonal tension ring are the reaction points for loading by the nitinol fuse assemblies, which are comprised of small-diameter nitinol wires in a loom-like support structure (Figure 4) that was designed to be lightweight, easy to fabricate and install, and easy to anchor to the masonry.

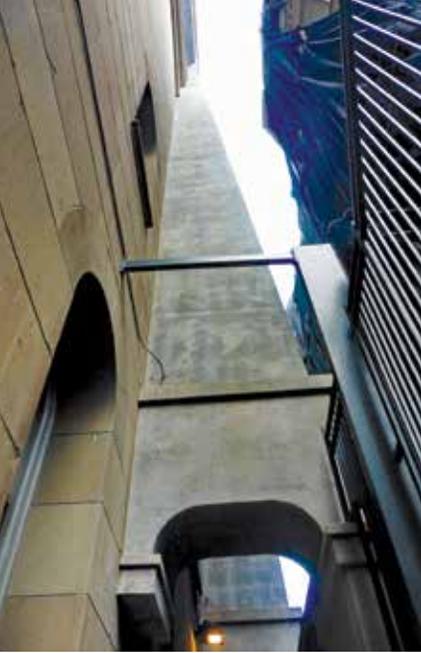
Figure 5. Pilaster end supported on rocking block in north alley. Courtesy of Charley Stern.

significant folds, this wall is far more prone to out-of-plane instability than the other perimeter walls, as evidenced by the inclined cracks that were caused by the 1906 earthquake and remain visible in several adjacent perpendicular plaster walls. Four reinforced concrete pilasters with unusual capabilities and geometries were designed for the north wall (Figure 5) to supplement its stability.

The pilasters were necessary to preclude the north wall falling outward from the building toward the north, but a typical pilaster designed to preclude northward instability would also stiffen the wall against southward displacement. Restraint against southward displacement was judged to be undesirable because, when the building displaces toward the south during an earthquake, the stiffened north wall could be torn free from the structure. To provide the necessary support against northward instability while permitting southward movement, the pilasters, dimensioned to approximate the plan articulations in the other three exterior walls, were designed to uplift when the building moves to the south and the base of each pilaster was designed to freely translate by supporting it on a “rocking block”.

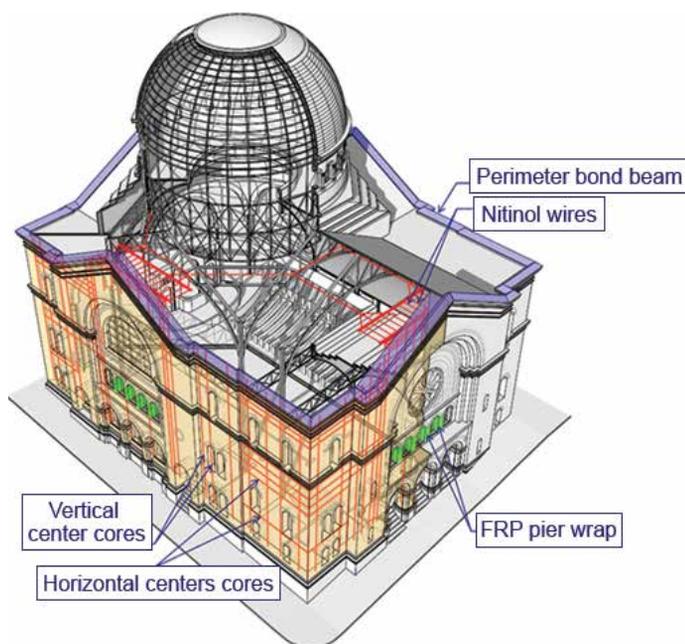
Figure 6. Schematic cut-away diagram showing some of the strengthening measures that were implemented. Courtesy of ELS Architecture and Urban Design.

Figure 6 shows a schematic cut-away diagram highlighting some of the strengthening measures that were taken during the project.
