Chicago's Bloomingdale Trail

Innovative Erection
Procedures for the
Milwaukee Avenue Bridge

By Scott K. Graham, P.E., S.E. and Jonathan E. Lewis, S.E.

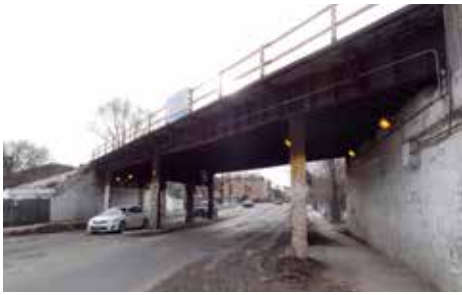
Figure 1. Existing bridge structure.

The original four-span bridge over Milwaukee Avenue was 26 feet wide by 98 feet long and had a skew of approximately 45 degrees (*Figure 1*). The structural framing consisted of a reinforced concrete deck on top of transverse steel floor beams that spanned between three main longitudinal built-up, riveted steel plate girders. The girders were simply-supported by three interior steel piers and two reinforced concrete abutments.

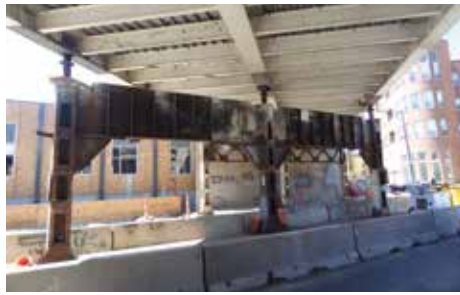
Figure 2. The elevated bridge structure.

To improve vertical clearance on Milwaukee Avenue, the final elevation of the new bridge needed to be approximately 3 feet 6 inches higher than the original elevation of 13 feet 6 inches. A jacking procedure was developed to lift the bridge off of its existing bearings up to its design elevation. The procedure began with the installation of new web splice plates and new top and bottom flange splice plates to make the simply-supported longitudinal girders continuous from abutment to abutment. The newly established continuity reduced the number of required jacking points from 24 (one at both ends of each simply-supported girder) to 12. The end spans of the girders cantilevered out past the interior jacking points, allowing unencumbered access to the existing reinforced concrete abutments and helping to facilitate the concrete repairs and new bearing installation. In general, the jacking procedure involved installing jacking towers and hydraulic rams underneath the longitudinal girders adjacent to the interior pier supports. The hydraulic rams – linked by a manifold – lifted the bridge from the piers and abutments in ¼-inch increments, while ¼-inch shims were placed on the piers. This limited the amount of displacement that would occur if hydraulic pressure was lost. As the hydraulic rams approached their full stroke (approximately 18 inches), they were locked into position; the shims were removed and new temporary steel shoring stools were installed on top of the piers. The girders were then lowered and secured to the new stools. Next, the hydraulic rams were relieved and a new custom jacking stool was placed underneath each ram. This lifting process continued until the bridge was raised to a height slightly above the final design elevation. New shoring stools, dimensioned such that they would support the girders at the final design elevation, were installed on top of the piers. The bridge was lowered and secured onto the new custom shoring stools, and then temporary diagonal bracing was installed to maintain a laterally braced structure during for remainder of construction. The elevated structure is shown in *Figure 2*.

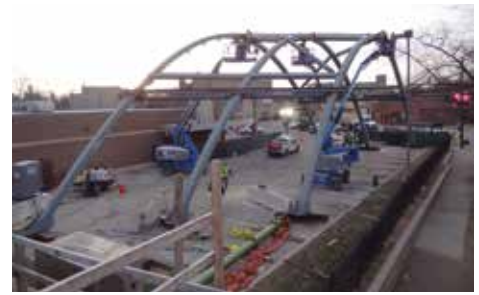
Figure 3. Erecting the three-arch assembly.

explore other innovative alternatives for erecting the three steel arches atop the in-place bridge. Ultimately, the team obtained permission to erect the arches in an adjacent grocery store parking lot and then lift the entire arch assembly from the parking lot to the existing elevated bridge structure. Each arch consisted of three separate HSS steel tube pieces that were laid horizontally and field-welded together. After all three arches were fully assembled, the first arch was tilted vertically using a crane and placed on top of horizontal steel HP sections – laid out to match the intended configuration of the bearing assemblies on the final bridge. A second crane tilted the second arch vertically and placed it on top of the steel HP sections. New steel cross framing was installed between the first and second arches. The third arch was installed similarly (Figure 3).

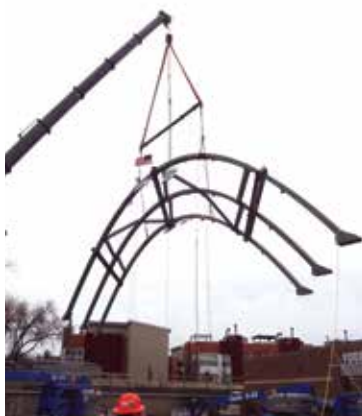
Figure 4. Lifting the arch assembly.

Interferences and crane limitations prohibited the assembly to be moved directly from the parking lot to the bridge, so it was done in two stages. First, the crane was placed in the parking lot and attached to the three-arch assembly at four points – two near the peak of each exterior arch (Figure 4). The three-arch assembly was lifted onto temporary timber bearing pads located adjacent to the existing bridge structure. Second, the crane moved to Milwaukee Avenue and the three-arch assembly was lifted off the timber mats, placed onto the elevated bridge structure, and bolted to the top flanges of the existing longitudinal girders. The flexibility of the arch assembly allowed the erection team to move the base plate connections into alignment with relative ease.

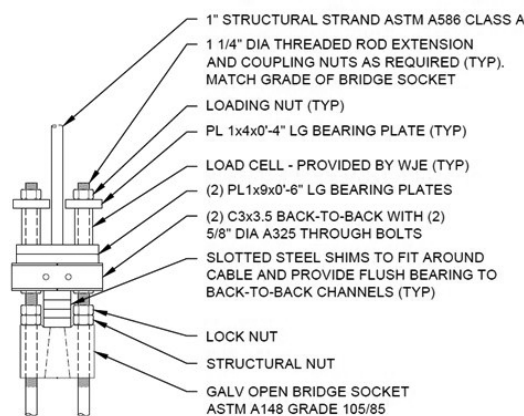
Figure 5. Custom steel fixture and load cell assembly.

the course of three iterations, each iteration adding approximately one-third of the full target load. “Full” load was intended to include all dead load plus some additional pretension as specified in the bridge design documents. Each socket was tensioned using a custom steel fixture and two calibrated load cells. The custom steel fixture and load cell assembly was designed to bypass the socket nuts (Figure 5).

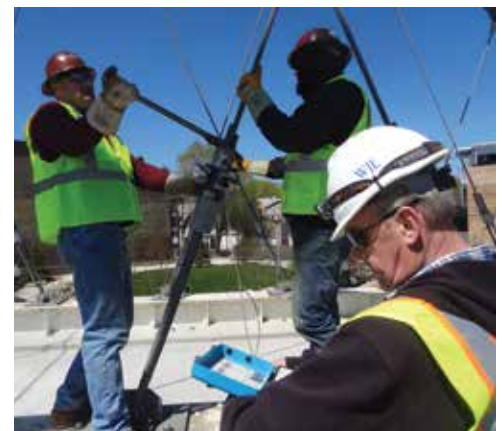
Figure 6. Tightening a cable and reading the load.

Separate loading nuts on top of the steel fixture and load cell assembly were turned, approximately in unison, to add tension to the cable until the target load was reached. Socket nuts below the custom fixture were tightened against the socket, again approximately in unison, until the readouts from the load cells were reduced to zero, thereby transferring the load to the socket nuts (Figure 6).
