# Nondestructive Evaluation of Fire-Damaged Reinforced Concrete

by Jacob Borgerson and Joshua White

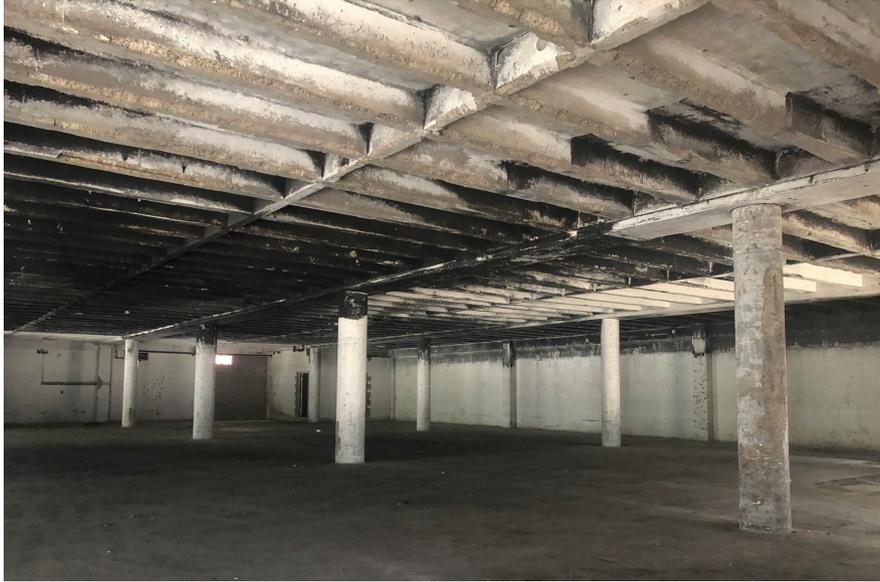
Fig. 1: A reinforced cast-in-place concrete structure that was damaged due to a fire event

**W**hen reinforced concrete is exposed to fire, both the concrete and reinforcement may be altered, which can result in structural and material damage. Figure 1 shows a photograph of a cast-in-place concrete structure that was damaged due to a fire event.

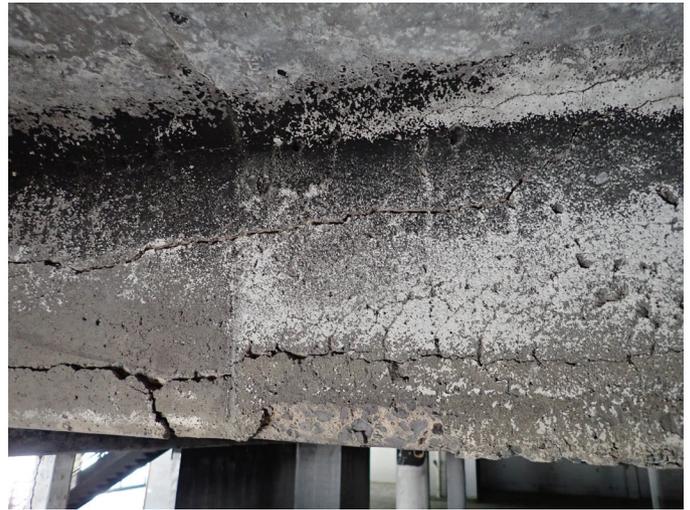
Fig. 2: Cracking along the length of a reinforced concrete joist due to fire exposure

Cracking related to fire damage is typically a result of restraint from thermal expansion due to temperature differentials between the exterior surfaces of a concrete element and the cooler interior concrete, often seen at the corners of concrete elements. Depending on the type of aggregate present, cracking can also be attributed to thermal expansion of aggregates which can lead to internal microcracking, popouts, and/or crazing. Figure 2 shows an example of cracking that occurred in a concrete joist due to fire exposure.

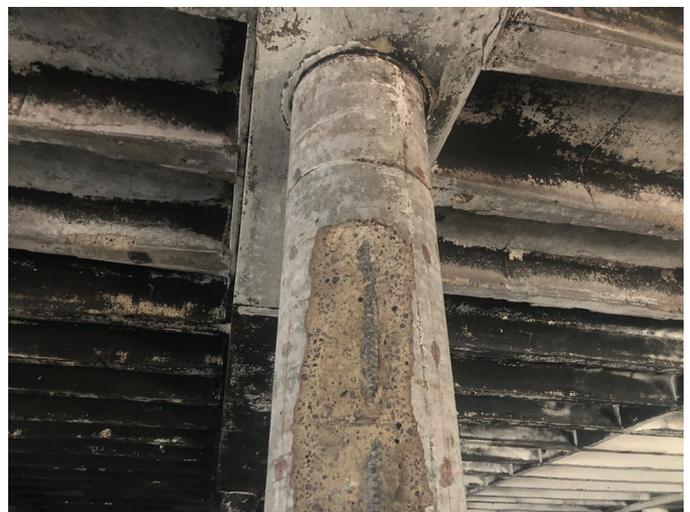
Fig. 3: Spalling that occurred on a concrete column due to fire exposure

Spalling is the surface flaking or disengagement of a fragment of concrete and can occur in the temperature range between approximately 300°F to 570°F (150°C to 300°C).<sup>3</sup> Figure 3 shows an example of spalling that occurred on a concrete column due to fire exposure. While opinions differ on the dominant mechanism that causes concrete spalling, it is generally believed to be caused by a combination of vapor pore pressure and thermal stresses.<sup>3,4</sup> Spalling induced by vapor pore pressure occurs when the free water in the concrete vaporizes and expands, causing the internal pressure to exceed the tensile strength of the concrete. Spalling induced by thermal stress is the result of a thermal gradient that induces near-surface compressive stress (due to restrained thermal expansion), creating a fracture plane between the heated surface and the cooler interior region.

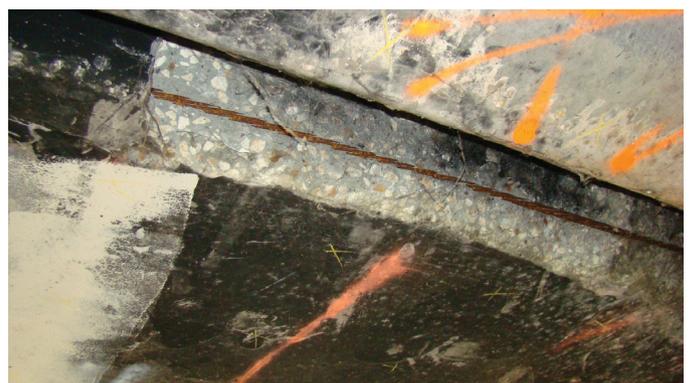
Fig. 4: Spalling of concrete box beam and exposed prestressed strand due to fire event

The reinforcing steel within concrete elements may be exposed during a fire event (Fig. 4) and, as a result, may also be affected by elevated temperatures. Strength reduction in reinforcing steel may occur while the steel is at high
