# The Franklin Avenue Bridge

## Part 2: Analysis, design, and accelerated bridge construction

by Dan Enser, Mario Grenville Ratnaraj, Arne P. Johnson, John S. Lawler, and Paul Backer

This is the second of a two-part series on the restoration of the Franklin Avenue Bridge in Minneapolis, MN. Part 1 focused on the rehabilitation aspects, and Part 2 focuses on the structural analysis and deck replacement using accelerated bridge construction (ABC). The engineering firms Wiss, Janney, Elstner Associates, Inc. (WJE) and HNTB Corporation worked together on the project and on these articles.

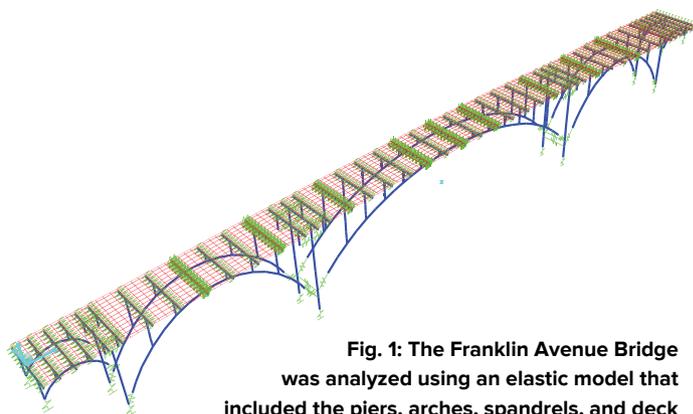
Fig. 1: The Franklin Avenue Bridge was analyzed using an elastic model that included the piers, arches, spandrels, and deck

The HNTB Corporation team was retained in April 2013 to perform detailed structural analyses and assess the bridge's load-carrying capacity, to educate and inform stakeholders, and to ultimately determine the scope of the rehabilitation. The analyses were made using an elastic model of the entire structure (Fig. 1). The initial evaluation culminated with development of inventory and operating ratings for all components of the bridge, including the arch ribs, spandrel columns, and spandrel cap beams to assess the need for structural enhancement and the ability to carry additional

loadings. Load ratings were developed using the AASHTO Load and Resistance Factor Rating (LRFR) method.<sup>1</sup> The minimum rating factors were found to be 1.69, 2.93, and 1.76 for the Span 2, 3, and 4 arch ribs, respectively; 3.44 for the spandrel columns; and 1.42 for the spandrel cap beams.

Inelastic behavior was evaluated in conjunction with the inspection results for Spans 1 and 5, and hinges were incorporated into the structural analysis model at the crown and quarter points of the arch ribs. This yielded an operating load rating factor, including pedestrian live load, of 0.63. Because the rating factor was less than 1.0, legal loads were evaluated and the bridge was posted to restrict live load until further rehabilitation could address the deficiency.

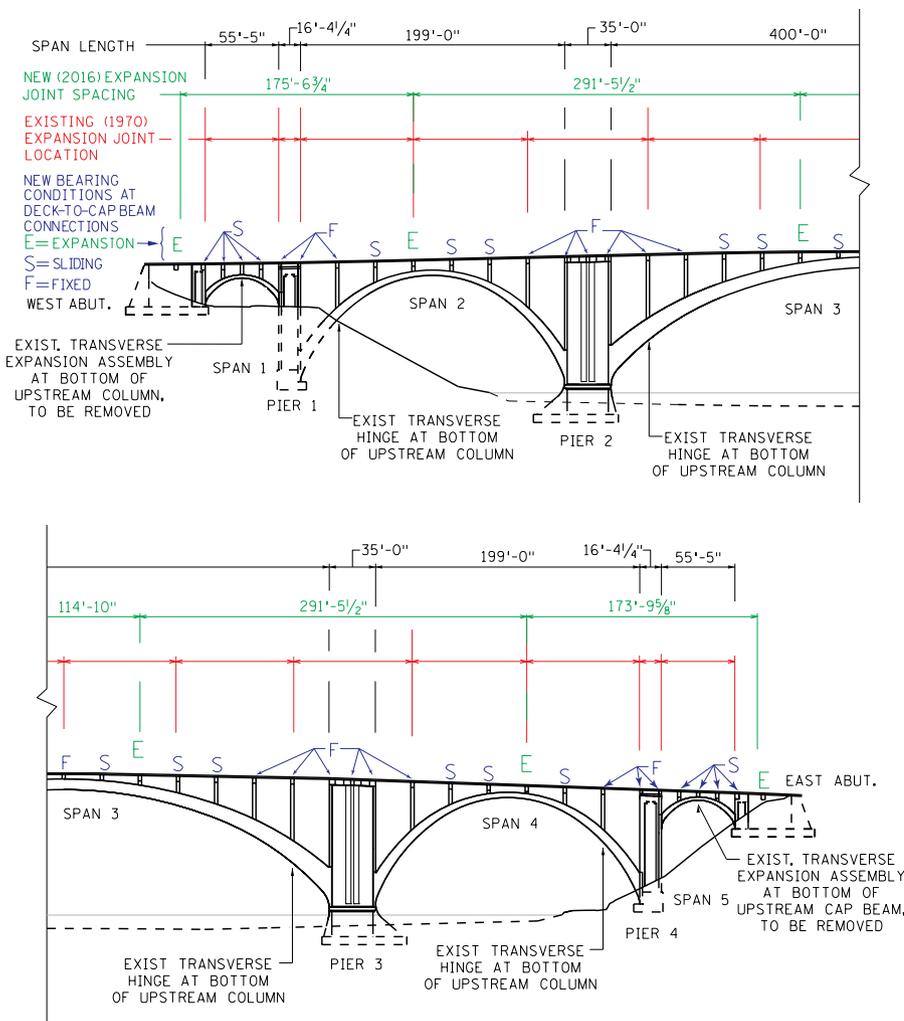
**Fig. 2: Existing and proposed joint locations and deck to cap beam bearing conditions (Note: Single prime ['] and double prime ['] marks indicate dimensions in ft and in., respectively; 1 ft = 0.305 m; 1 in. = 25.4 mm)**

The greatest levels of degradation were found below the failed seals of the bridge’s 15 existing expansion joints, where the underlying non-air-entrained original concrete elements were exposed to chloride-laden water. Minimization of the number of expansion joints was therefore a major goal of the new deck design, and this required radical revision of the structural connectivity of the deck and cap beams to minimize the effects of thermal expansion and contraction on the shorter spandrel columns.

A sliding plate bearing was developed to allow translation between the deck and the spandrel columns and minimize the buildup of thermal forces within the columns and arch ribs. The bearing detail comprises polished stainless steel plates embedded in the underside of deck panels and polytetrafluoroethylene (PTFE) sheets attached to the top of the cap beams. For stability, the deck was integrally attached to the underlying cap beams at the piers, making the piers points of zero relative movement, and the bearings were located away from the pier. In the main span (Span 3), with an overall length of 400 ft (122 m), expansion joints were placed at quarter points and the deck was fixed to the midspan spandrel in addition to the piers. Detailed structural models were developed to evaluate the outcome of the proposed approach and to predict the forces within the system in both restrained and released configurations. The new deck has only six expansion joints, and these are located away from the major substructure elements below (Fig. 2).

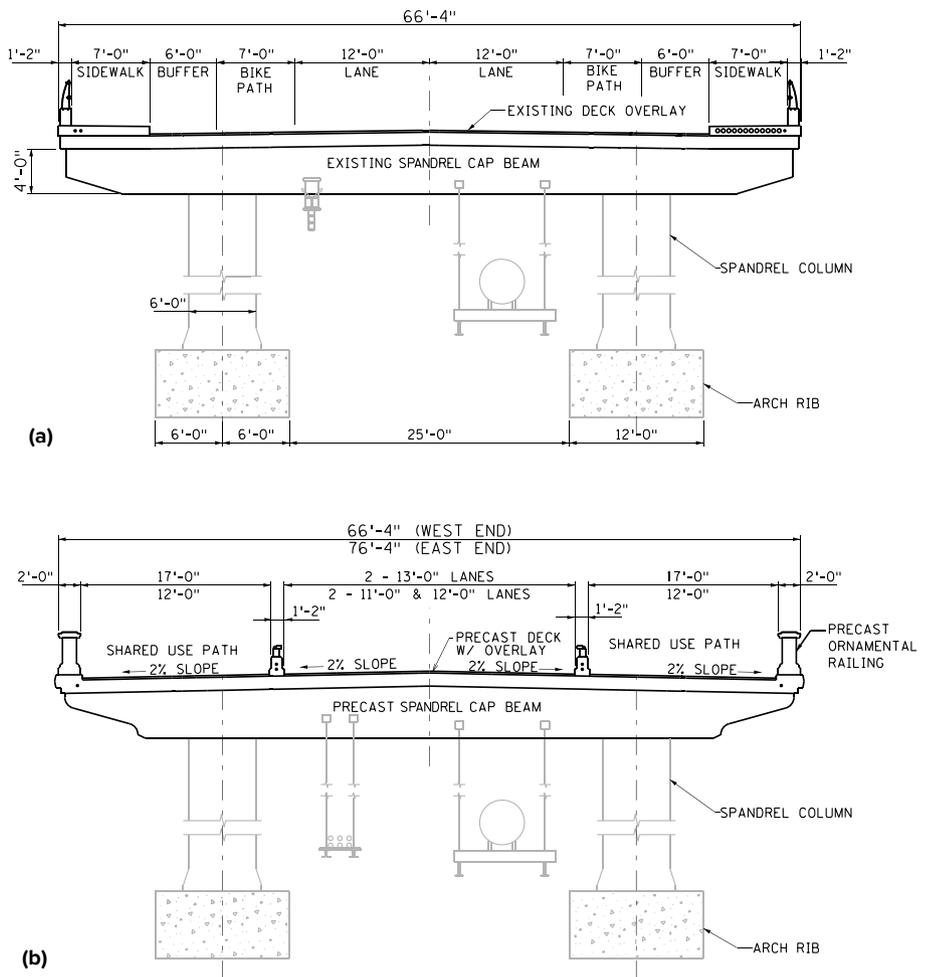
**Fig. 3: Typical deck sections: (a) existing, as of the 1970 renovation; and (b) current, as of the 2016 renovation (Note: Single prime ['] and double prime ["] marks indicate dimensions in ft and in., respectively; 1 ft = 0.305 m; 1 in. = 25.4 mm)**

**User-friendly multi-modal facility**—The new deck configuration establishes continuous barrier protection along the entire length of the bridge, physically separating motorized vehicles from pedestrians and bicycles (Fig. 3). To accommodate turning lanes associated with a five-way intersection at the east end of the bridge, the deck was locally widened by 10 ft (3 m). Analyses and design checks indicated the existing Span 4 arch had adequate capacity to support the additional dead load associated with widening of the deck. Checks also showed that Span 5 had adequate capacity after the restoration of the original spandrel column layout.

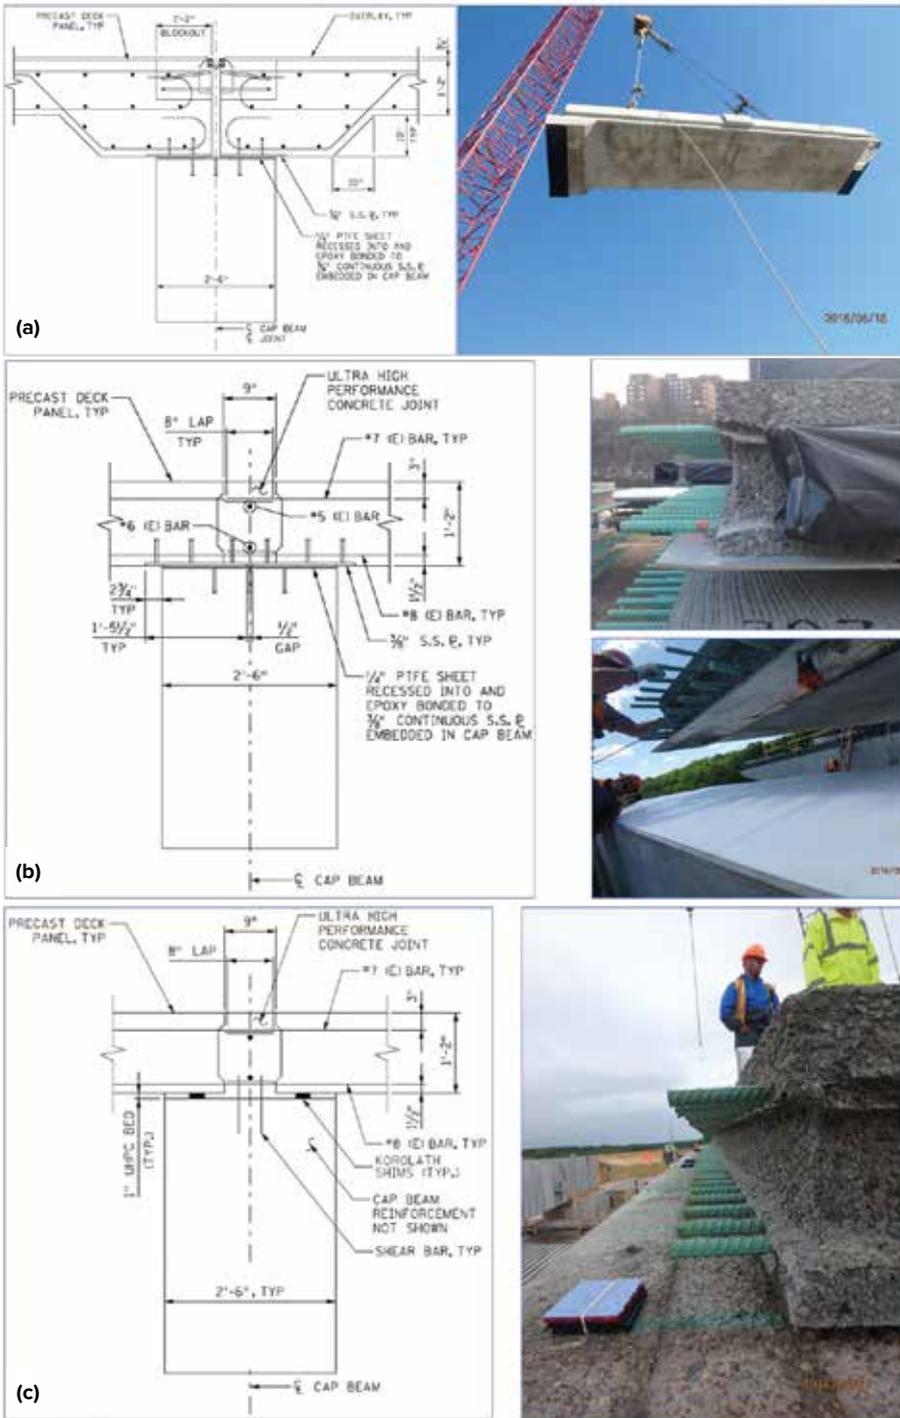
Fig. 4: Precast deck panel joints: (a) expansion joint; (b) sliding joint; and (c) fixed joint

Full-depth precast deck panels were the most logical choice for accommodating the project’s rapid construction schedule. Panels were detailed as expansion joint panels, sliding panels, or fixed panels (Fig. 4). The panel length was designed to match the spacing between spandrels, with the maximum length being 27 ft 11.5 in. (8.52 m). The panel width was set at 8 ft

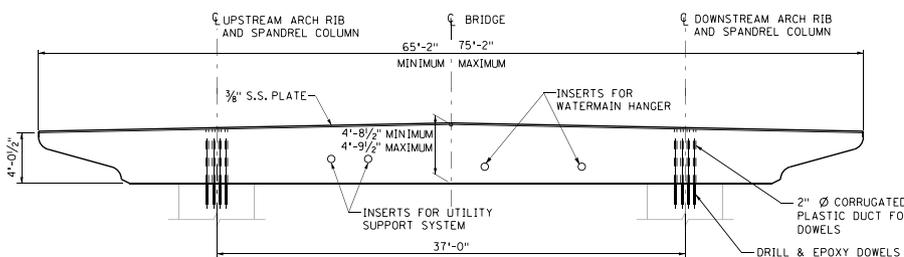
Fig. 5: Elevation view of typical precast cap beam geometry

existing spandrel columns. Developing a fully integral connection was not readily feasible; a quasi-fixed connection was established by drilling holes into the existing spandrel column and bonding deformed reinforcement bars using epoxy adhesive. A hole depth of 3 ft 6 in. (1.07 m) was specified to provide adequate development. The bar pattern was established by casting 2 in. diameter corrugated polyvinyl chloride ducts, typically used for post-tensioning, into the cap beams (Fig. 5).

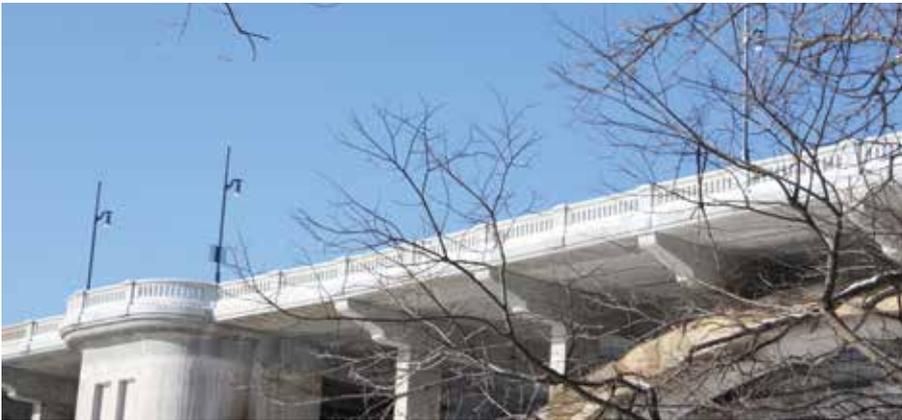
**Fig. 6: Ornamental railings were constructed using architectural precast concrete** (photo courtesy of Koichiro Shimomura)

A distinctive feature of the original 1923 design was a concrete ornamental railing with pilasters. A precast railing was designed to match the original aesthetic details and address historians' concerns. Because vehicular traffic would be restrained by inner barriers, the ornamental railings (Fig. 6) were designed and detailed for pedestrian loading. The precast ornamental railing panels were fabricated with architectural precision to the tolerances provided in Cast Stone Institute standards.<sup>4</sup>

Ornamental railing panels were installed by bolting them through a series of clip angles to galvanized hollow structural section (HSS) posts anchored to the deck panels. Once the railing panels were installed, a cast-in-place pilaster was placed around the HSS section and railing panel ends to encapsulate the connections. Joints through the pilasters were designed for thermal movement at expansion joint locations while maintaining aesthetic appeal. Of the 163 ornamental railing panels produced, including 16 curved panels, all fit with no need for modifications.

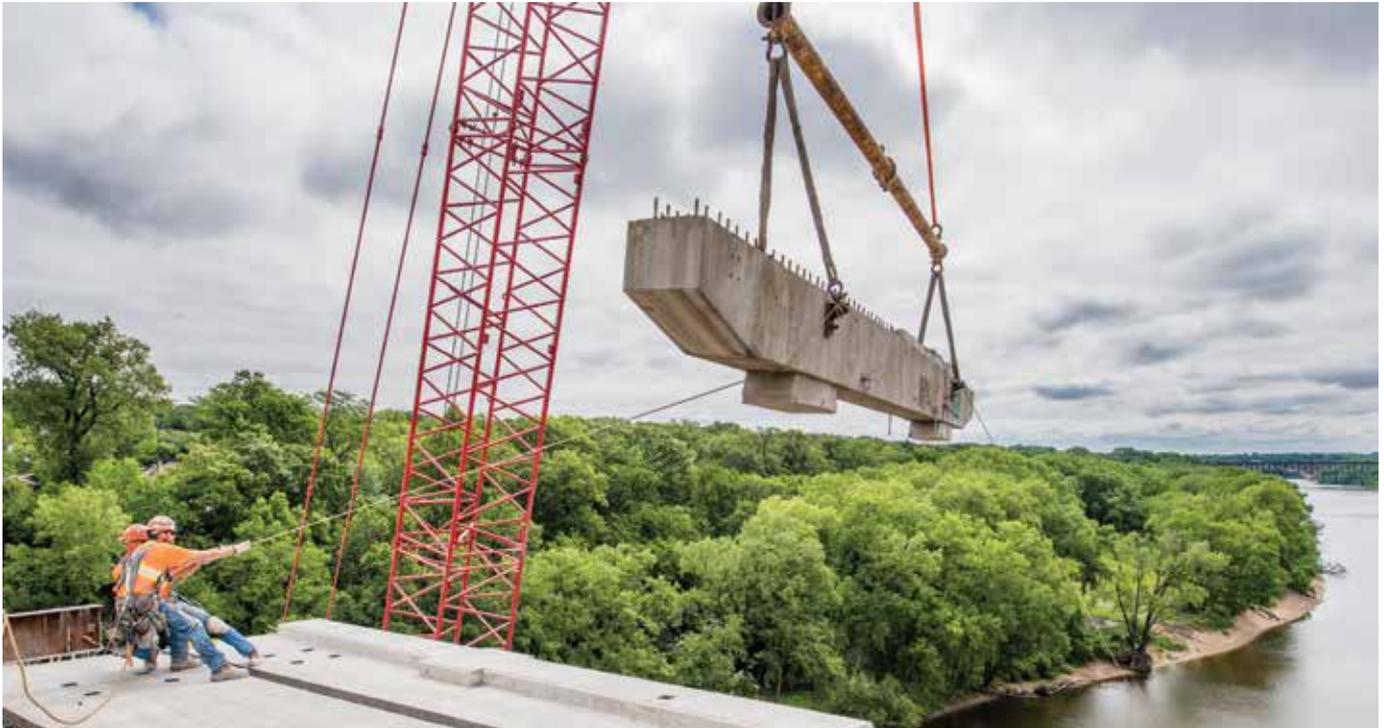
**Fig. 7: Workers remove an existing cap beam from the structure** (photo courtesy of HNTB Corporation and Joe Szurszewski Photography LLC)

The bridge was closed on the evening of May 8, 2016. The contractor immediately started making transverse cuts in the deck at the faces of the cap beams. The deck panels were then removed per an approved demolition sequence. Once two adjacent bays of deck were removed, the common cap beam was removed by wire sawing through the spandrel columns at a predetermined elevation and lifting it from the structure (Fig. 7). The replacement cap beam was then lifted into place and aligned longitudinally and transversely (Fig. 8); shimmed to proper elevation and pitch (accounting for dead load deflection, longitudinal profile grade, cross slope, and thermal expansion of arch ribs); and temporarily anchored with external rods. Using corrugated ducts embedded in the precast cap beam as a guide, the contractor then drilled holes into the existing spandrel column, installed reinforcing bars in the drilled holes with an epoxy adhesive, and placed forms around the gap between the existing spandrel column and the new cap beam. The ducts and gap were then filled with nonshrink grout to complete the connection.

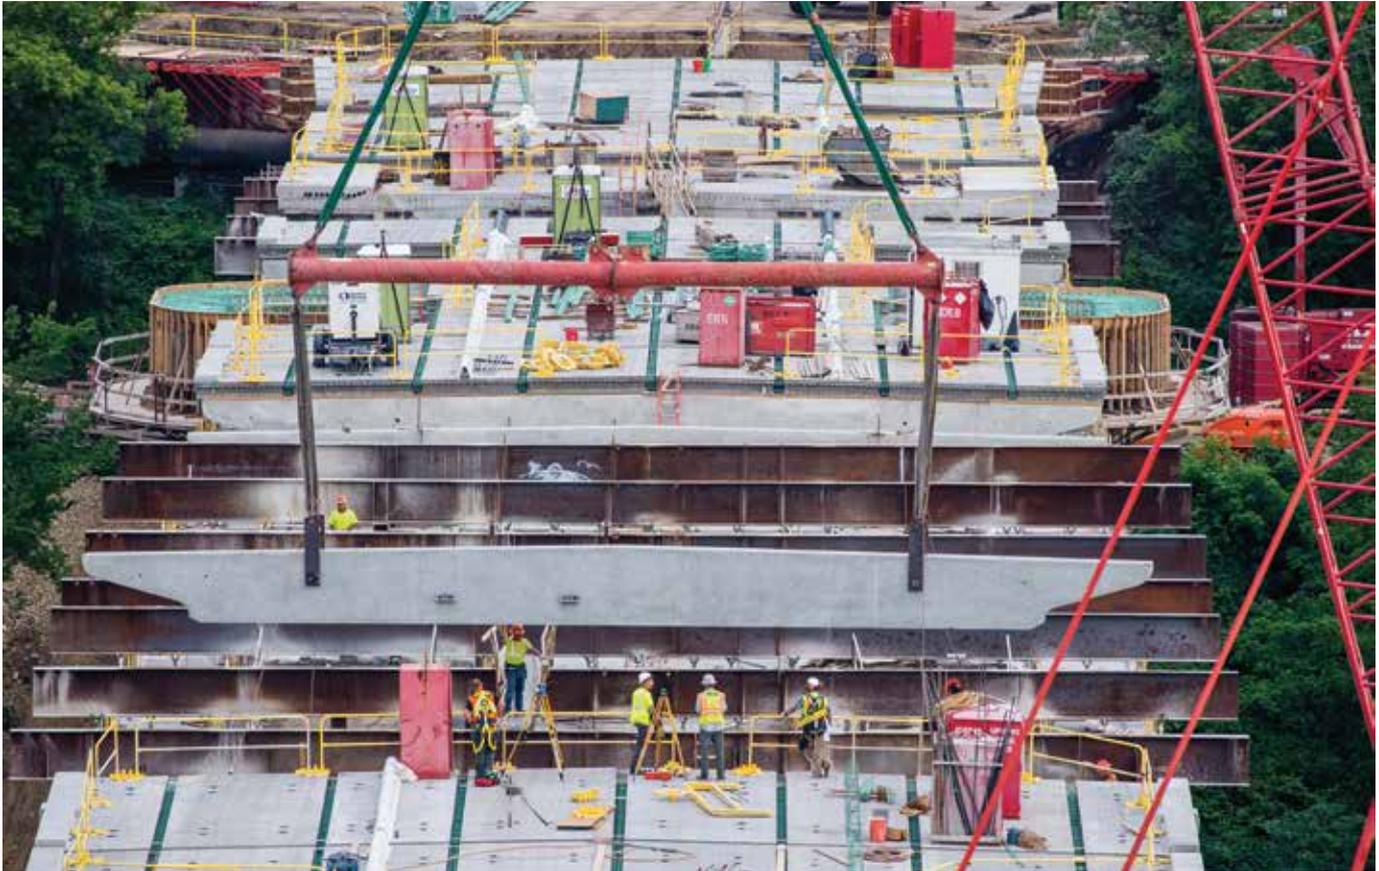
**Fig. 8: An overview of the ABC process. In the foreground, a new cap beam is being placed. New deck panels are already in place in adjacent spans** (photo courtesy of HNTB Corporation and Joe Szurszewski Photography LLC)
